Herd Creek

General Information

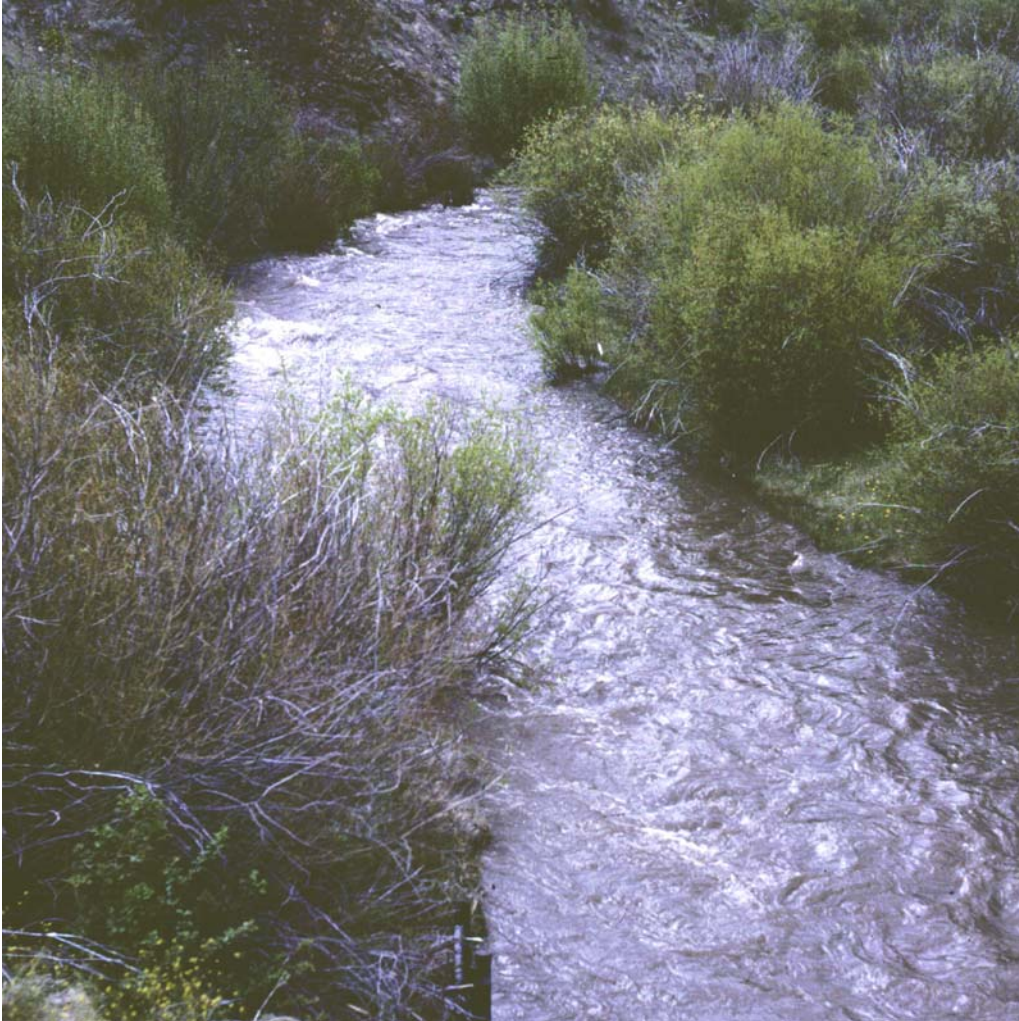
Figure 1. Herd Creek looking upstream from the measurement site.

In 1994 and 1995, personnel of Case Western Reserve University established a stream gage and measured sediment transport and streamflow at this site. Additional measurements included a survey of the stream reach, pebble counts of the substrate surface and transport distance of painted rocks during high flows. Figures 1 and 2 show photographs of Herd Creek looking upstream and downstream from the measurement location for stream discharge and sediment transport.

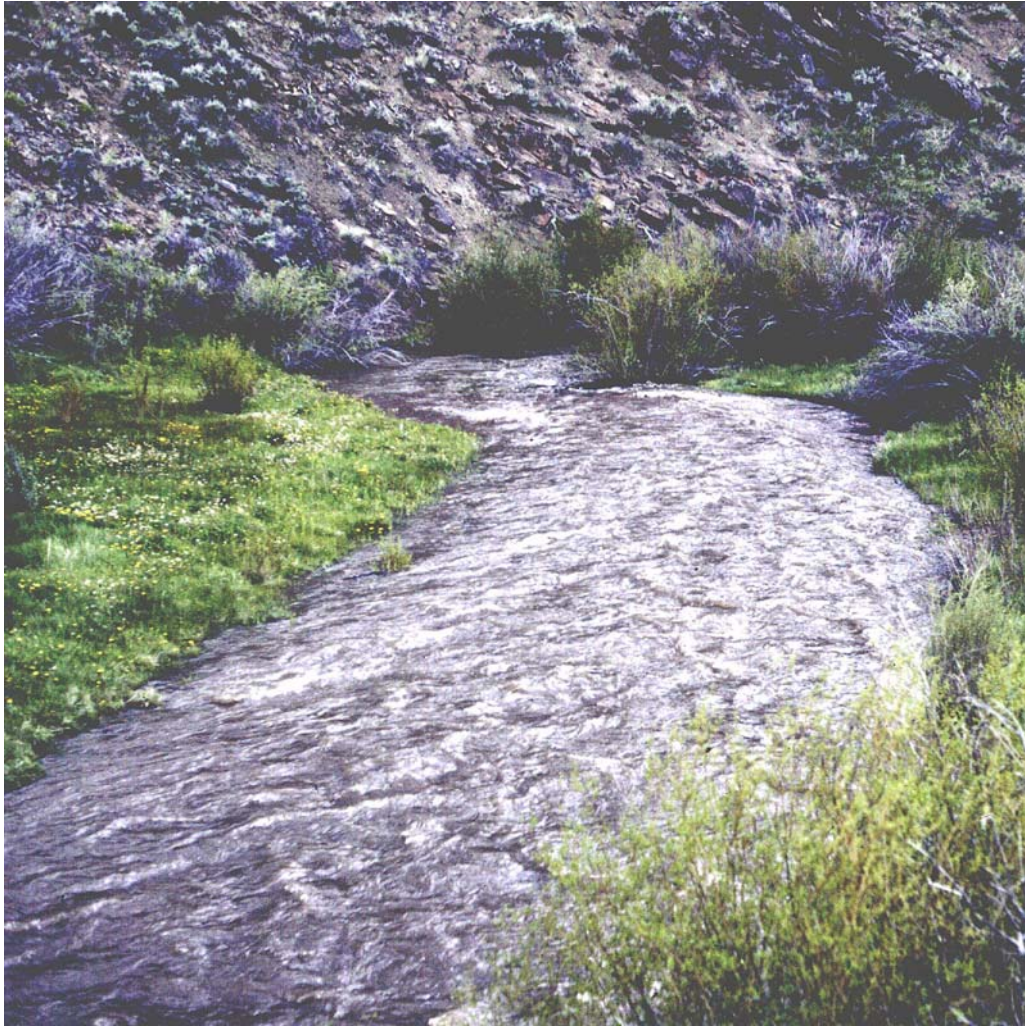
Figure 2. Herd Creek looking downstream from the measurement site.

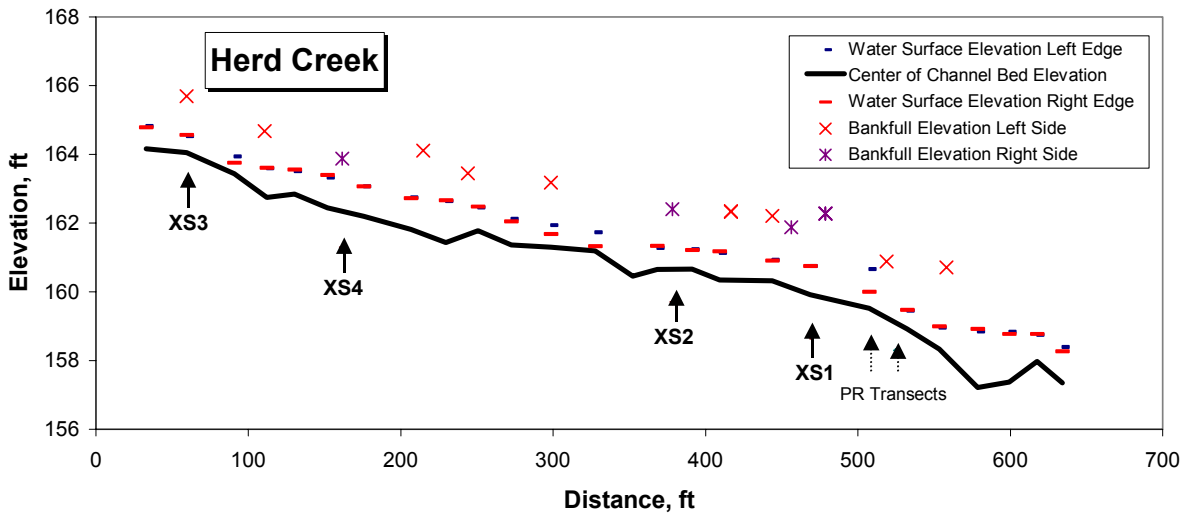
Figure 3 shows the longitudinal profile for the channel bed in the center of the channel, the water surface elevations along each bank at the time of the survey and bankfull flow elevations (floodplains). The average gradient for the study reach is 0.0077 ft/ft. Cross-sections of the channel were surveyed at four locations. Discharge and sediment transport measurements were made at cross-section 1 (XS1) and the movement of painted rocks during the spring and early summer snowmelt flows in 1995 were measured at two transects (PR transects in Figure 3) about 39 and 56 ft downstream of XS1.

Figure 3. Longitudinal profile of the study reach in Herd Creek.

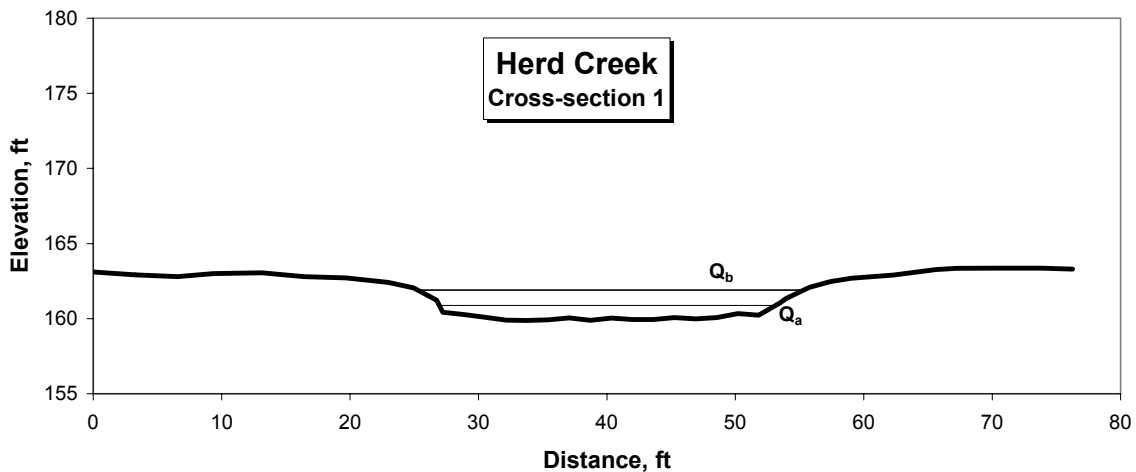
Figure 4. Cross-section of Herd Creek at the sediment transport measurement site.

Figure 4 shows the cross-section at the sediment transport measurement site, cross-section 1. The channel geometry relationships for this cross-section are shown in Figure 5. All data collected in 1994 and 1995 were used to develop the displayed power relationships with discharge. Over the range of discharges when sediment transport was measured (10.2 to 287 ft³/s) estimated stream width, estimated average depth and estimated average velocity varied from 23.9 to 30.31 ft, 0.40 to 1.89 ft, and 1.1 to 5.0 ft/s, respectively. The average reach gradient is 0.0077 ft/ft.

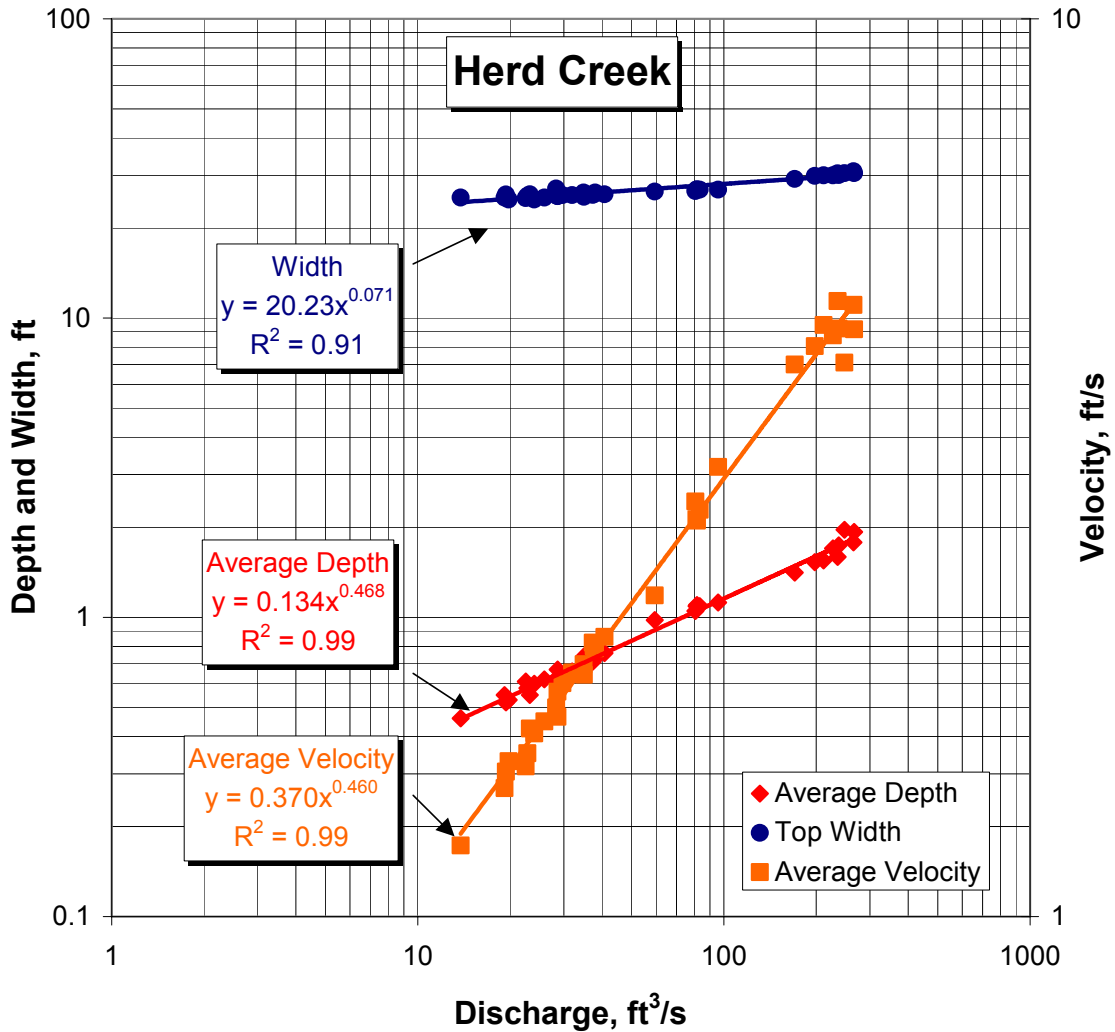
Figure 5. Width, average depth and average velocity versus stream discharge at the measurement cross-section on Herd Creek.

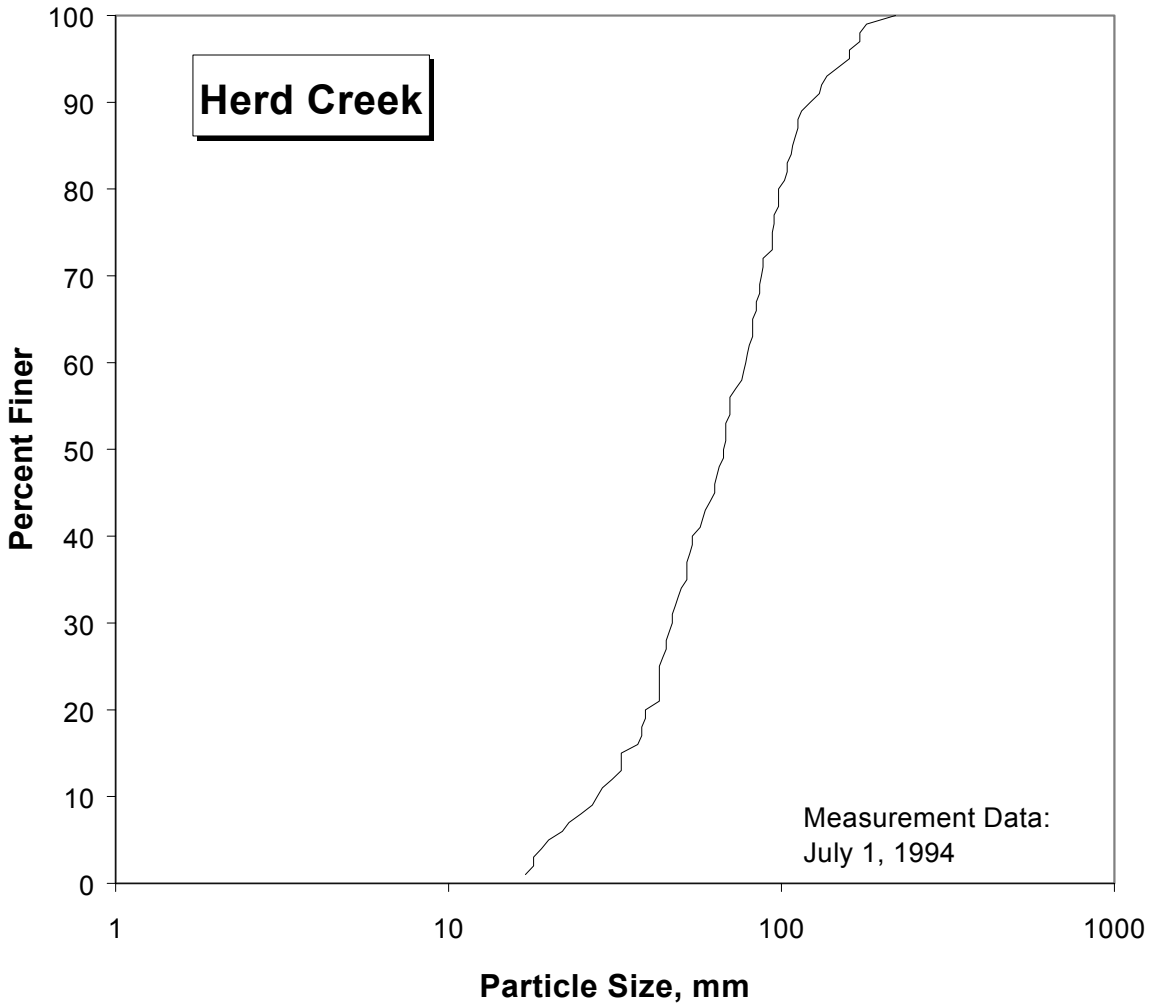
Surface pebble counts were made along four transects near cross-section 1 in July 1994. No subsurface core samples were collected at this site. The average D_{50} and D_{90} for the surface material was 67 mm and 122 mm, respectively (Figure 6).

Figure 6. Particle size distribution for surface material samples in Herd Creek.

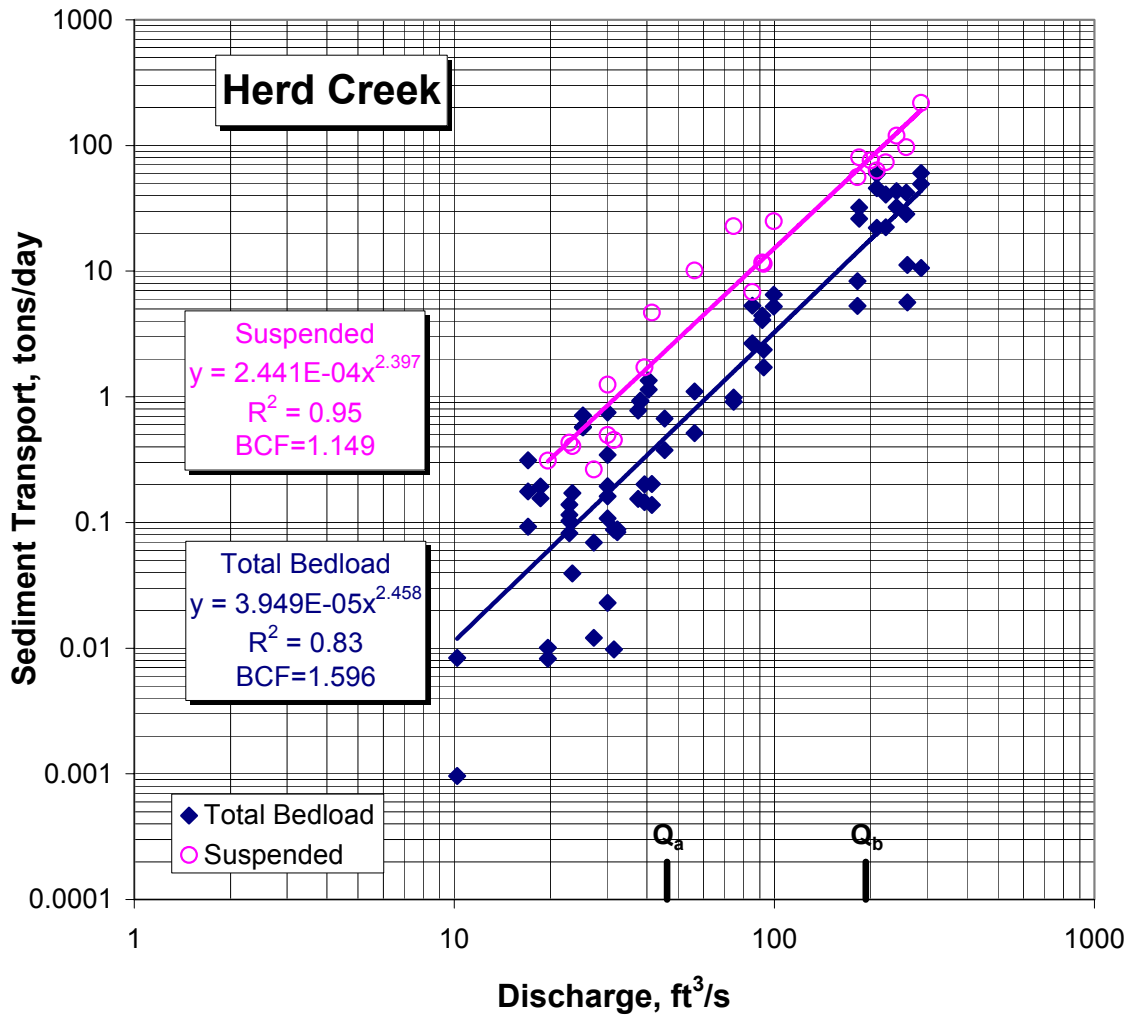
Sediment transport measurements made in 1994 and 1995 include 72 measurements of bedload transport and 23 measurements of suspended sediment transport. Sediment transport measurements spanned a range of stream discharges from 10.2 ft³/s (0.22Q_a; 0.05Q_b) to 287 ft³/s (6.21Q_a; 1.49Q_b). Bedload transport ranged from 0.000964 to 60.2 t/d and suspended transport ranged from 0.265 to 218 t/d. Over the range of measured discharges, suspended transport accounts for the majority of the material in transport with a four to over five fold greater transport rate than the bedload transport rate (Figure 7).

Figure 7. Bedload and suspended load transport rate versus discharge.

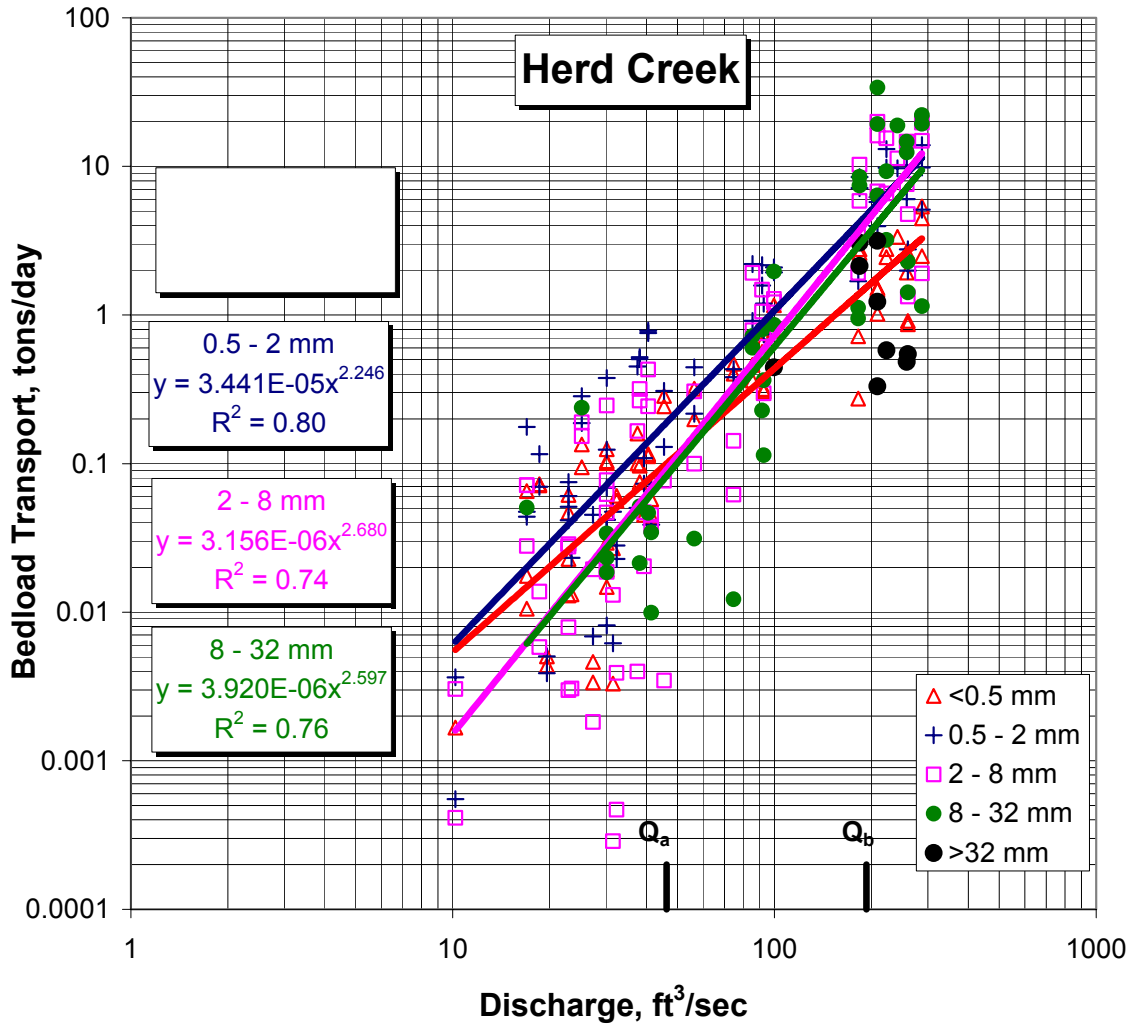
The bedload transport rates by size class (Figure 8) shows that the larger rates are associated with material in the 0.5 to 2mm diameter size class. No curve fitting was done for sediment >32mm diameter since only nine of the samples contained this size class of material. All discharges transporting material >32mm exceeded 100 ft³/s.

Figure 8. Bedload transport rate versus discharge for selected size classes.

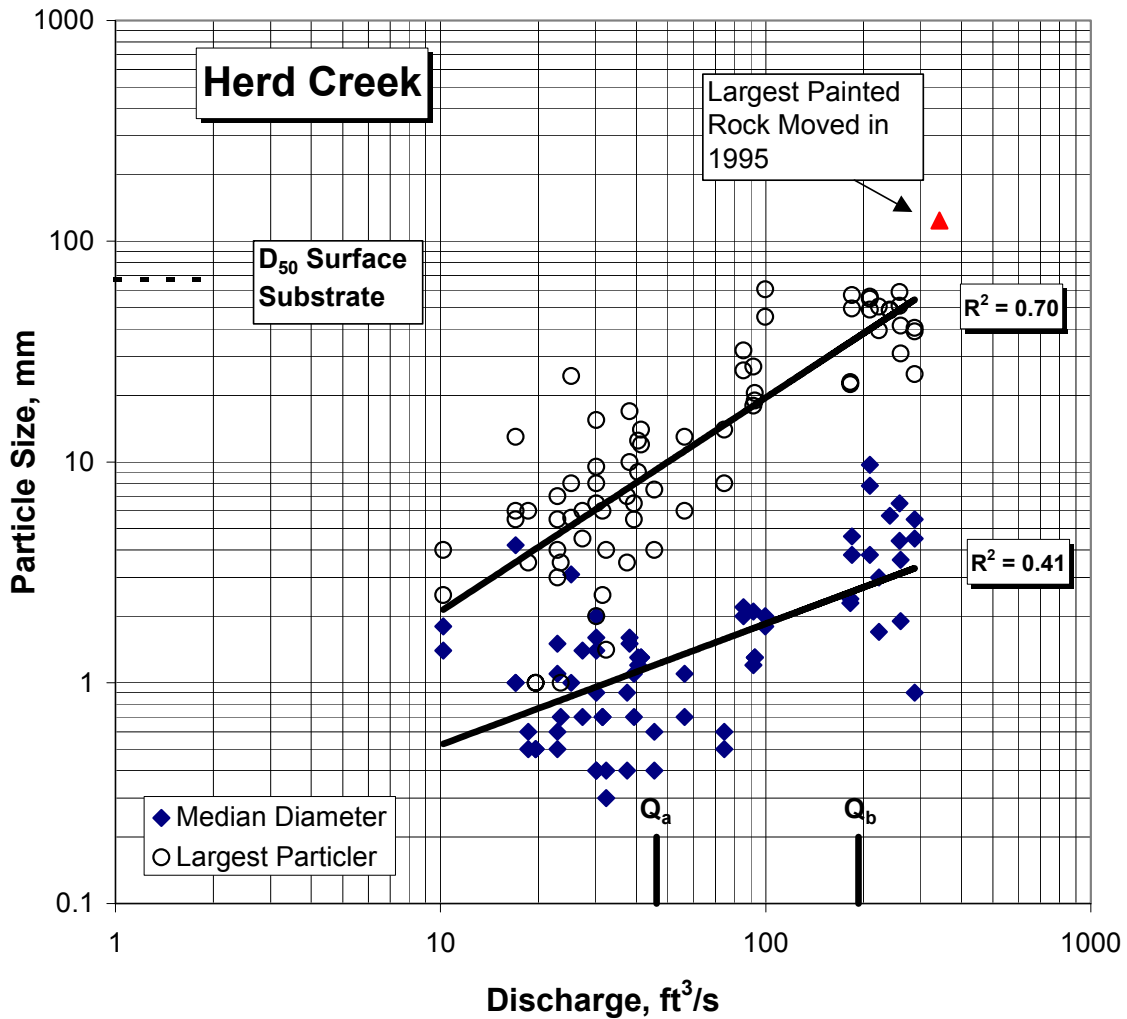
The size of the largest particle in the bedload sample increased with discharge (Figure 9). The largest particle measured in a bedload sample was 60.5 mm at a discharge of 95.7 ft³/s. At discharges greater than bankfull (193 ft³/s) the largest particle usually exceeded 40 mm. There is also a trend of increasing median size of the bedload sample with increasing discharge. The D₅₀ for most of the bedload samples was in the sand size, 0.5 to 2.0 mm. The largest median diameter of a bedload sample was 9.7 mm. The information on the largest particle in the bedload sample and observations of painted rock movement suggest that discharges at or slightly above the bankfull discharge are capable of moving the median diameter particles on the channel surface.

Figure 9. Median size of the bedload sample and the largest particle size versus stream discharge for Herd Creek.

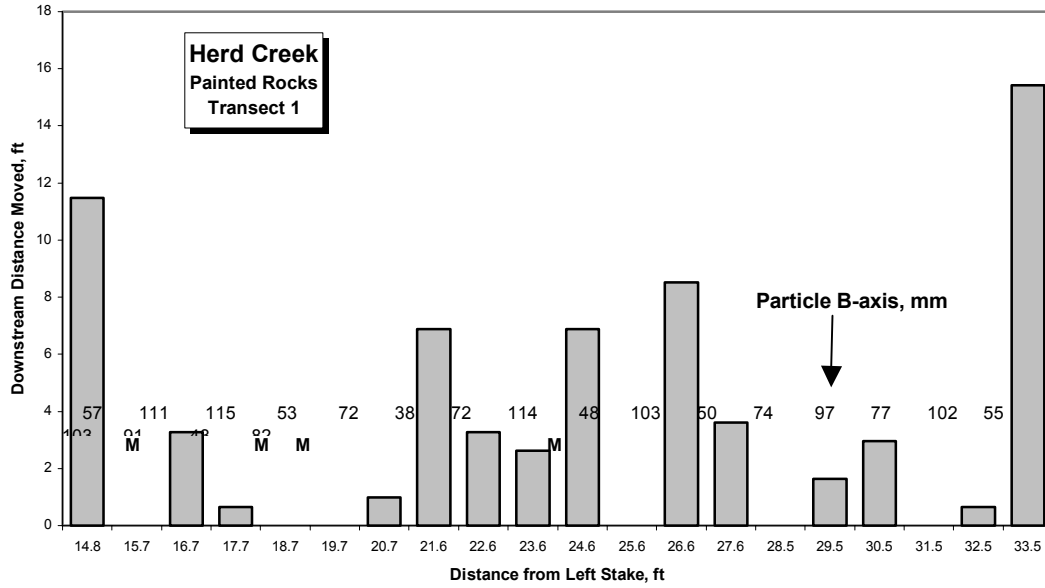
A total of forty painted rocks were placed across two transects (twenty per transect) on April 27, 1995. Daily mean discharge on the day of rock placement was $18.75 \text{ ft}^3/\text{s}$. The size of the rocks ranged from 38 to 115 mm diameter (b-axis) which represents the D_{17} up to the D_{89} of the surface particle size distribution measured at cross-section 1. Transport of the rocks as of July 12, 1995 are shown in Figures 10 and 11.

Figure 10. Transport distance of painted rocks at transect 1.

Twenty five of the forty rocks were found. Of those found, only two had not moved. The maximum transport distance was 15.4 ft for a 82mm diameter rock and the average was transport distance was 4.5 ft. The largest daily mean discharge during this period was 275 ft³/s on June 28, 1995 and the largest instantaneous discharge was 342 ft³/s.

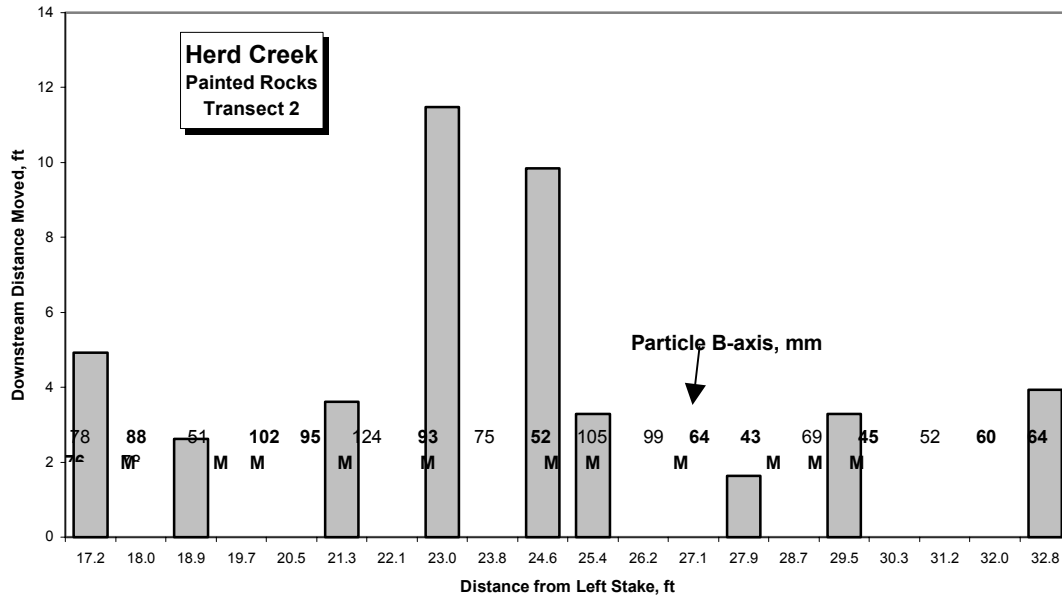
Figure 11 Transport distance of painted rocks at transect 2.
