Post-fire rill and gully formation, Schultz Fire 2010, Arizona, USA

Daniel G. Neary^{a,*}, Karen A. Koestner^a, Ann Youberg^b, Peter E. Koestner^c

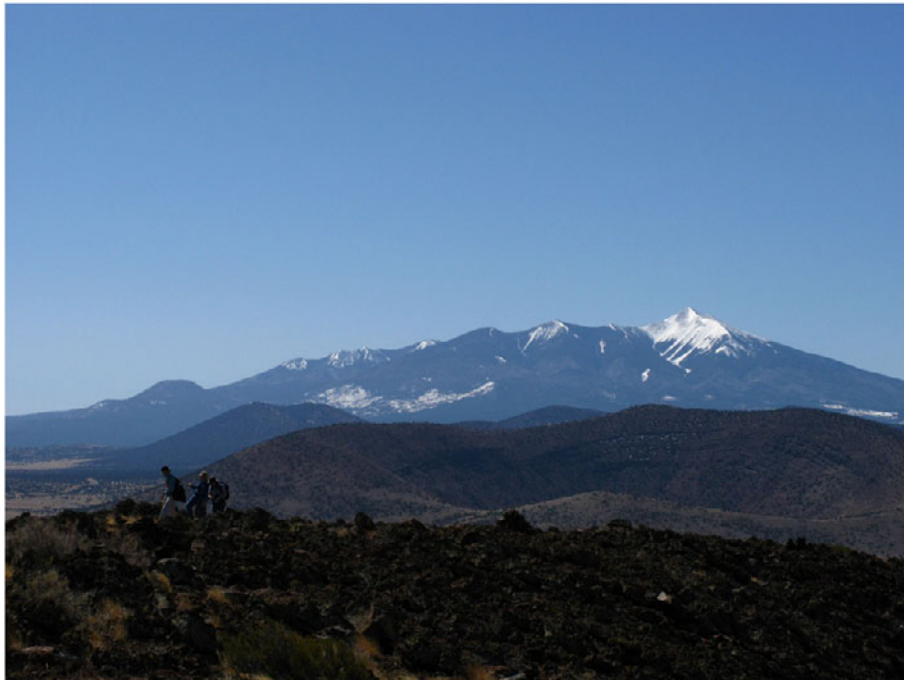
Fig. 2. San Francisco Peaks stratovolcano, Coconino National Forest, north central Arizona, USA (Photo courtesy of the American Geophysical Union).

The Schultz Fire burned 6100 ha on the eastern slopes of the San Francisco Peaks, a dormant Middle Pliocene to Holocene-aged strato-volcano in northern Arizona (Figs. 1 and 2). The fire burned in the

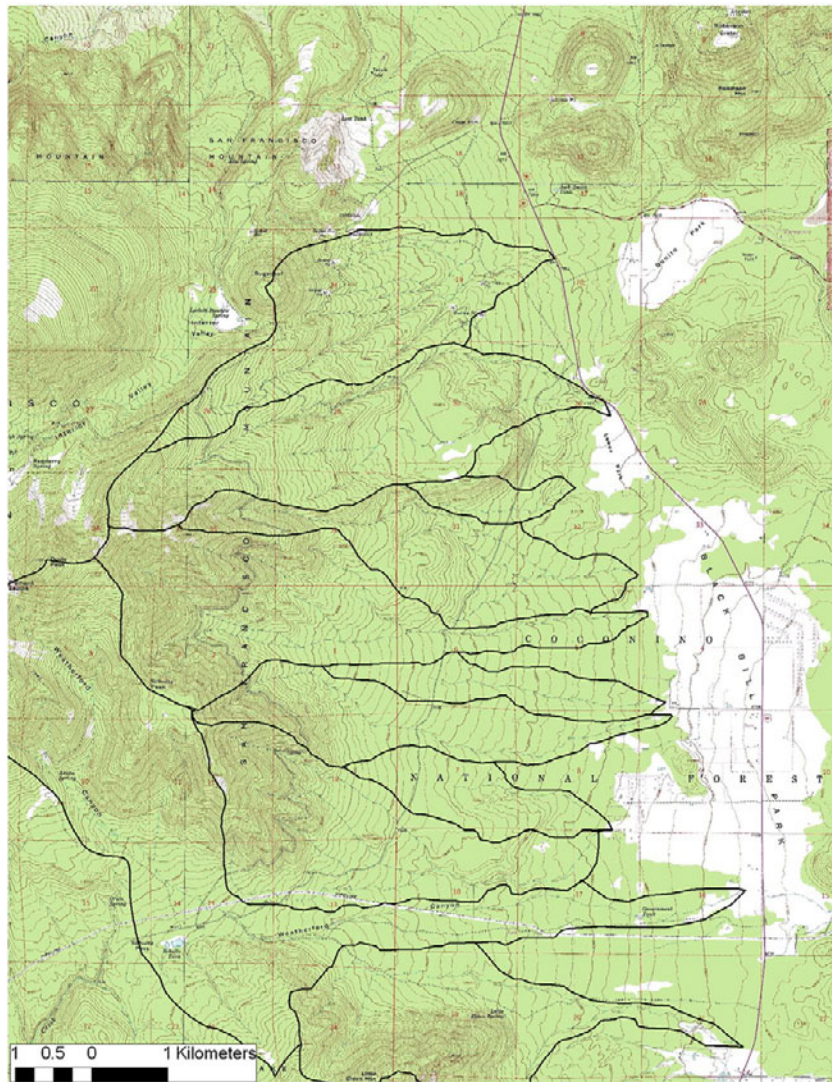
Fig. 3. Principal watersheds and topography of the east flank of the San Francisco Peaks, Arizona, burned by the Schultz Fire of 2010.

The development of an extensive rill and gully network fundamentally changed the hydrologic response of the upper portions of every catchment (Fig. 3). Rills are self-organizing erosion systems characterized by numerous and randomly occurring small channels of only several centimeters in depth and centimeters to tens of meters long (Nearing et al., 1997). Sediment yields increase with increasing slope, rill spacing decreases as slope angle increases, rill patterns show an increased elongation and parallelism on steeper slopes, and hillslope rills tend to be evenly spaced on bare, straight slopes (Favis-Mortlock et al., 2000).

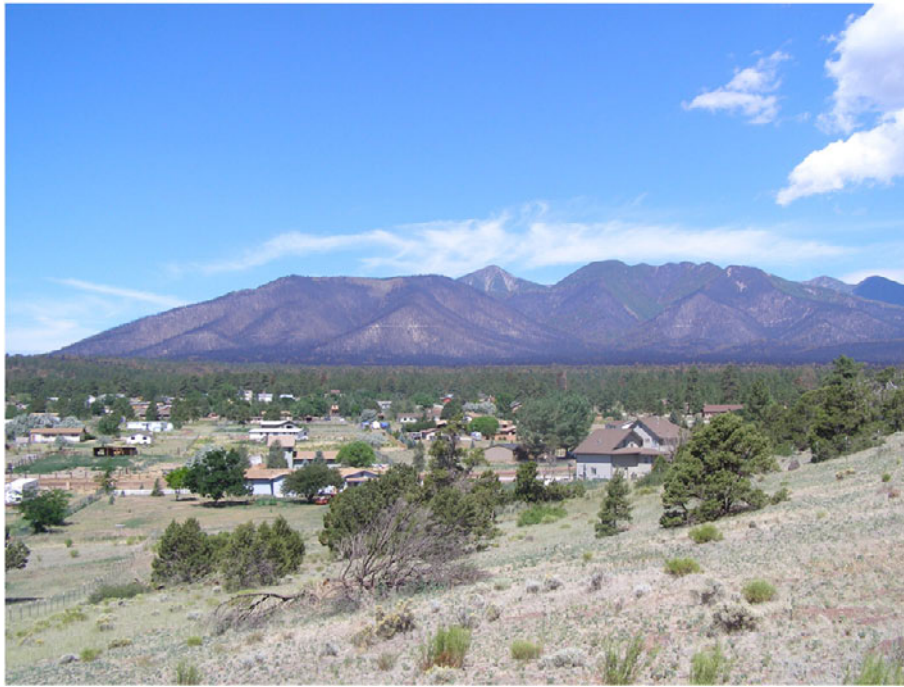
Fig. 4. Schultz Fire burned area on the east flank of the San Francisco Peaks, Coconino National Forest, Arizona, USA, July 2010. (Photo by Daniel G. Neary).

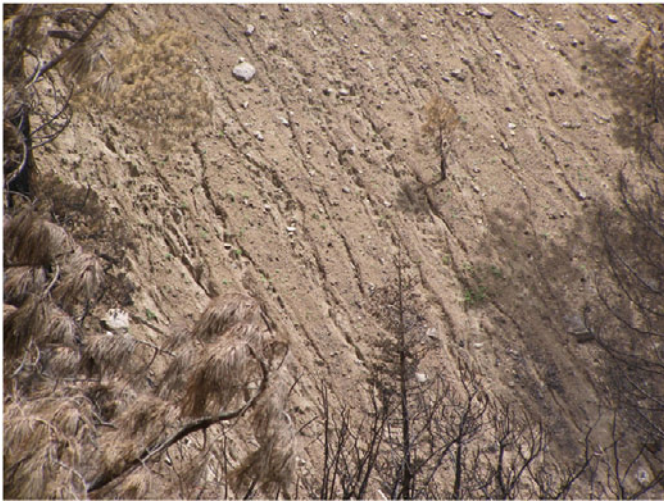
Fig. 8. Rill systems developing on a steep slope, Schultz Fire, 2010, above the Waterline Road, Coconino National Forest, Arizona, USA. (Photo by Daniel G. Neary).

Rills on the upper slopes of the San Francisco Peaks within the Schultz Fire perimeter are now 10–20 cm deep into the B and C horizons running the entire length of slopes. Parallel rills in the right of the Fig. 8 photo demonstrate the transition from sheet erosion to rill erosion. The rills are 30 to 40 cm apart crossing entire slopes. They are up to 5 cm deep and beginning to coalesce. The rills shown in Fig. 9 are transitioning to small gullies 20 to 30 cm deep. They are cutting below the ponderosa pine surface root systems and into fragmented and weathered C horizon andesite and dacite.

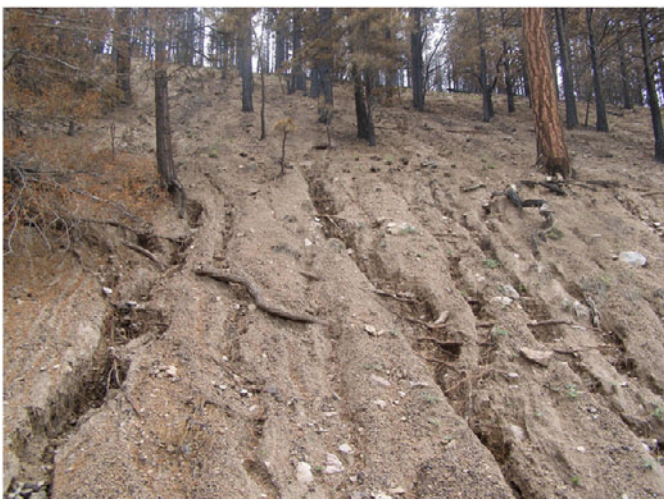
Fig. 9. Small gully development on steep slopes above the Waterline Road after the Schultz Fire, 2010, Coconino National Forest, Arizona, USA. (Photo by Daniel G. Neary).

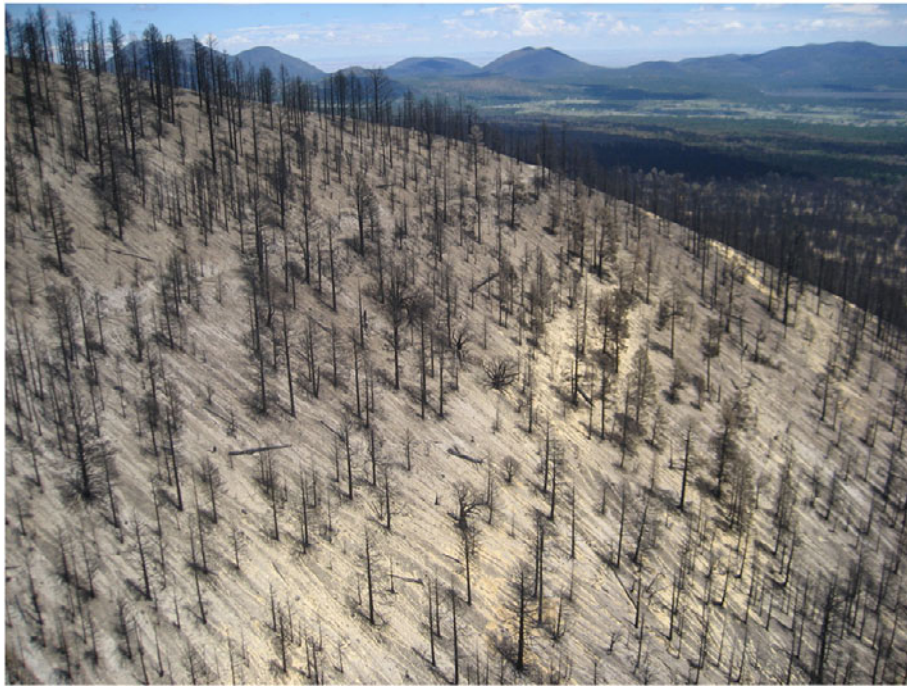
Fig. 10. Rill and gully system on a ridge of the San Francisco Peaks marked by straw mulch removal. (Photo courtesy of the USDA Forest Service).

The large scale of the rilling and gullying on hill slopes after the Schultz Fire is shown in Fig. 10. This slope was treated with straw mulch, but the runoff from July 20, 2010, that created the rill and gully system, stripped the mulch off soil surfaces. All the slopes of the upper watersheds where gradients are 100% or more, were eroded in a similar fashion. These rills and gullies did not exist before the Monsoon runoff started as demonstrated by post-fire and pre-runoff photos.

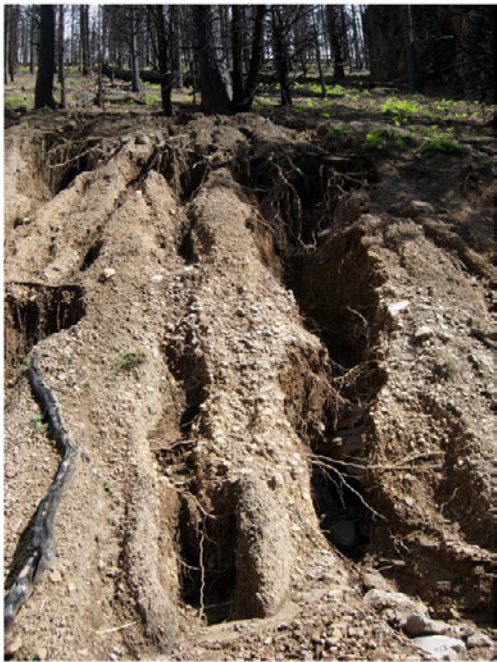
Fig. 11. Large rill systems developing on a steep slope (right) and small gully development beginning (left). Schultz Fire, 2010, above the Waterline Road, Coconino National Forest, USA. (Photo by Daniel G. Neary).

Small lateral gullies that are 50–100 cm deep (Fig. 11) merge into now deeply incised main drainage gullies (3–5 m deep) that occupy previous swales in the upper mountain slopes (Fig. 12). Despite the elevation and precipitation regime there are no perennial stream channels on these slopes. Flood flows in July and August of 2010 incised deeply into the slopes consisting of volcanic colluvial material and ash and tephra deposits. In many places the gullies have cut down to bedrock, thus allowing subsequent flood flows to scour out fresh, un-weathered material. The pre-fire slope surface was about 1 m above the individual on the left in Fig. 12. The deep incisions of these main drainage gullies has lowered the base level of the smaller lateral gullies, leading to additional headward cutting of the gully system, and the potential for lateral expansion.

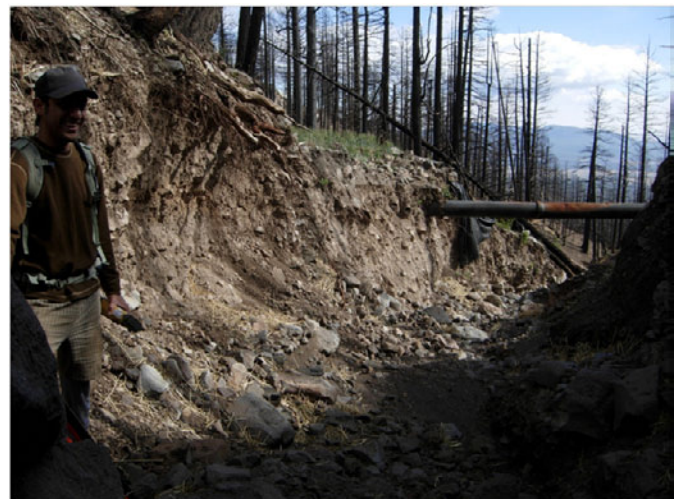
Fig. 12. Deeply incised (3 m) main drainage gully within the Schultz Fire along the Waterline Road, Coconino National Forest, Arizona, USA. (Photo by Karen A. Koestner).

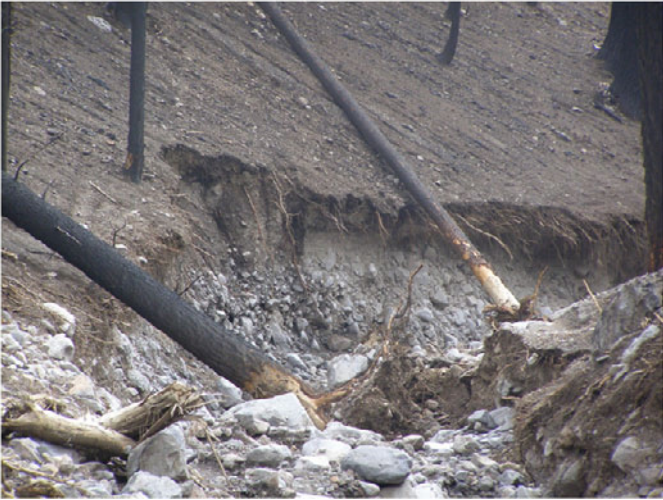
Fig. 13. Deeply incised drainage channel with over-steepened banks and exposed root systems, Schultz Fire 2010, Coconino National Forest, Arizona, USA. (Photo by Daniel G. Neary).

Fig. 13 shows the exposed tree root systems along a deeply incised drainage channel below the Waterline Road (contour-following road

along the western side of the watersheds shown in Fig. 3). The over-steep banks are future sources of sediment for the drainage channels which now convey surface runoff and sediment rapidly into the major drainages. The tree roots pose another future erosion hazard. There is a potential for mass slope failures on the steep slopes of the upper watersheds within the Schultz Fire perimeter 5 to 10 years after the fire due to decomposition of the roots. Tree roots provide much of the shear strength on forested slopes, but shear strength
