Legacy Roads and Trails Monitoring Project

Road Decommissioning in the Bull Run River Watershed

Mt. Hood National Forest

December 2, 2011

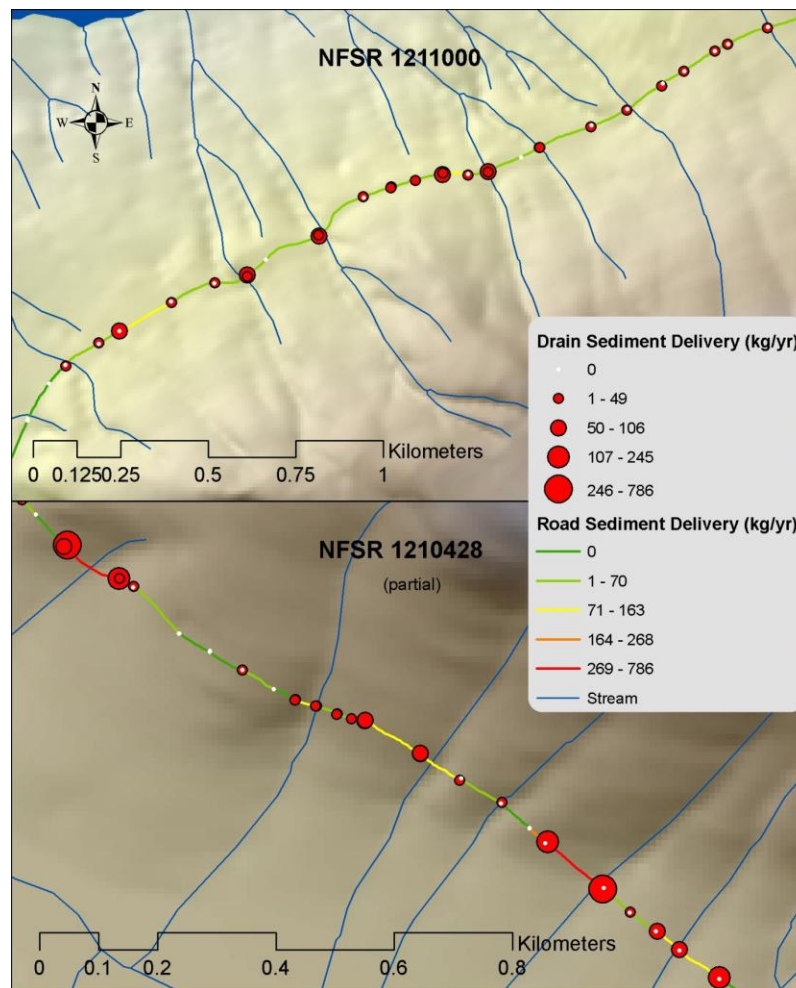
Figure 3. Fine sediment delivery to channels by road segment and drain point, pre-treatment roads. The road line is colored to indicate the mass of fine sediment that is generated on the road and delivered to the channel (kg/yr). The size of the circle indicates the accumulated mass of sediment delivered through each drain point (kg/yr).

Delivery of eroded sediment to the channel network is determined by observations of each place that water leaves the road. Each of these drain points is classified as delivering, not delivering, or uncertain. No estimate of fractional delivery is made because there is insignificant hillslope sediment storage in locations where there is a clear connection to the channel under most circumstances. For this analysis, uncertain observations were treated as delivering. A map of the road surface sediment delivery and the accumulated sediment delivered through drain points is shown for the 1211000 and 1210428 roads in the pre-treatment condition (Figure 3).

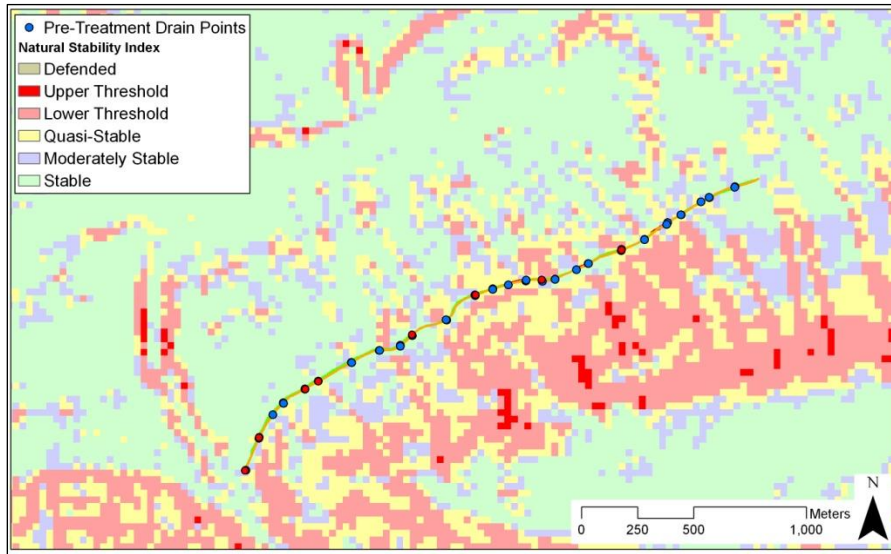
Figure 4. Natural slope stability risk in the area of NFSR 1211000. The yellow, blue, and green cells are generally predicted to be stable, while the pink, red, and tan cells are generally predicted to be unstable.

Figures 4 and 5 illustrate the risk and change in risk in the area. SINMAP was run initially to determine the intrinsic stability of the slopes over which the road traverses and to identify locations that are at high risk of failure without the road. The modeled inherent landslide risk is generally moderate in the area of the treated roads (Figure 4). This is contrary to the low risk that was observed during this inventory and by forest personnel, as well as described by Shulz (1980) and confirmed during the 1995/1996 large storm events (T. Parker, personal communication, 2008). A second stability index run was performed to address the effects of road water contribution to drain points on the original, pre-treatment road network. A third model run was performed to illustrate the risk of shallow landsliding with the modified road drainage system resulting from the restoration treatments.

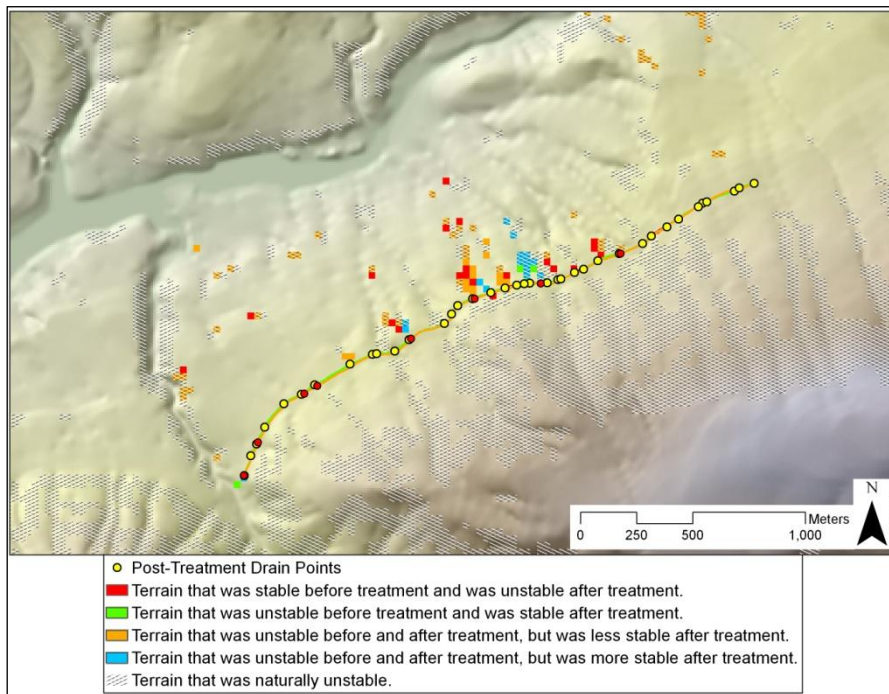
In Figure 5, the areas along NFSR 1211000 where the treatment increased modeled risk (red and orange cells) or decreased risk (green and blue cells) is shown. Increased risk is due to the addition of new drainage (e.g. waterbars) or more water at existing drain points over steep slopes. The areas where risk was decreased are due to the removal of water from those features, usually due to the removal of that drain point (such as a ditch relief culvert). Cross-hatch areas are places where the terrain was modeled as unstable without road drainage. These areas cannot be made to be stable by road treatments.

Figure 5. The changes in slope stability due to treatment. Red and orange cells far downslope of the road are model artifacts, and are unlikely to be real risk increases.

The net effect of the decommissioning treatments, which replaced old drainage features and added new features, achieved the goal of reducing risk at only a few of the modeled high risk locations in the sample area. However, modeled risks were increased in even more locations because in steep, dissected terrain, it is difficult to redirect discharge from one location without elevating the risk in other locations.

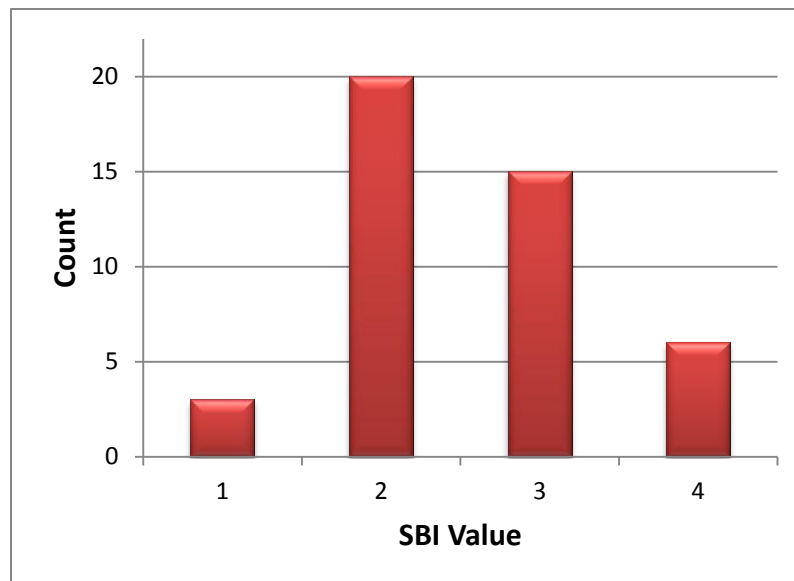
The SBI values for the pre-treatment stream crossings were moderate to high with an average value of 2.5 for the 45 stream crossings (Figure 6). This is out of a range of 1 to 4, where 1 suggests no risk of blockage. Of the 21 stream crossings with SBI values of 3 and 4, all had culvert to channel width ratios of 0.7 or less. The angle at which the stream enters the pipe was greater than 75 degrees on 10 of them, generally due to an intermittent or ephemeral channel running down the cutslope and ditch slightly up-road from the pipe. All 45 stream crossing pipes were removed during decommissioning, which completely eliminated the risk of pipe plugging (Figure 7). Thus the post-treatment SBI score was zero at all crossings.

Figure 6. Distribution of Stream Blocking Index values for pre-treatment group.

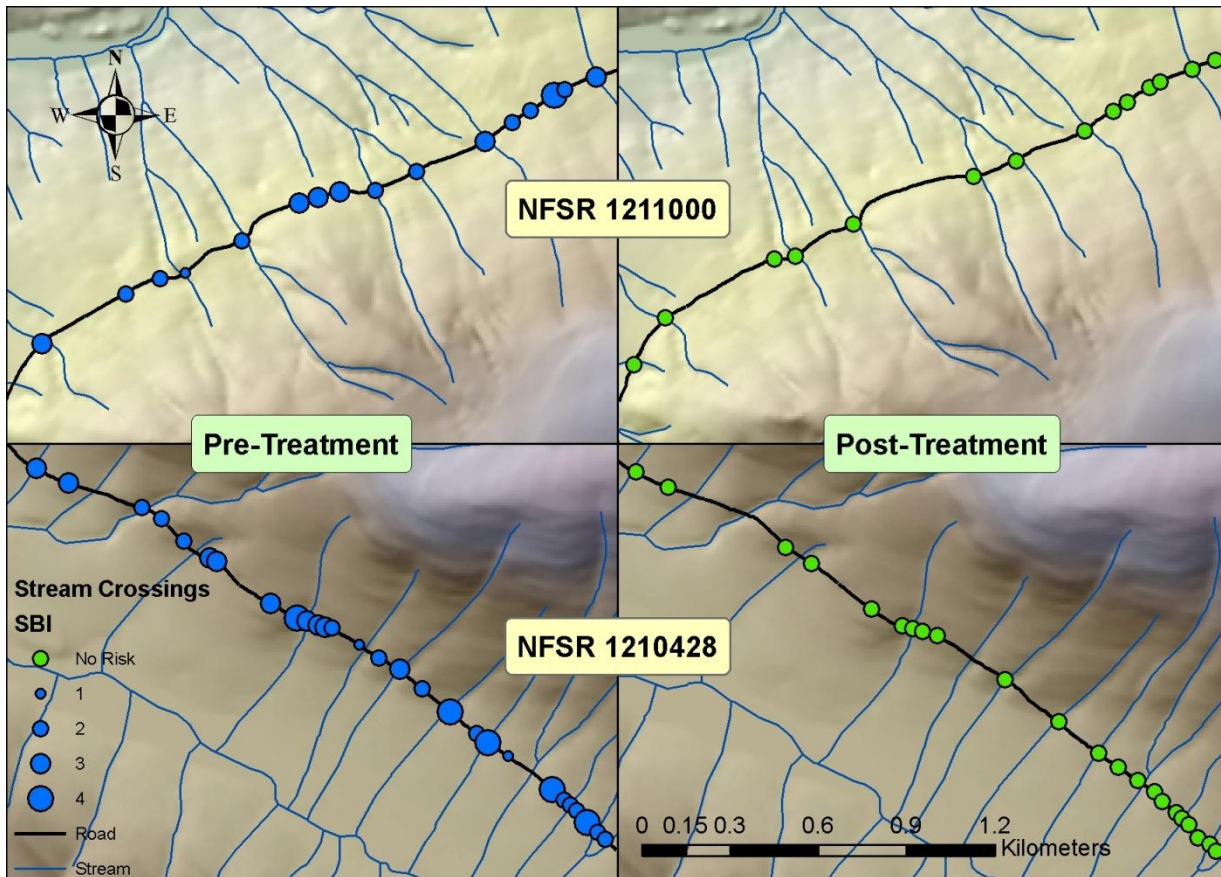
Figure 7. SBI values of stream crossings.

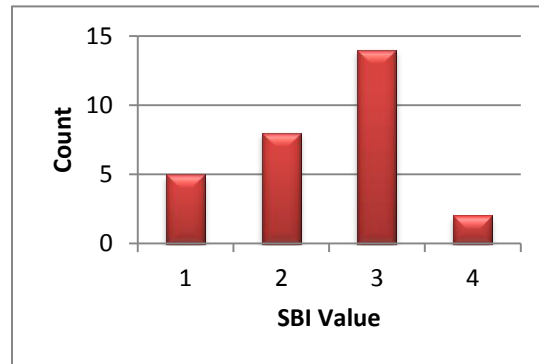
Figure 14. Distribution of Stream Blocking Index values for control group.

Control roads had an average SBI of 2.3 (Figure 14), and none of the 29 observed crossings had diversion potential. There was 4430 yd³ of fill at risk. One crossing on road 1200-222 was observed to have plugged and overtopped before the storm-event (Figure 13). This crossing had an SBI of 3. There were no changes to the stream crossings due to the storm event.
