Power Fire GRAIP Watershed Roads Assessment

Bear River, Panther Creek, and
Upper North Fork Mokelumne River Watersheds
Eldorado National Forest, California

April, 2016

U.S. Forest Service

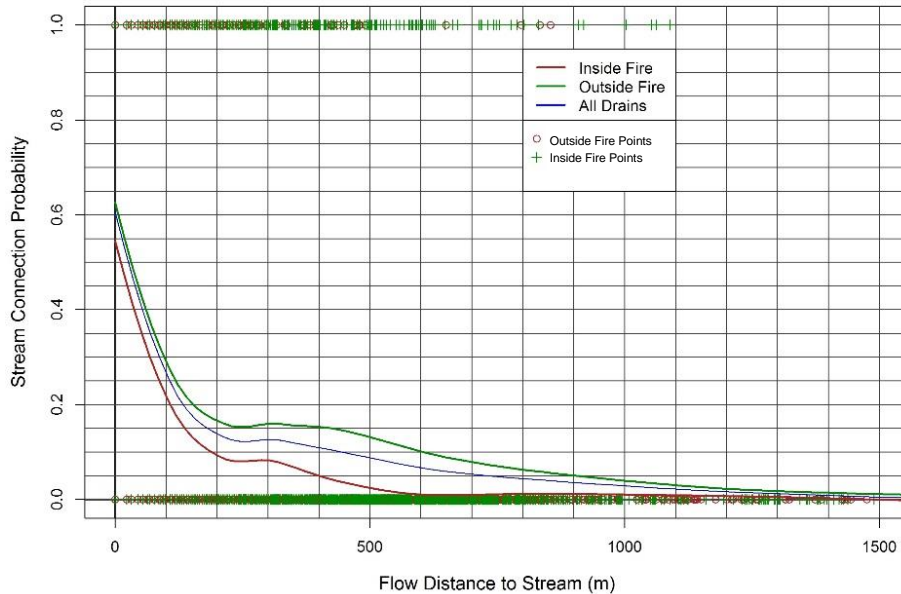
Figure 10. There was a lower probability of stream connection within the Power Fire perimeter compared to drain points outside the fire.

were 2,914 drain points outside the fire perimeter, and 1,743 within. Outside of the fire, for drain points that discharged 50 m (160 ft) from a modeled stream, probability of connection was the same as for all points (45%), but for drain points within the fire perimeter probability at that same distance from stream was 35%. At drain point distance to stream of 400 m (1,310 ft), outside the fire, probability of connection was 15%, and for drain points within the fire perimeter, 5%. This counterintuitive pattern may be due to a variety of factors resulting from post-fire effects, but one factor observed commonly in the study area that has been shown to reduce post-fire erosion was vegetation cover (MacDonald 2014). The extreme density of vegetation regrowth during the 10 years after the fire is shown in Figure 4.

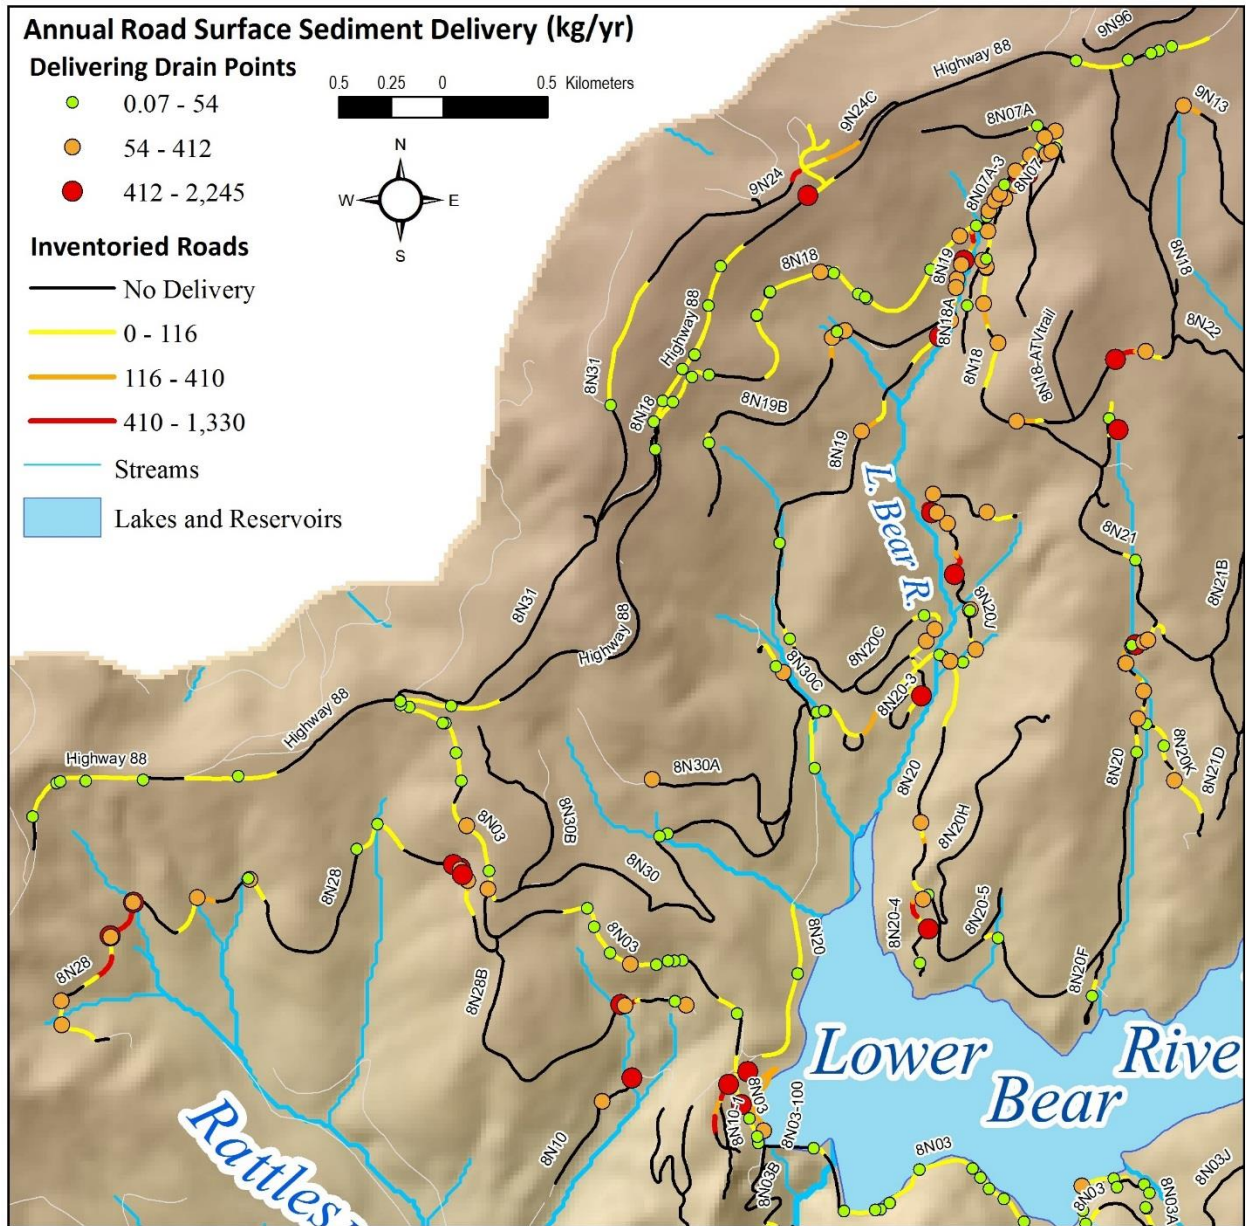
Delivery of eroded road surface sediment to the channel network was determined by observations of each place that water left the road. Each of these drain points was classified as either delivering or not delivering to the stream network. No estimate of fractional delivery was made, because there is insignificant hillslope sediment storage in locations where there is a clear connection to the channel under most circumstances. A map of the road surface sediment delivered through each drain point (Appendix B, Map 2), and by each road segment (Appendix B, Map 3) is shown for the whole watershed, as well as for a portion of the project area northwest of Lower Bear River Reservoir (Figure 11).

Figure 11. Road surface fine sediment delivery to channels by road segment and drain point in the northwest portion of project area. The road lines are colored to indicate the mass of fine sediment delivered to channels. Drain points that do not deliver sediment are not pictured.

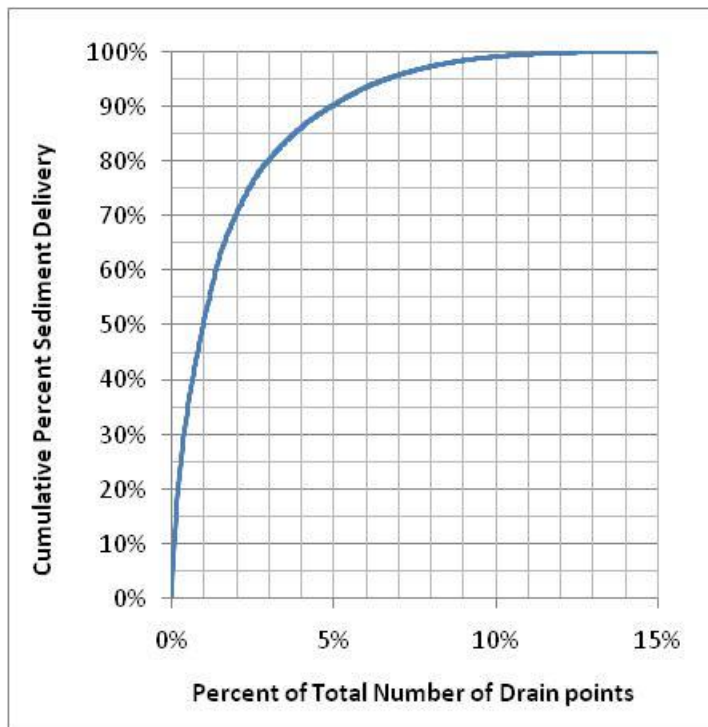
Diffuse drains were the most effective drain point type at reducing hydrologic connectivity with 1% of diffuse drains stream connected. They received 11% of total estimated sediment produced, but routed only 1% of total estimated sediment delivered (Table 2, Figures 12, 13, and 14). Waterbars and ditch lead-offs were also very effective. Six percent of all waterbars, and 8% of ditch lead off drains were stream connected. Waterbars received 13% of all sediment produced, but delivered only 6% of all sediment delivered. Lead off ditch drains received 3% of sediment produced, and delivered 2%. Non-engineered drains, broad based dips, stream crossings, and ditch relief culverts routed the most delivered sediment (91% collectively; 21 Mg/yr , 17 Mg/yr , 14 Mg/yr , and 12 Mg/yr , respectively; Table 2, Figures 12, 13, and 14). Four percent of broad based dips and non-engineered drains were located within 10 m (33 ft) of a stream crossing point. Including these with stream crossings, there was a 72% delivery rate. Drain points outside of 10 m (33 ft) of a stream crossing had a 10% delivery rate. Sediment delivery in the study area was routed by a very small percentage of all drain points. 90% of delivered sediment was routed via only 5% of drain points (Figure 15, Appendix B, Map 2).

Figure 15. Cumulative percent of total sediment delivered to streams by percent of drain points. 5% of all drain points deliver 90% of the delivered sediment.

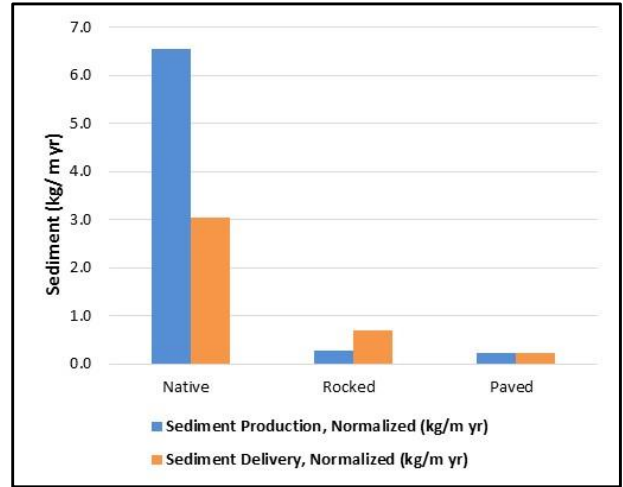
Using the same method of normalizing sediment production and delivery by road length it was clear that native surface roads produced and delivered the vast majority of sediment (Figure 17). Roads with native surfaces were 20% (67 km, 42 mi) of road length surveyed, 93% (6.5 kg m⁻¹ yr⁻¹) of normalized road surface sediment produced, and 77% (3 kg m⁻¹ yr⁻¹) of normalized road surface sediment delivered. Roads with crushed rock surfaces were 51% (173 km, 108 mi) of road length surveyed, 4% (0.3 kg m⁻¹ yr⁻¹) of normalized sediment produced, and 18% (0.7 kg m⁻¹ yr⁻¹) of normalized sediment delivered. Roads with paved surfaces were 29% (97 km, 60 mi) of road length surveyed, 3% (0.2 kg m⁻¹ yr⁻¹, in ditches and on shoulders) of normalized sediment produced, and 6% (0.2 kg m⁻¹ yr⁻¹) of normalized road surface sediment delivered.

Figure 17. Normalized sediment production and delivery by road surface type. The values are normalized by road length for each surface type category.

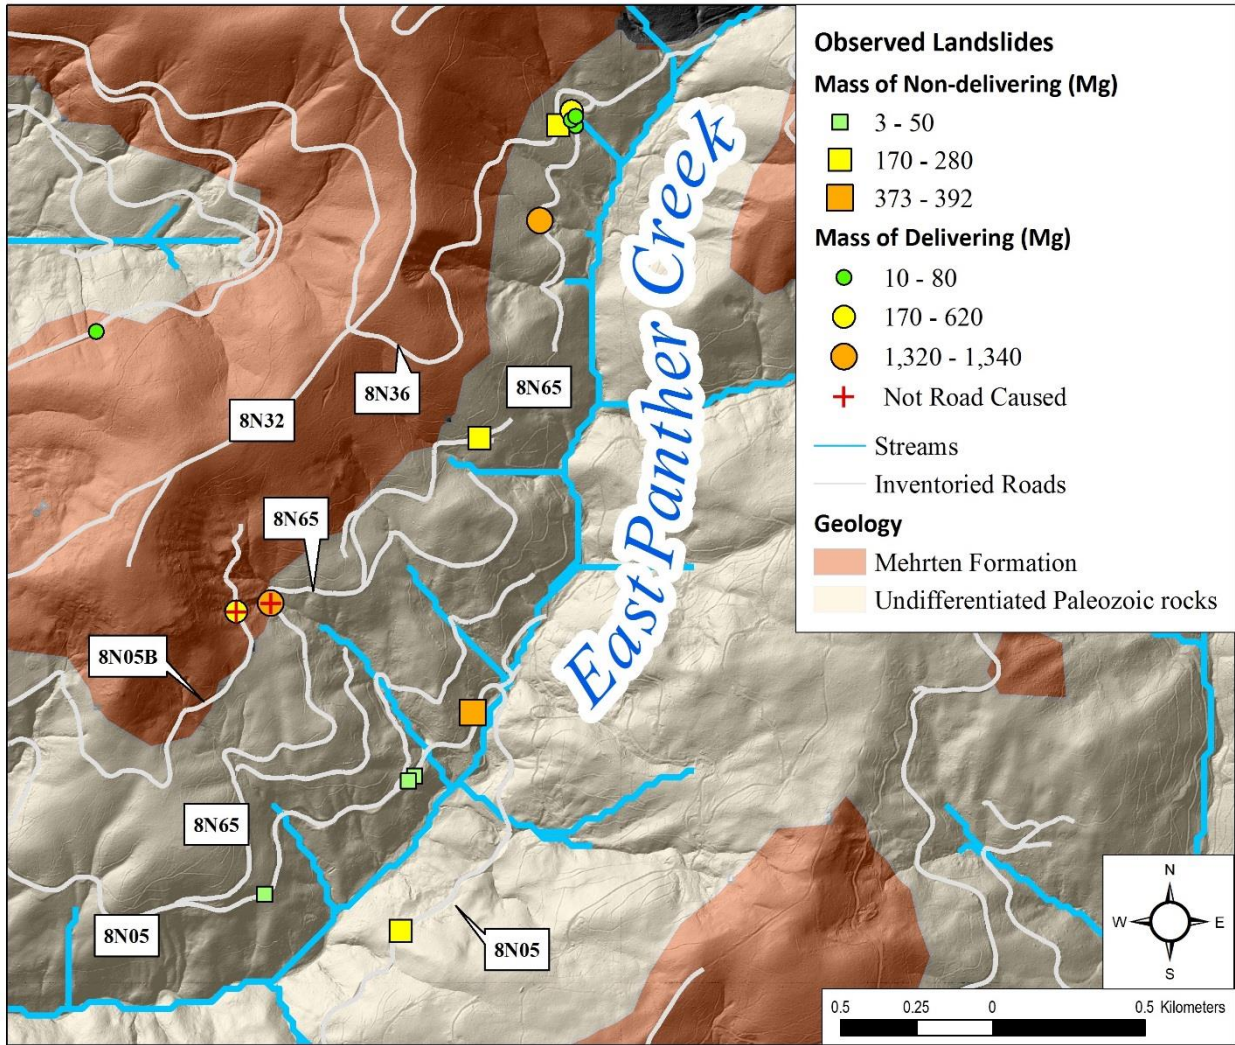
Susceptibility to landslides in the study area may be governed in part by underlying geology (Figures 6 and 20, Spittler 1995). Though not strongly prone to landslides within the unit, the Mehrten Formation is permeable and readily transmits water, commonly creating springs and decreasing stability in less permeable underlying units (Spittler 1995). McKitterick (1995) classifies East and West Panther Creek watersheds as High to Extremely Susceptible to landslides due to recently observed landslide activity, and the Mehrten formation overlying undifferentiated Paleozoic metamorphic rocks (Figure 20) which were observed in the field to be a highly deformed, steeply tilted assemblage that formed weathered surfaces with an abundance of clay. The inherent decompositional properties of this unit, along with spring flow from the base of the Mehrten Formation may play a role in the high frequency of landslides in the area. The metamorphic Paleozoic rocks, though susceptible to landslides, hold steep slopes and develop soils that are not highly erodible. The Mehrten Formation forms soils susceptible to surface erosion which may be a factor in the high occurrence of gully formation in the unit throughout the study area (see Section 5.5). The degree of weathering in granite has a strong influence on its erodibility and landslide susceptibility (Spittler 1995, Clayton et al. 1979). Areas of very poorly cohesive, deeply weathered, biotite rich granite are highly susceptible to surface erosion. Areas within the project area with weathered granitic rocks, especially near the Mehrten contacts are classified as Moderately Susceptible to rotational landslides (McKitterick 1995). In this study large rotational landslides were not recorded and few shallow landslides were observed in granitic areas.

Figure 20. Locations of the majority of all observed landslides; East Panther Creek area.

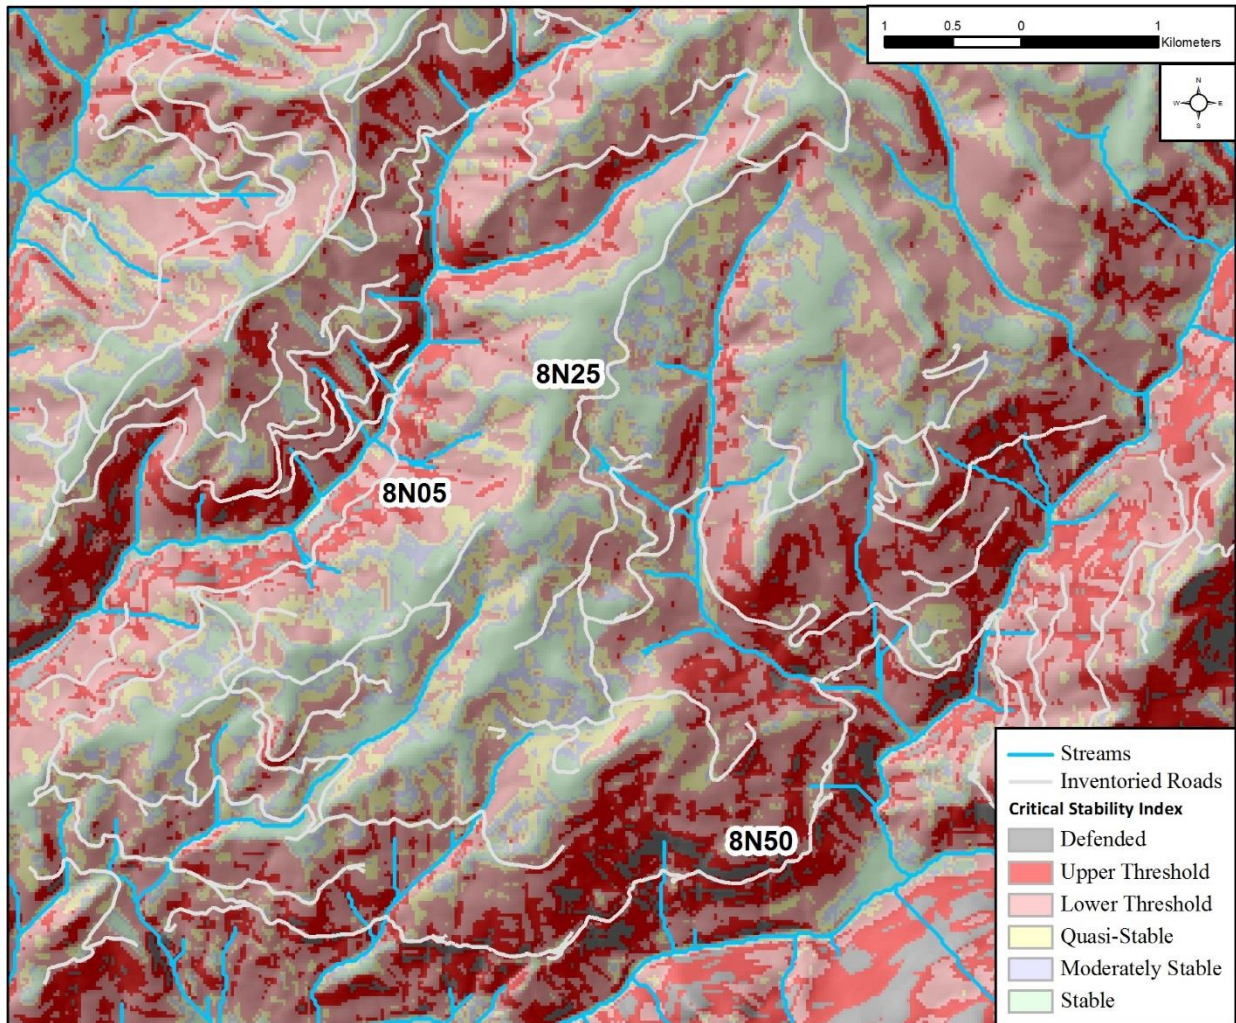
Figure 24. Natural slope stability in the south central portion of the Power study watersheds. The yellow, blue, and green cells are generally considered to be stable, while the pink, red, and grey cells are generally considered to be unstable.

Figures 24, 25 and 26 illustrate the natural slope stability risk and change in risk with the addition of water from roads to hillslopes in the south central portion of the Power study watersheds. SINMAP was calibrated and run initially to determine the intrinsic stability of the slopes over which the roads traversed, and to identify locations that were at a high risk of failure without the road. The surveyed roads were distributed across various landscapes with 56% of inventoried road length located in SINMAP predicted naturally unstable, and 44% in stable areas. Modeled landslide risk was generally high across the steepest slopes throughout the watershed (Figure 24; Appendix B, Map 7).

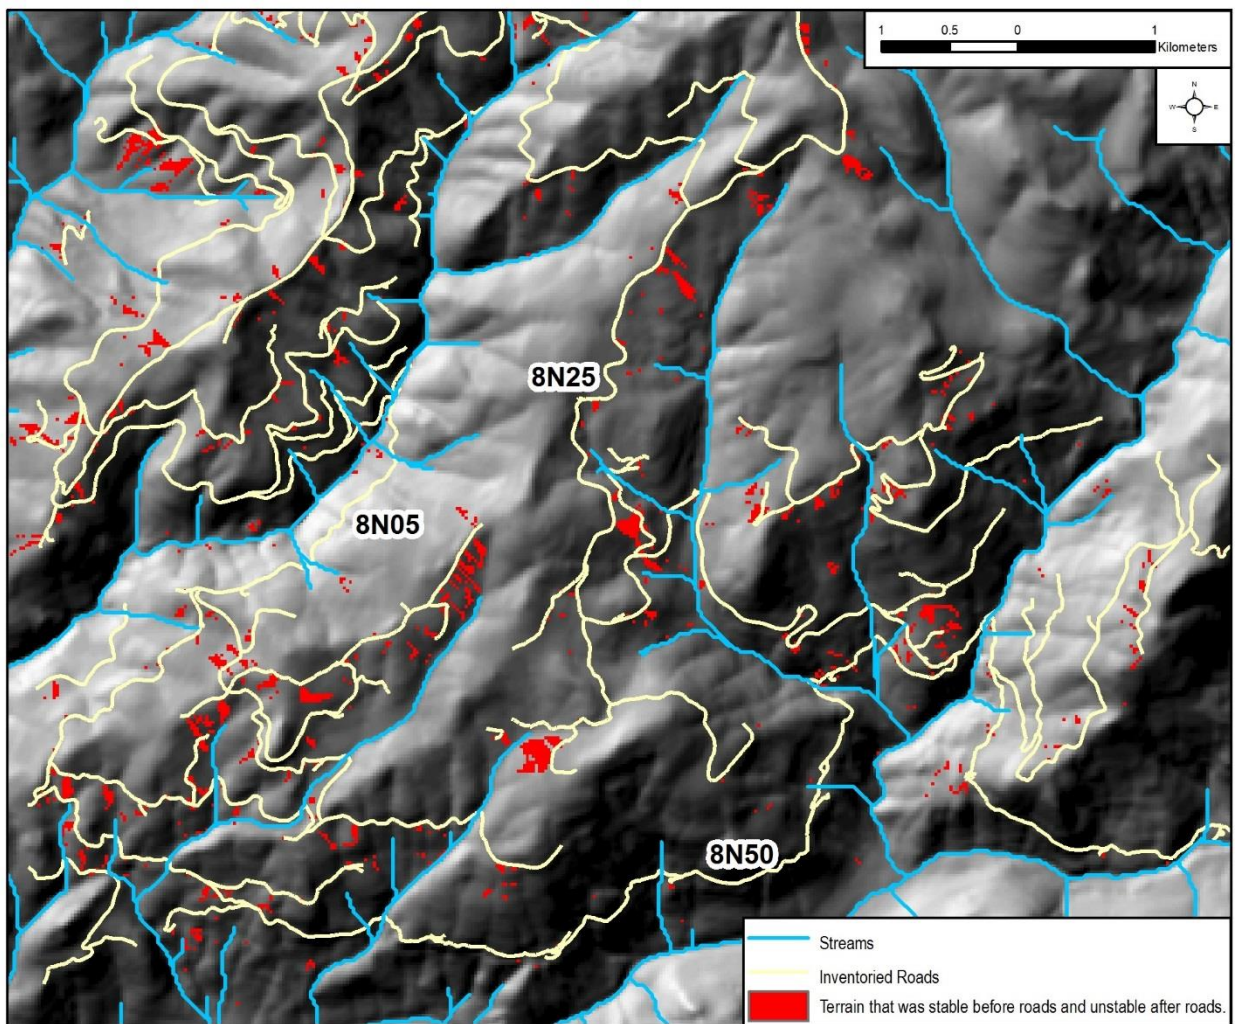
A second calibrated stability index run was performed to address the effects of road water contribution to drain points. In Figure 25, shown in red are the areas in the south central portion of the watershed where roads changed the risk from the stable category (stable, moderately stable, quasi-stable from Figure 24, above) to the unstable category (lower threshold, upper threshold, defended). These were areas where road drainage was installed

Figure 25. The most significant slope stability risk changes due to the roads in the south central portion of the Power study watersheds. The risk in the red areas was significantly increased.

over slopes predicted by SINMAP to be naturally stable, and the added water increased the predicted instability of the area into the unstable category.

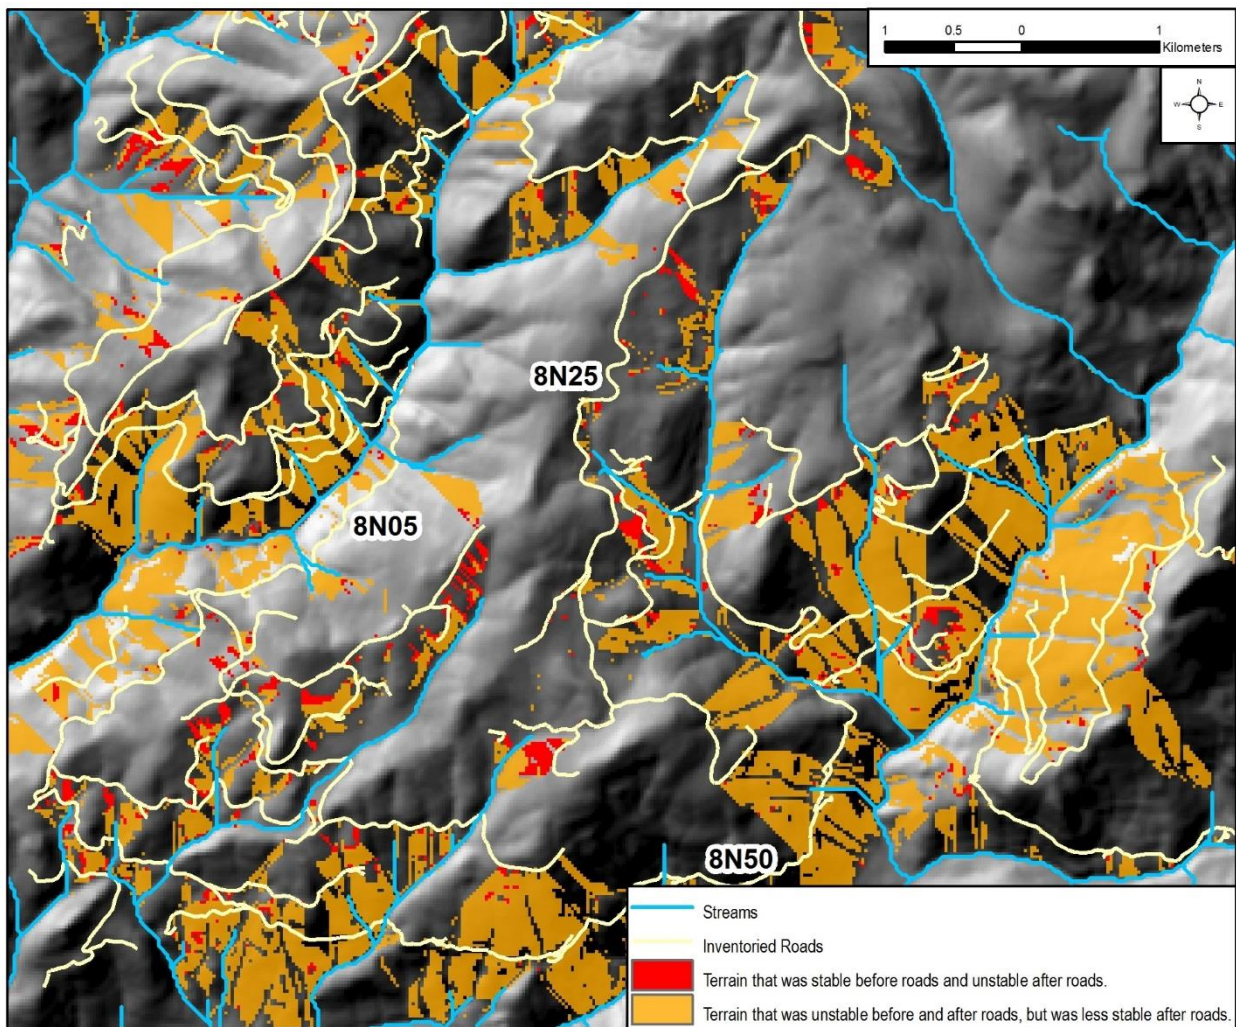
Figure 26 adds the areas where the risk of shallow landsliding was high both before and after road construction. The orange cells are areas where the predicted risk increased (became less stable) after road construction. The terrain was unstable (lower threshold, upper threshold) prior to road construction, but changed to a higher degree of instability due to the installation of road drainage over naturally unstable slopes. Risk may not extend as far downslope as is shown. In steep and wet areas with naturally high landslide initiation risks such as this, it may be difficult to place road drainage in such a way that risk is not significantly increased.

Figure 26. Changes in slope stability risk in the south central portion of the Power study watersheds. The orange areas are where the risk increased. Risk may not extend as far down slope as shown in some locations.

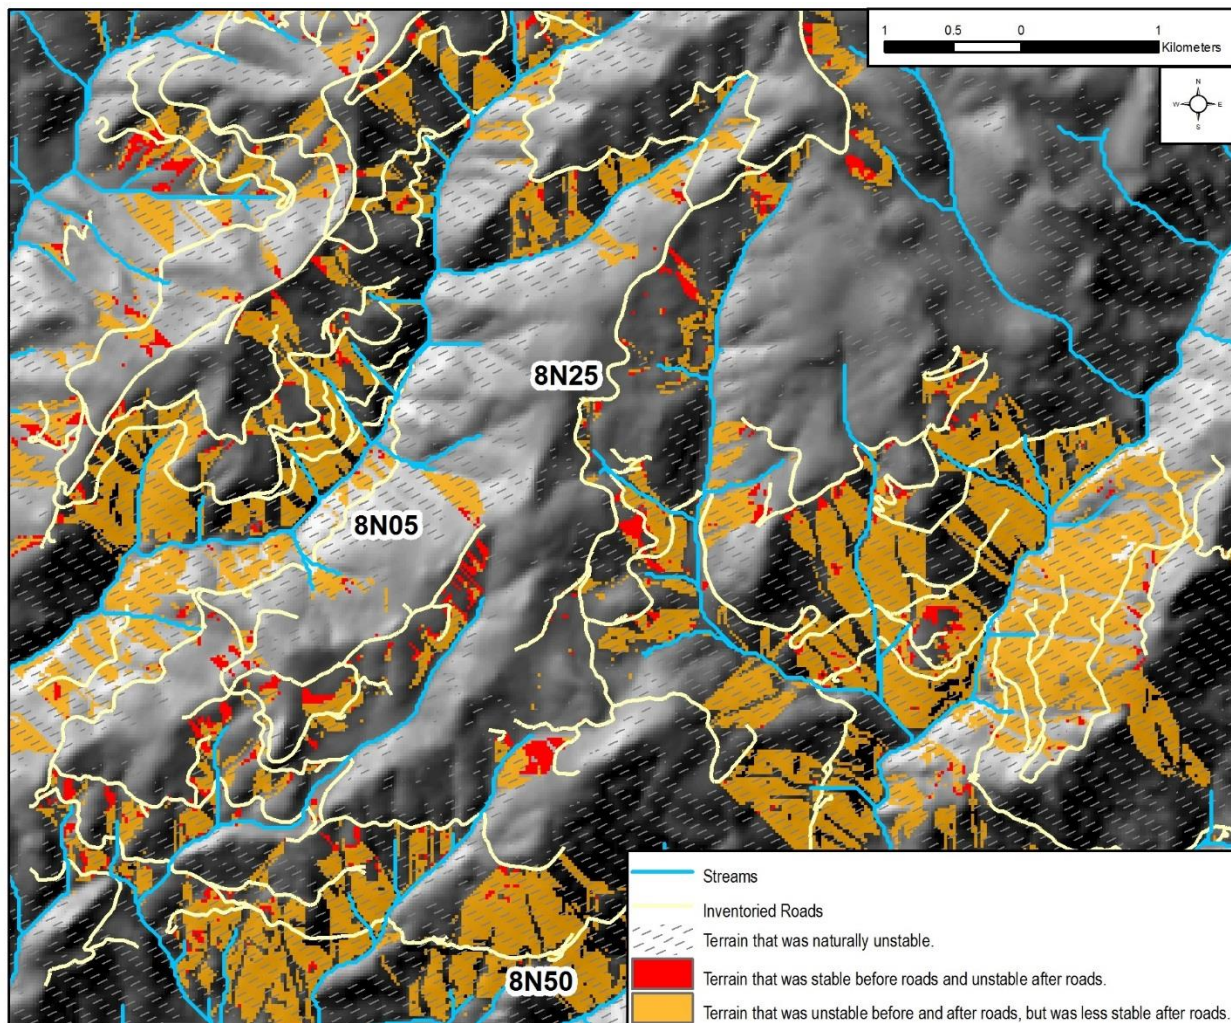
Figure 27 adds all areas where SINMAP predicted naturally high risk. They are shown in light grey hatches and correspond to the pink, red, and grey unstable categories (lower threshold, upper threshold, and defended) on the natural slope stability image (Figure 24). This shows

areas where naturally high risk was not increased to even higher predicted risk categories with increased road flow.

Figure 27. Areas of naturally high risk and risk changes, south central portion of Power study watersheds.

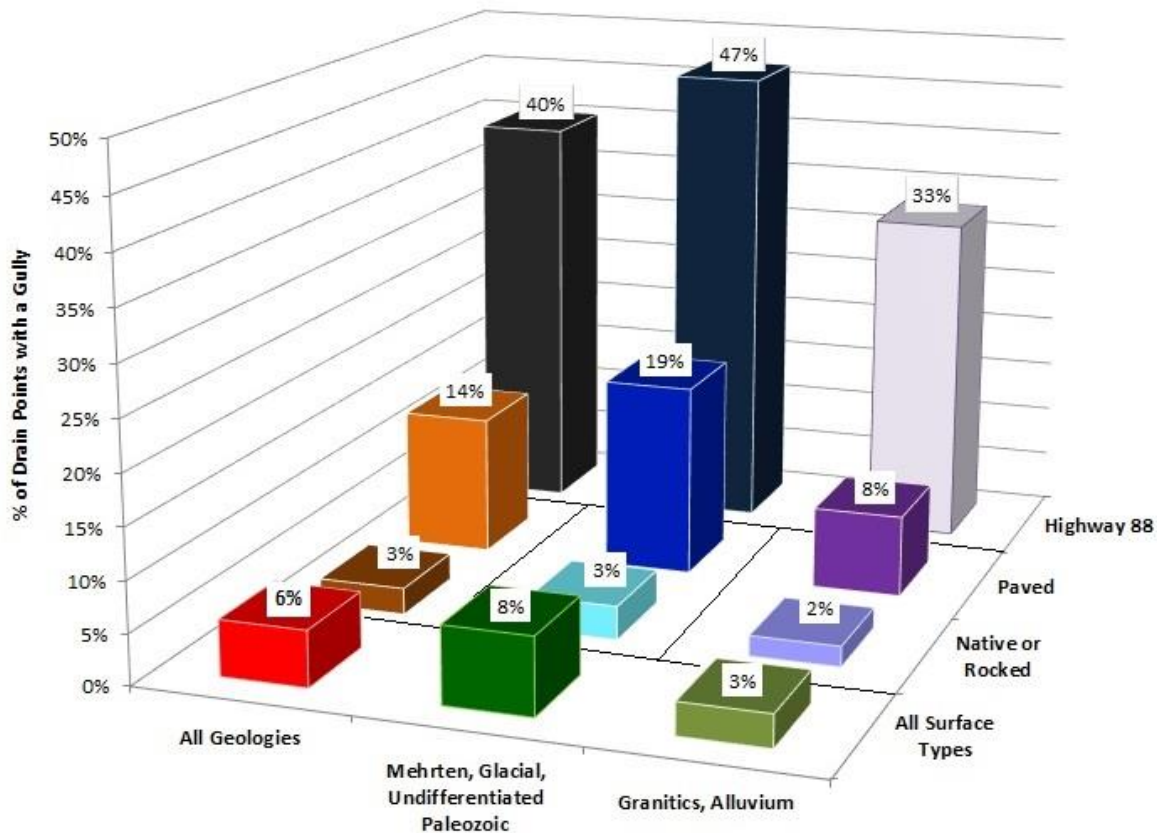
Gully occurrence rates were much higher in some classes when classified by road surface type and underlying geology (Figure 28). Only drain points that concentrate flow on hillslopes below the drain were considered in gully analyses. Stream crossings direct flow to streams, not hillslopes, and diffuse drains diffuse rather than concentrate flow, so these drain point types are not included in gully analyses. The average incidence of road-related gullies below drain points (not including stream crossings or diffuse drains) on all roads throughout the entire project area was 6%. Gullies were observed at a higher rate below drain points along all paved roads (14%), as compared to native or rocked roads (3%). Rates were also higher along roads in geologies of the Mehrten Formation, Glacial deposits, or the metamorphic undifferentiated Paleozoic rocks (MGP, 8%) as compared to those in granitics or alluvium (GA, 3%). Broken into finer categories, rates were higher along paved roads in either geology type, and especially high in MGP geologies along paved roads at 19% versus unpaved roads at 3%. Gully rates were highest below drain points off Highway 88. Gullies were below 40% of all drain points along Highway 88, 47% in MGP geologies, and 33% for GA geologies. These results suggest that remediation efforts should be focused along Highway 88 and along paved roads especially in MGP geologies. Remediation methods are discussed in the next section, Gully Initiation Risk.

Figure 28. Gully rates as percent of drain points in each category (not including stream crossings or diffuse drains) by surface type and geology type. Lines are drawn to guide comparisons between classes within groups.

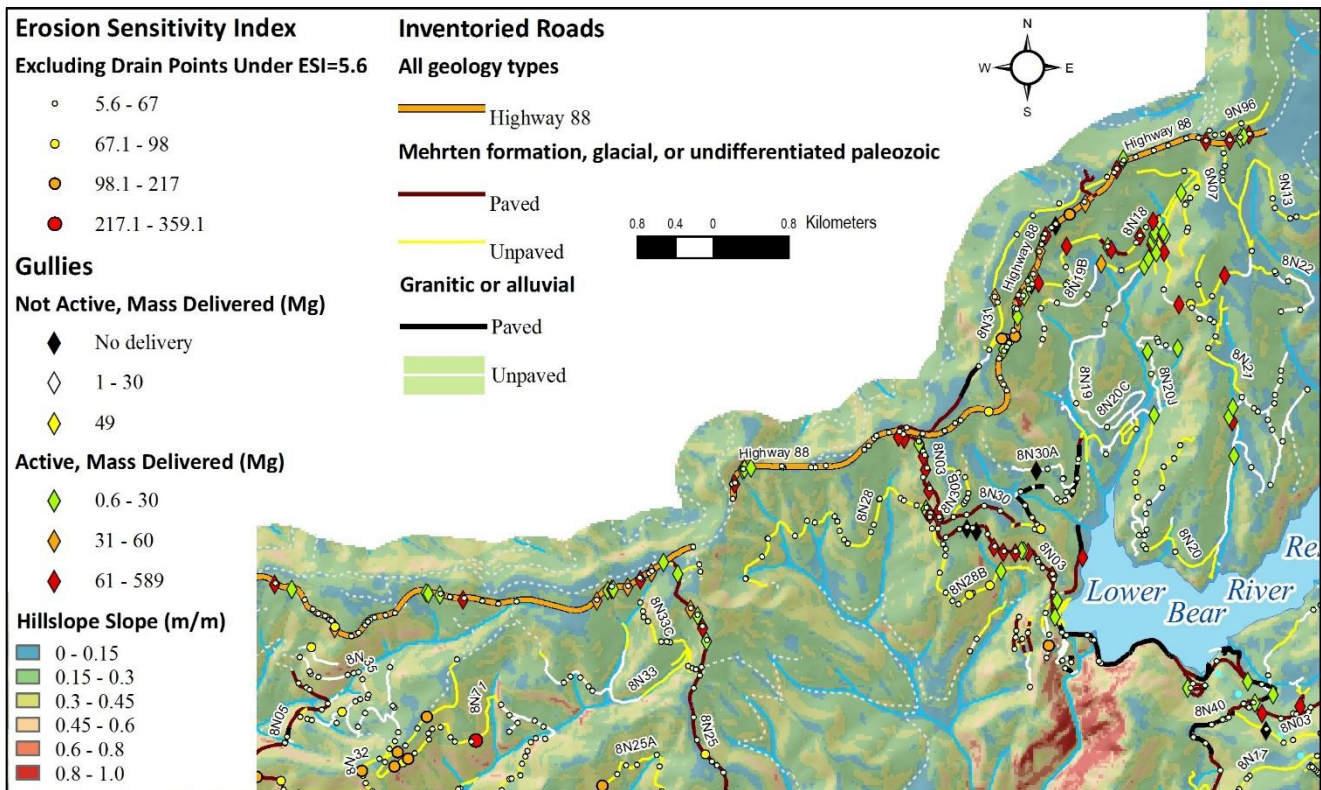
Figure 30 shows the locations of the gullies in the northwest portion of the watershed and along Highway 88, as well as the same gully initiation risk information.

Figure 30. Locations of observed gullies with activity level and delivered mass, ESI risk at drain points, hillslope slopes below drain points, paved and unpaved surfaces, and roads in two geology groups along Highway 88 and the northwest portion of the study area. Only drain points with ESI>5.6 are shown. Drain points are shown whether or not a gully is present at the drain point, but for drain points where ESI>ESI_{crit}, the drain point is superimposed on the gully point.

Figure 30 shows the distribution of gully risk along Highway 88 in the northern portion of the project area, and Appendix B, Map 9 shows the same for the entire watershed. Along Highway 88, a total of 148 non-diffuse, non-stream crossing, non-orphan drain points were used in this analysis (Table 11). Of the 148 drain points, 59 had gullies for a gully rate of 40%. Among all 148 drain points, there were roughly an equal number of drain points with $ESI > ESI_{crit}$ (76, 51%) as with $ESI < ESI_{crit}$ (72, 49%). Of the 59 drain points with gullies, 66% had an $ESI > ESI_{crit}$. For drain points without gullies, fewer drain points (43%) had $ESI > ESI_{crit}$. The average ESI for drain points with gullies was 16.8, while the average ESI for drain points without gullies was 9.3.

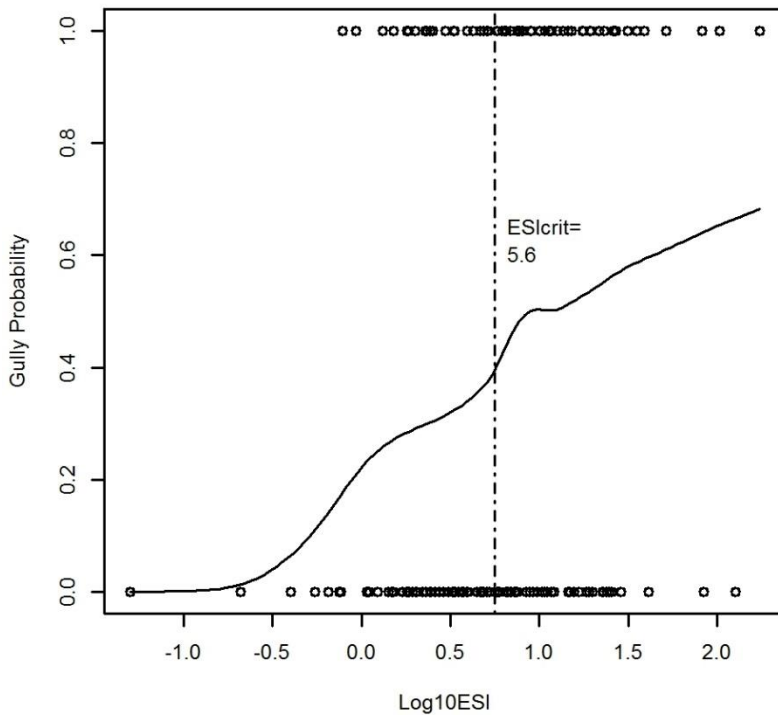
Power Project, CA, ESI, Highway 88

Figure 31. Calibration graph from the R local fit calibration for drain points along Highway 88. Gully Probability is a binary yes/no field. Log₁₀ ESI corresponds to an ESI value. Although there are gullies below the chosen ESI_{crit} value of 5.6, their probability is less.

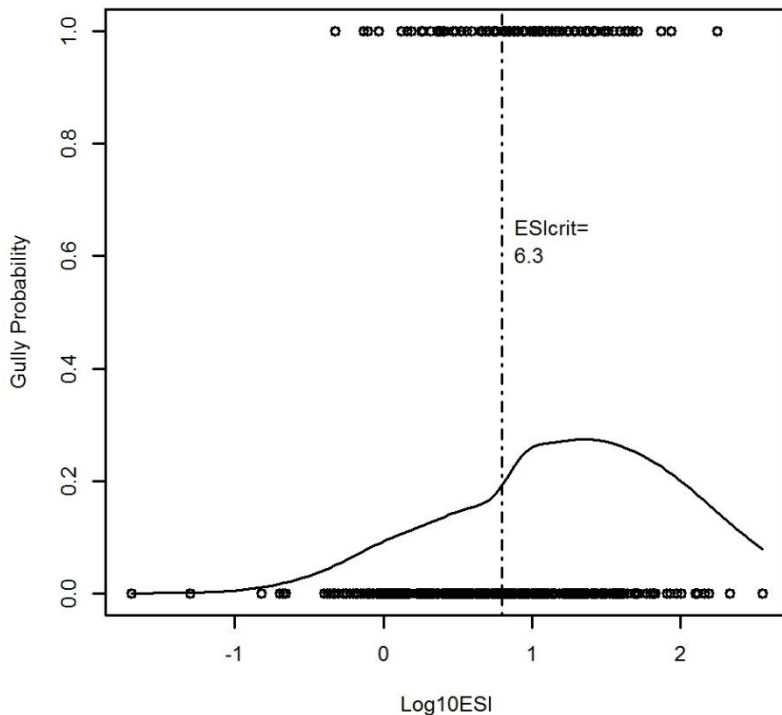
Power Project, CA, ESI, Paved Roads
Mehrlen, glacial, and undifferentiated Paleozoic

Figure 32. Calibration graph from the R local fit calibration for drain points along paved roads in the MGU geology types. Gully Probability is a binary yes/no field. Log₁₀ ESI corresponds to an ESI value. Although there are gullies below the chosen ESI_{crit} value of 6.3, their probability is less.

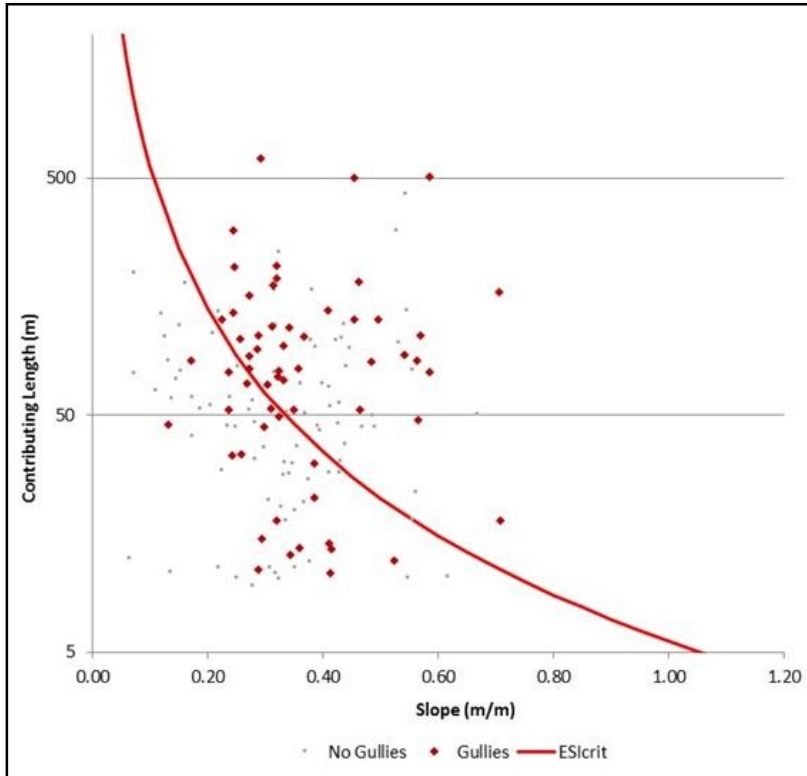
Figure 33. Length-slope plot that shows the distribution of gullied and non-gullied drain points along Highway 88. Notice that there are more non-gullied points towards the left of the graph. As the ESI increases (upper right part of the distribution), there about the same number of gullied points. Above the red $ESI_{crit} = 5.6$ line, there is a 51% chance of a point being gullied, while below the ESI_{crit} line, there is a 29% chance.

An easy way to conceptualize this is to think of these distributions as densities in length-slope space. That is, while the density of non-gully drain points decreases as ESI gets larger, the density of gullied points remains roughly the same. Therefore, along Highway 88, the ratio of gullied to non-gullied points increased as ESI increased. In this case, below ESI_{crit} , the ratio was 29%, but increased to 51% above ESI_{crit} . Along Highway 88, if the road was newly built or upgraded with 100 drains placed with spacing and hillslope slopes below that resulted in an ESI (LXS^2) for each drain point of less than 5.6, it would be expected that 29 drain points would develop a gully. If a different road was built or upgraded with 100 drains placed with spacing and hillslope slopes below that resulted in an ESI (LXS^2) for each drain point of greater than 5.6, it would be expected that 51 drain points would develop a gully.

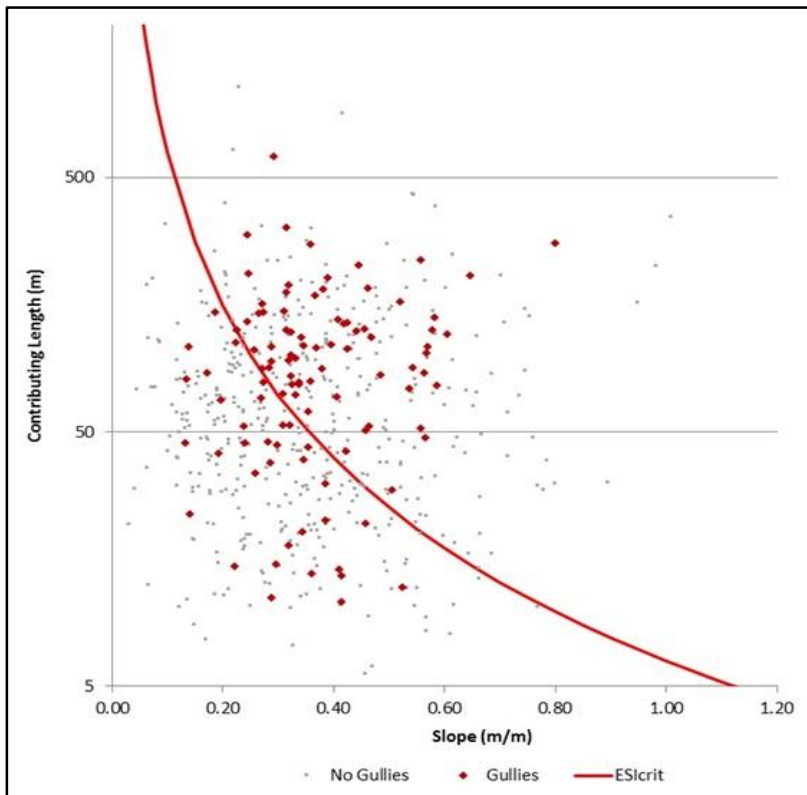
Figure 34. Length-slope plot that shows the distribution of gullied and non-gullied drain points along paved roads in MGP geology types. Notice that there are more non-gullied points towards the left of the graph. As the ESI increases (upper right part of the distribution), there about the same number of gullied points. Above the red $ESI_{crit} = 6.3$ line, there is a 26% chance of a point being gullied, while below the ESI_{crit} line, there is a 12% chance.

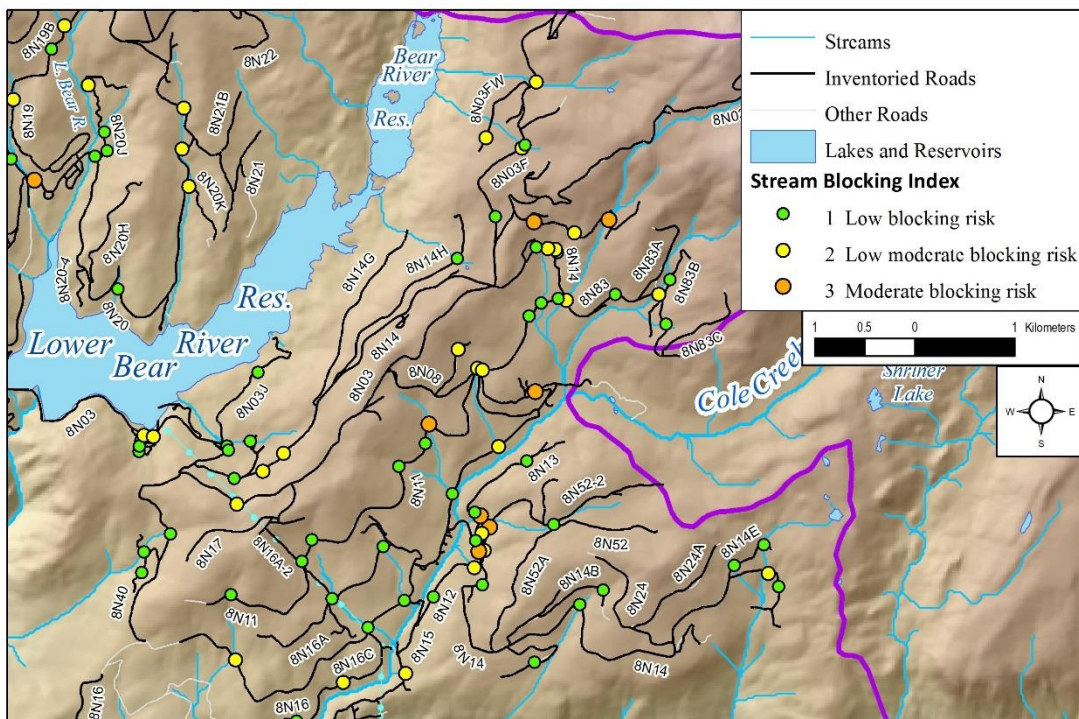
Within the watersheds, culvert plugging at stream crossings posed low to moderate risk. For the 212 stream crossings with SBI values within the Power study watersheds there was an average of 1.5. There were no stream crossings with an SBI of 4. There were 16 crossings with SBI = 3 (8% of 212 crossings), 79 crossings with SBI = 2 (37% of 212 crossings), and 117 crossings with SBI = 1 (55% of 212 crossings; Figures 35 and 36; Appendix B, Map 10).

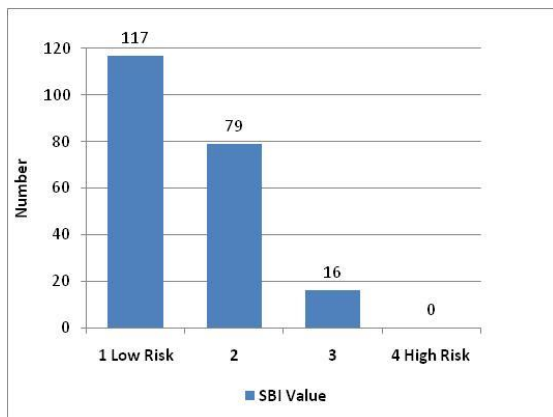
Plugging risk at crossings throughout the watersheds was due more to pipe diameters sized smaller than channel widths than to high skew angle. Of the crossings with SBI = 3, 9 (56%) had pipe diameter to channel width ratios less than 0.5 (as low as 0.14), so their SBI value and high plugging risk was due entirely to undersized culvert diameter and not to high skew angle. The remaining 7 crossings with SBI = 3 had pipe diameter to channel width ratios of 0.5 to 0.75; so were moderately undersized culverts coupled with plugging risk from a high skew angle to create high plugging risk overall. Of crossings with SBI = 2, most (76, 96%) had pipe diameter to channel width ratios between 1 and 0.5 (all less than 0.84); so their SBI value and moderate plug risk overall was due entirely to undersized culvert diameter and not to high skew angle. Only 3 crossings with SBI=2 had pipe diameter greater than or equal to channel width, so overall moderate risk of plugging at those crossings was due as much to high skew angle as pipe size. Of crossings with SBI = 1, all had a pipe diameter greater than or equal to channel width, low skew angle, and had low plugging risk.

Figure 36. Distribution of SBI values for the Power study watersheds.

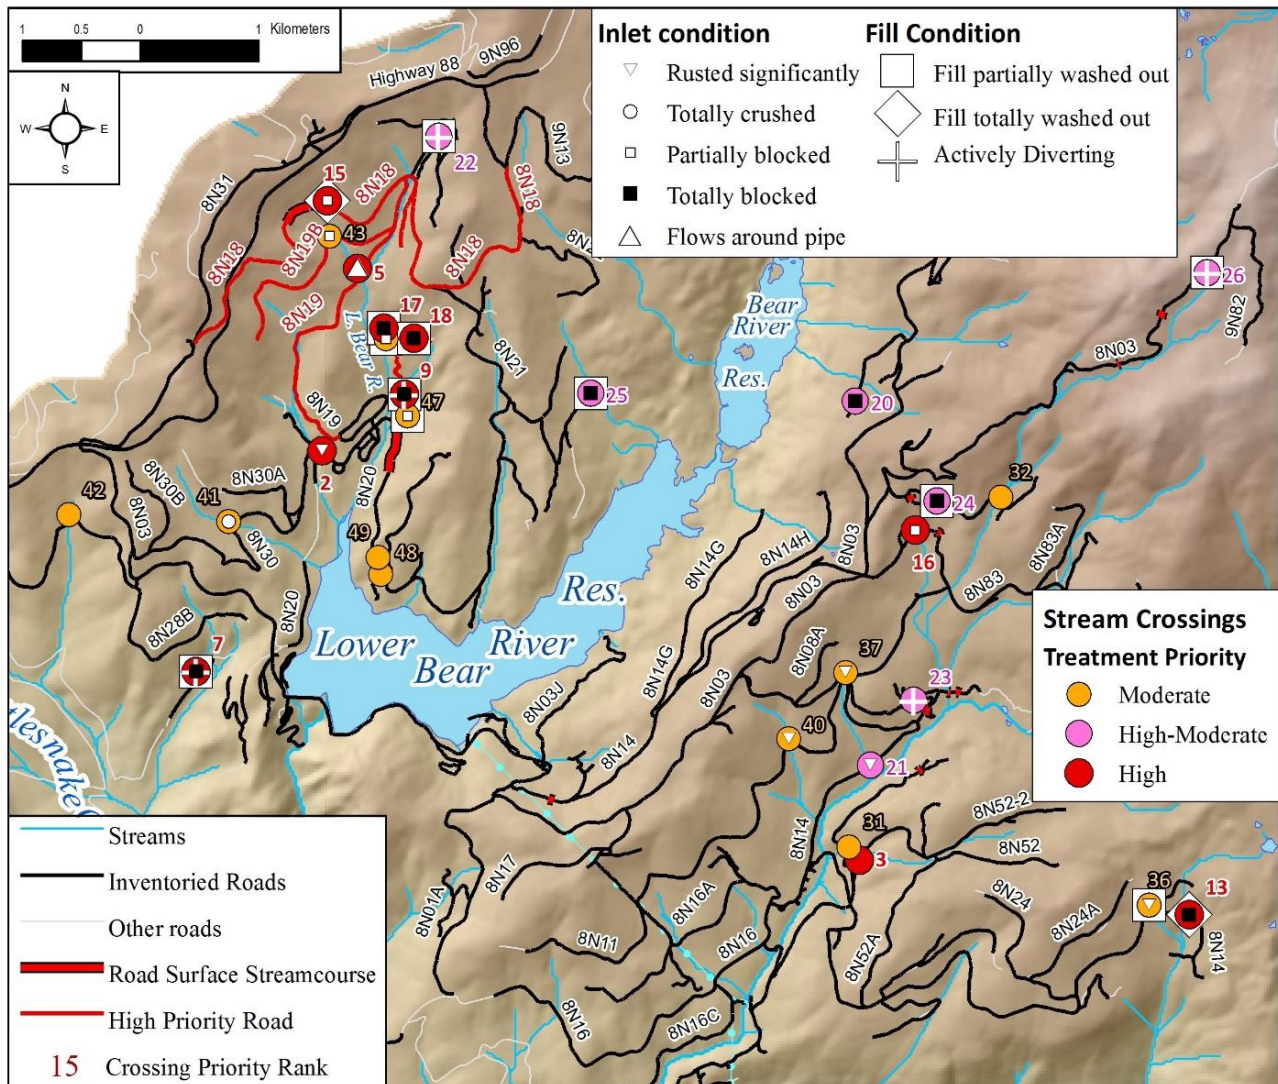
The highest risk crossings in the Power study watersheds were high risk in all three stream crossing risk areas (high SBI, more than 100 m³ [160 Mg] of fill at risk, diversion potential in one or both directions, Figure 37). There were 7 crossings with an SBI = 3, but no diversion potential. Of those, 3 had more than 100 m³ of fill at risk. There were 9 crossings with both an SBI = 3 and the potential to divert streamflow. Four had more than 100 m³ of fill at risk. These 4 crossings had the highest combined stream crossing risk and are good candidates for risk reduction treatments.

Figure 37. The stream crossings with the highest treatment priority in the northern part of the Power study watersheds.

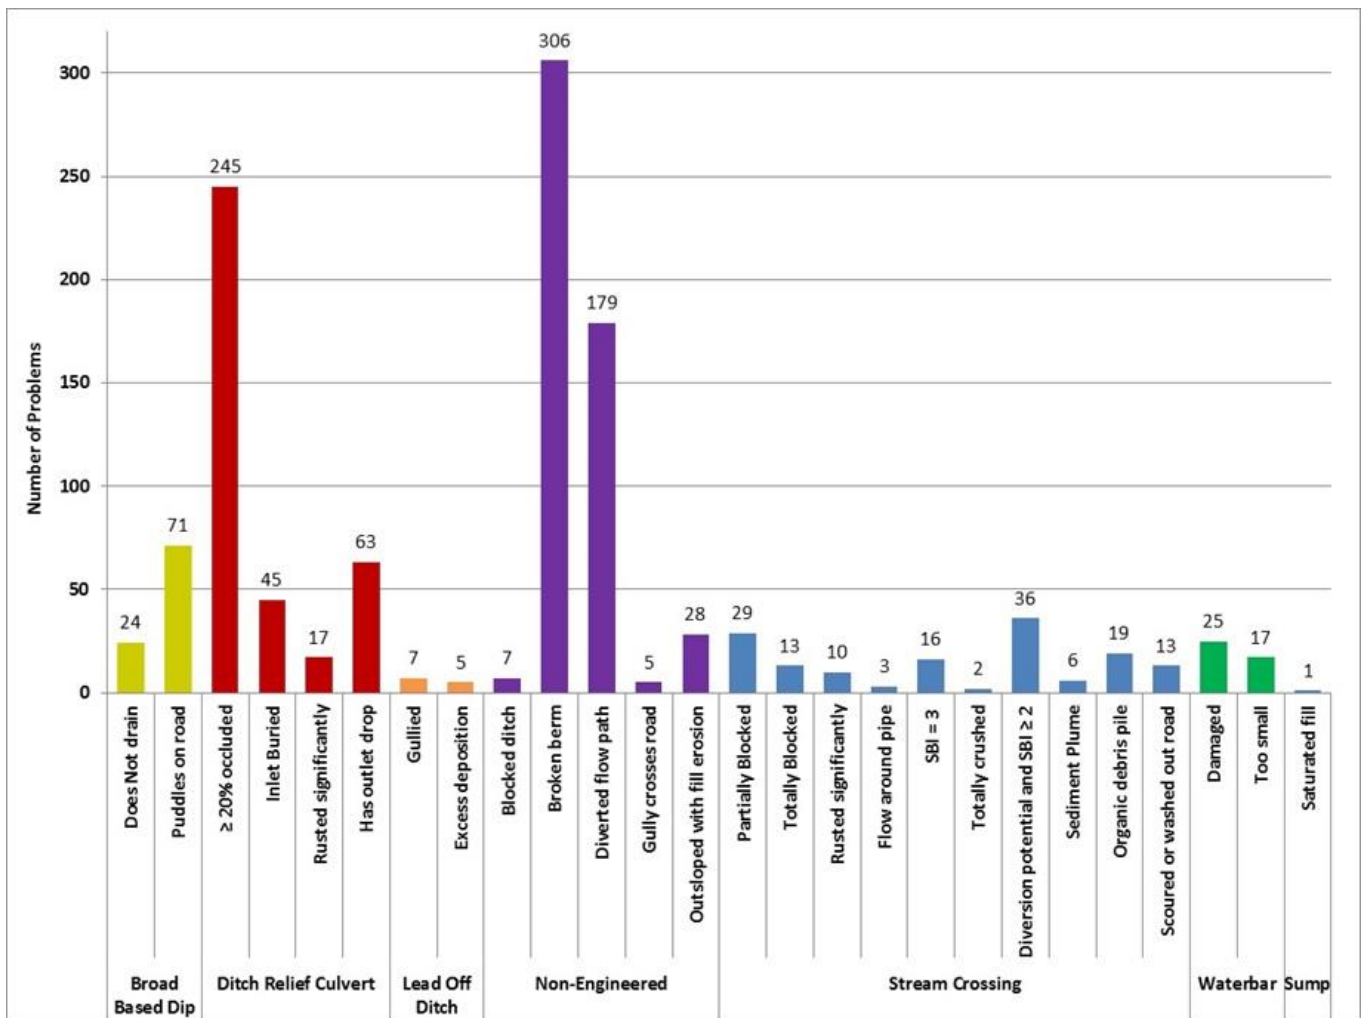
Figure 38. Number of problems by drain point type in the Power study watersheds.

were damaged, under-sized, or did not drain properly were defined as problematic. Sumps were a problem if they ponded water on the road surface or caused fill to be saturated. Diffuse drains (outsloped roads) were rarely observed to have problems. Figure 38 shows number of drain point problems by drain point type. Figure 39 shows locations of drain points with problems by drain point type for the northern portion of the study area, and Appendix B, Map 12 shows the same for the entire study area. Figure 40 shows some common ditch relief problems.
