Power Fire GRAIP Watershed Roads Assessment

Bear River, Panther Creek, and
Upper North Fork Mokelumne River Watersheds
Eldorado National Forest, California

April, 2016

U.S. Forest Service

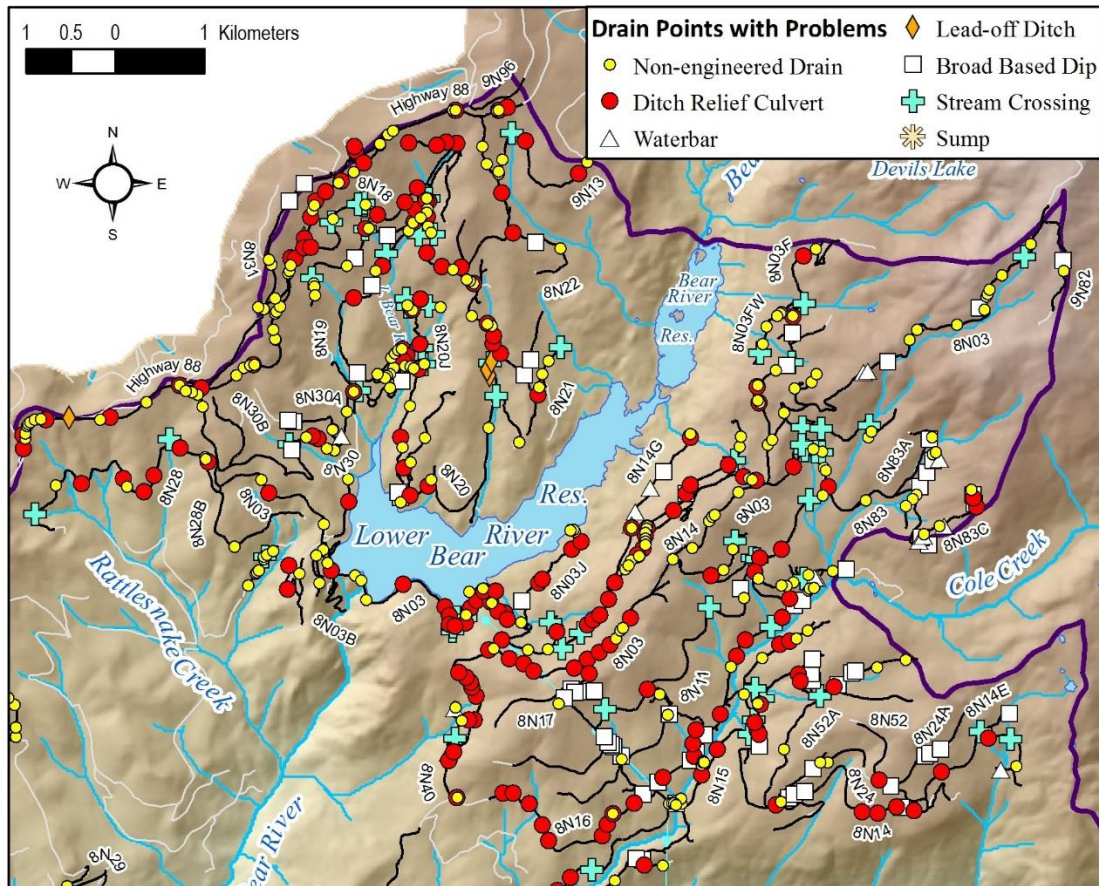
Figure 39. Locations of problems by drain point type in the northern portion of the Power study watersheds.

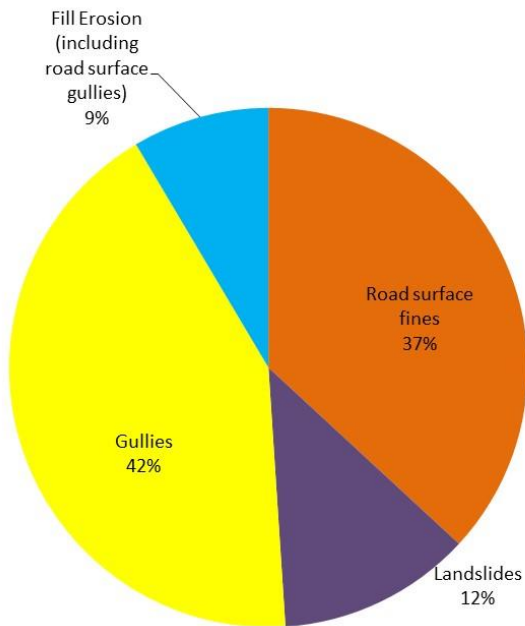
Among road related sediment sources, gullies produced and delivered the most sediment (Table 18, Figures 41 and 42). Road surfaces produced nearly the same amount of sediment mass as gullies, but delivered less sediment. Fill erosion and landslides delivered similar amounts of sediment as road surfaces. Stream crossing fill mass for high and high-moderate risk crossings was 2,430 Mg, or 3.5 times the mass of sediment delivered annually from all other road related sources.

Figure 41. Percent of total sediment produced from each road related sediment source in the Power study watersheds.

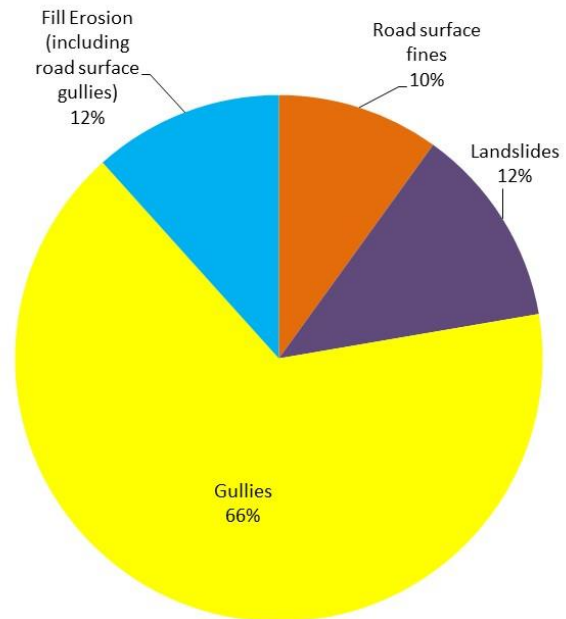
Figure 42. Percent of total sediment delivered to streams from each road related sediment source in the Power study watersheds.
