San Pedro Parks Wilderness

Fisheries, Arizona Willow and Water Quality Monitoring

Annual Monitoring Report

Santa Fe National Forest Surveyed: 2001 to 2002 Submitted: May 2004

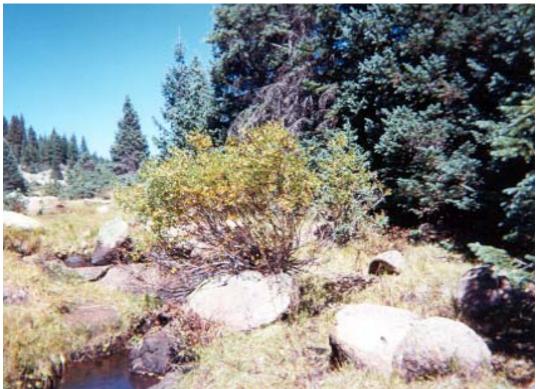
In 2000, Rio de las Vacas, Rito Anastacio and Rito de Los Pinos were surveyed. The two new locations are both along the Rio de las Vacas. One of them was identified by Howard Cordova, the ranger rider, a few weeks previously, but by September, the plant was no longer evident. Howard was able to re-locate the plant the following July. Most of the known willows in the large meadow below the confluence of the Rio de las Vacas, and Rito Anastacio are inside enclosures. Another willow growing out of the crevice of a rock along Rio de las Vacas is tall and vigorous (see Photo 4). In general, if the willow is protected either by an enclosure, or a natural barrier, the plants are relatively tall and full.

Photo 4. Arizona willow adjacent to Rio de las Vacas (September 2000).

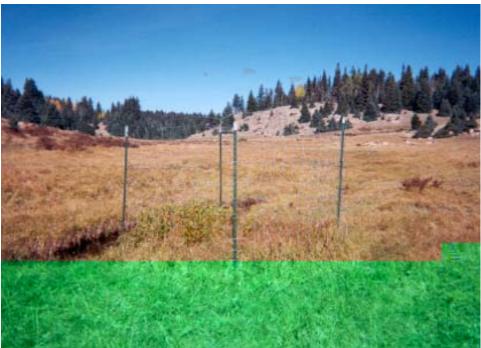
Re-visited plants within the enclosures, and located a willow in the same meadow outside an enclosure. The enclosed willows show little to no browsing on ends as in previous year. There is some potential encroachment from small spruce trees within a couple of the enclosures.

Photo 8. Wire enclosure along Rio de las Vacas below Rito Anastacio (September 2000).

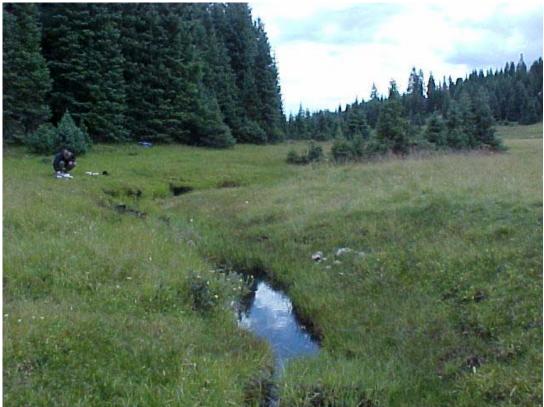
The location for the Rio de las Vacas (Site #4 on map) was in an open meadow. At the time of sampling, there was evidence of recent cattle activity. The stream at this location had an average width of 2.0 ft and an average depth of 1.0 ft. The banks in this segment were in fair condition, no significant bank instability. Note: Water quality at this site was in compliance with State Standards; with the exception of DO, which was slightly

Photo 10. Site #4: View of Rio de Las Vacas segment looking south (downstream).

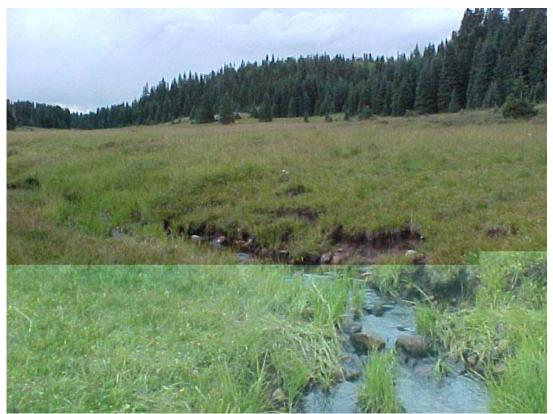
Photo 11. Site #4 View of Rio de Las Vacas segment looking north (upstream).

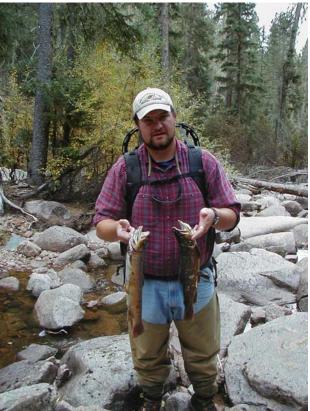
Photo 12. James Simino holding two spawned out brown trout, 20 to 24 inches.

The presence of brown trout above the barrier could be the result of the following: 1) People illegally introducing browns above the barrier; 2) chemical treatment did not extirpate the whole brown trout population; and 3) barrier is ineffective. This section of stream is boulder dominated, steep gradient, and confined within a tight canyon ("A2" Rosgen Stream Type).

• On 2 Oct 01, the epicenter of brown trout activity was located. A spawned out pair of brown trout were removed; they were 20 to 24" in length (see Photo 12); within the vicinity of this pair was the majority of the brown trout that were removed; shortly above this pair, brown trout numbers declined dramatically.

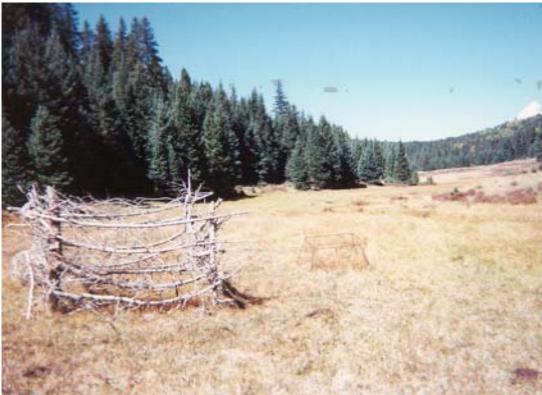
The entire length of Rito Anastacio was surveyed from its confluence with Rio de las Vacas to where it joins with Los Pinos. Four small willow populations have enclosures along the edge of the stream. The willows were at least two feet high, and showed new leader stems. No additional willows were observed.

Photo 14. Wooden enclosure along Rito Anastacio (September 2000).

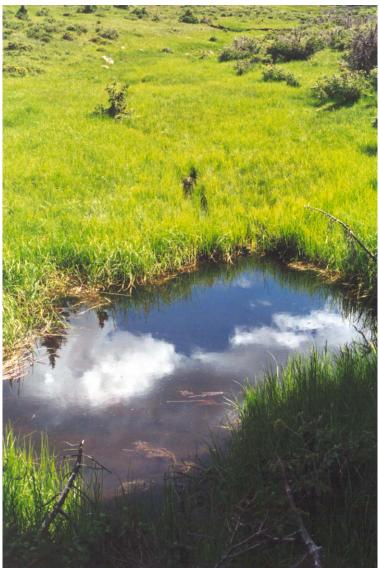
Photo 18. Upper limits of RGCT in Rio Puerco

Once the flow begins to connect pools, RGCT were observed. The uppermost pool is significantly deep (>3') and is quality overwintering habitat (see Photo 18). This pool and subsequent downstream pools were snorkeled, a distance of 150 feet (S. Ferrell, K. Behrens). The numbers relate to the uppermost pool.

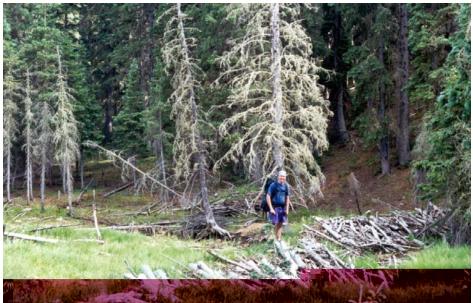
The stretch of stream from the open meadow downstream to the mouth of Cow Hump Creek hosted a diverse age class of RGCT. Fish were also occupying riffle areas. Three large beaver dams (see Photo 19) stretched across the floodplain between T#1 and T#2.

Photo 19. Old beaver dam that once blocked Rio Puerco

The complex had blown out some time ago, but had left behind a rich riparian with tall grasses and sedges and resurgence of willow. This beaver dam was referred to in a 1974 survey as functional (Stork and McInnis 1974). Beaver, willow and aspen were observed as dominant fixtures in San Pedro Parks in the early 50's (FS Files). Since introduction of fire suppression and extensive livestock grazing, the ecosystem has evolved to a thick conifer forest encroaching on riparian meadows. The 1974 survey also noted some loss of undercut banks from grazing.

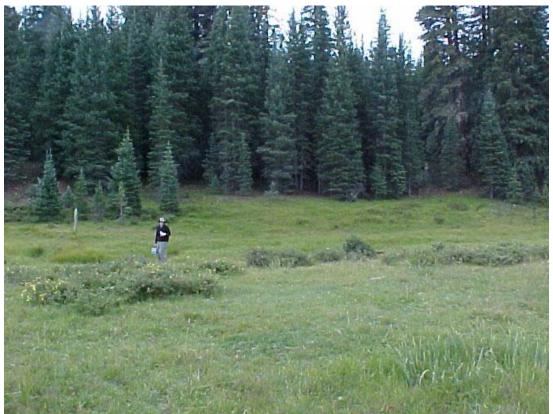
The site selected for Cow Hump Creek (Site #2 on map) was located in an area with no canopy cover. The stream at this location had an average width of 2.0 ft and an average depth of 0.5 ft. The banks in this segment were in good condition, not too much significant bank instability. Arizona willow exclosure was present on the right bank. Note: Water quality at this site was in compliance with State Standards; with the exception of DO which was slightly lower than the state standard. This may be attributed to no canopy cover at location.

Photo 25. Site #2: Cow Hump Creek. Trail 435 marker in background. Water quality sampled at this location. Arizona willow exclosure to right in background. (13 S 0332577, 3996369).

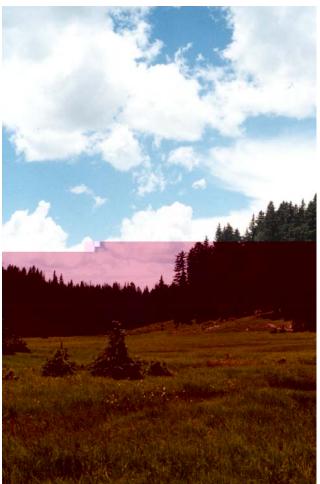
Cañon Madera was surveyed from the headwaters, down stream approximately one and one half miles to where the canyon narrows and the grade starts to drop off considerably. Atwood's original Arizona willow population was re-located on the eastern end of Cañon Madera. The willows are growing in a wet meadow with water flowing through small seeps or springs covering a 400-foot square area. The plants are slightly browsed, and there is ample evidence of recent cows in the area.

Photo 27. Arizona willow habitat along Cañon Madera (July 2001).

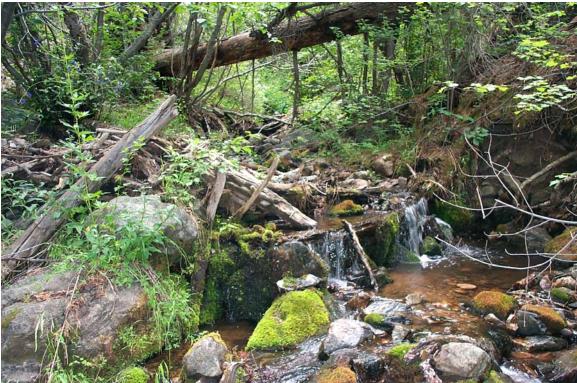
Photo 28. Boulder plunge barrier on La Jara Creek. No fish were found above this point (17 July 2002).

The high energy and unstable nature of the bedload may be a limiting factor to Rio Grande cutthroat trout distribution. It is likely that the upper limits are in a generalized area and will vary depending on annual bedload movement and temporary barrier formation. No permanent barriers were located, but at the time of the survey fish presence was terminated at a minimal boulder plunge approximately 0.3 miles below the wilderness boundary (see Photo 28). Large pool formation continued above the upper limits with adequate habitat for fish survival (see Photo 29). Snorkeling observations above fish presence noted abundant macroinvertabrate populations that were freely swimming without any threat from predators. The survey continued approximately 0.8 miles above the upper limits through a confined canyon.

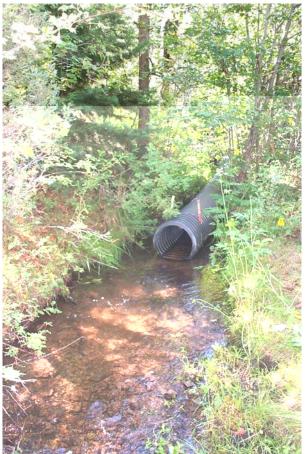
The irrigation ditch diverts all the water (see Photo 31) for agricultural purposes to ranches outside of Cuba. There is no headgate or fish screen, which is allowing escapement of non-native brook trout from ranch ponds. Eastern brook trout were captured in minnow traps but not observed during snorkeling.

Photo 31. Rito de los Pinos is 100% diverted into this ditch,

Two minnow traps were deployed overnight in the non-wilderness portion of the survey. Trap #1 was placed in the irrigation ditch immediately below the point of diversion (noted as a black flex pipe; see Photo 31). Sub-adult brook trout were observed in the pool below the flex pipe. Trap #2 was placed upstream from the first official trail crossing (Note: the trail does cross irrigation ditch). RGCT and eastern brook trout were noted from the point of diversion to the first trail crossing.

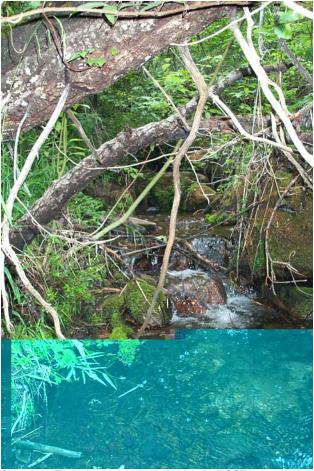
Photo 32. Typical habitat occupied solely by RGCT near wilderness boundary (16 July 2002).

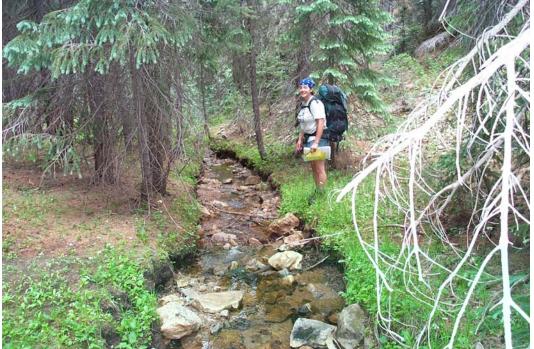
Photo 34. Typical habitat in Rio Gallina through "A" Rosgen Stream Type (July 2001)

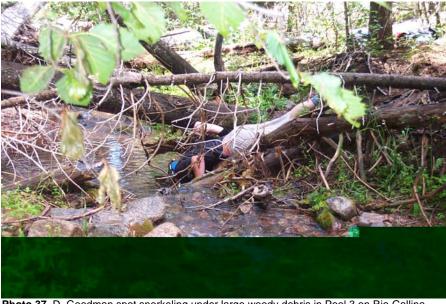
Photo 37. D. Goodman spot snorkeling under large woody debris in Pool 3 on Rio Gallina. Twenty-six rainbow trout were observed in Pool 3 (16 July 2002).

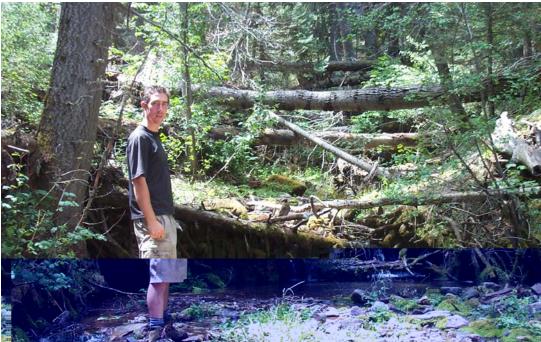
Photo 38. Typical habitat along Rio Gallina. Note: the density of the large woody debris component (16 July 2004).

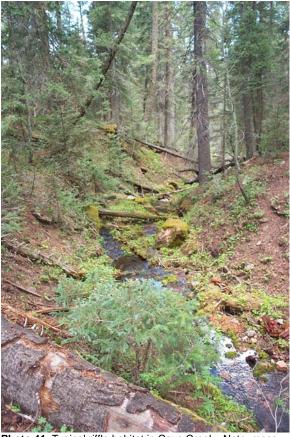
Photo 41. Typical riffle habitat in Cave Creek. Note: moss along stream's margin and covering substrate (16 July 2002).

The team noted a high content of woody debris during their survey. The stream was well intact with heavy concentrations of moss on the banks and stream substrate (see Photo 41). Much of the substrate comprised of gravel and cobble. A single stream temperature reading was taken, 46°F (12:20 on 16 July 2002). The high gradient system created naturally unstable banks in some areas but some cattle trailing was noted.

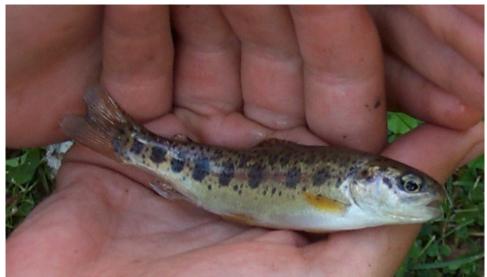
Photo 45. Naturalized rainbow trout in Capulin Creek captured by minnow trap (18 July 2002).

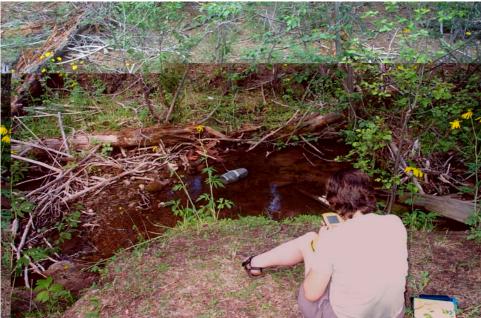
Photo 47. S. Eddy with Trap #2 at the end of Reach 1 on Capulin Creek. Two juvenile rainbow trout were found in the trap but 10 additional fish were observed in the pool upon collection (17 July 2002).

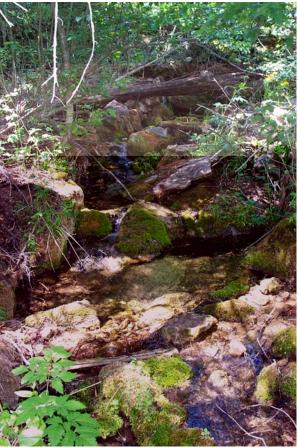
Photo 49. Looking upstream, a typical riffle-pool complex on Cecilia Creek above the Wilderness Boundary (17 July 2002).

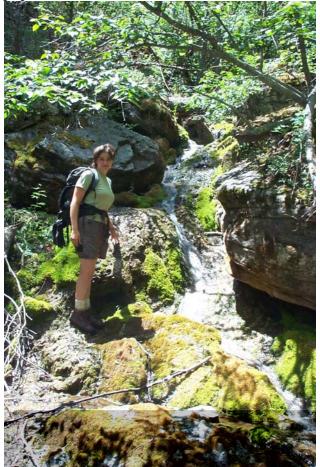
Photo 51. One of several bedrock fish passage barriers on Cecilia Creek (17 July 2002).

sediment and large woody debris into the stream (see Photo 53). Bedrock chutes were above this, which were likely barriers as well (see Photo 51). The survey continued for approximately 0.3 miles above the last observed fish.

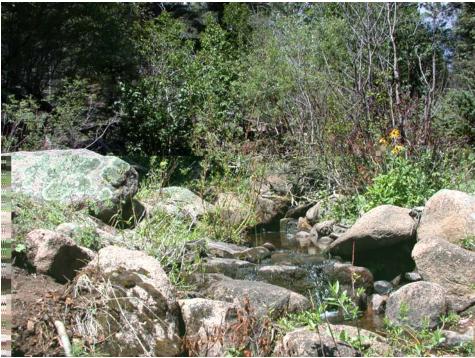
Photo 54. Typical pool formation associated with boulder cascades in Oso Creek (16 July 2002).

Oso Creek is separated from Rito Resumidero by a four-foot boulder plunge that likely prevents seasonal migration of RGCT. Oso Creek is characterized as a series of step pools separated by boulder cascades (see Photo 54). The first several pools contained no fish, however, subsequent pools had RGCT present. A total of 66 fish representing all ages were observed. Further surveys are needed to establish the upper limit of this creek.

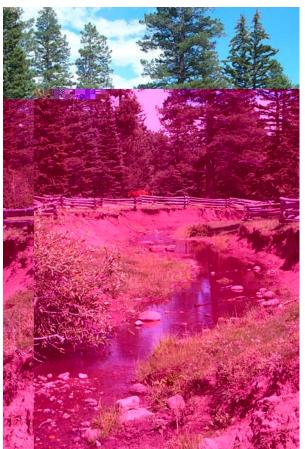
Photo 55. Herrera Ditch as it flows through Resumidero Campground, September 2001.

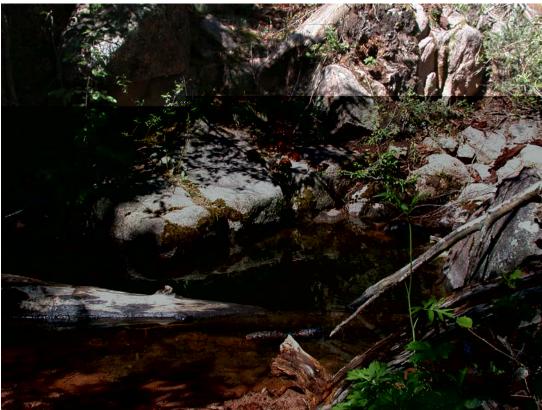
Photo 57. Typical pool in step pool section. Fish were found in this reach (15 July 2002).

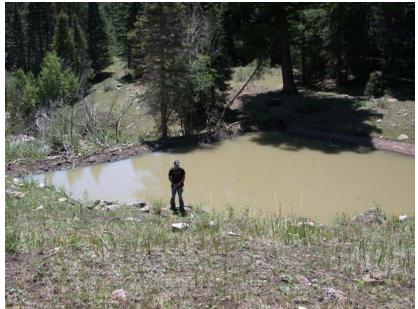
A series of beaver dams (3) were observed along this reach of Rito Resumidero. A huge beaver dam was observed above these dams (see Photo 58). This dam had a face approximately 15' high with an an extensive amount of impounded water. Beaver burrows were observed on the east side of this pond. Towards the end of this survey rain and cloud cover reduced visibility, and water became very turbid.

Photo 58. Large beaver dam (15' height) with substantial pool. Fresh beaver activity was noted. Note: Turbidity is due to a recent rain event (16 July 2002).

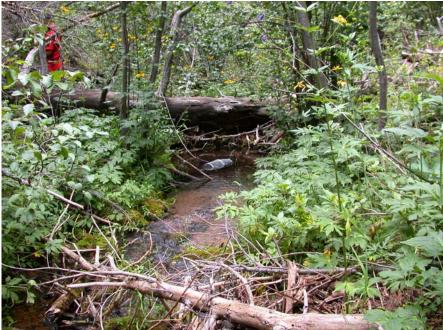
Photo 60. Minnow trap deployed in the only quality pool located above FS Road 93 (15 July 2002).

Very little flow was observed. Only one pool was observed and a minnow trap was set overnight, but there was no evidence of fish (see Photo 60). Areas of the creek that had sufficient water had a high sediment substrate. No fish were observed during the survey. Rito Redondo is characterized as a low gradient stream with little flow. Several springs were found along this reach of the creek, but recharge of the creek was minimal.

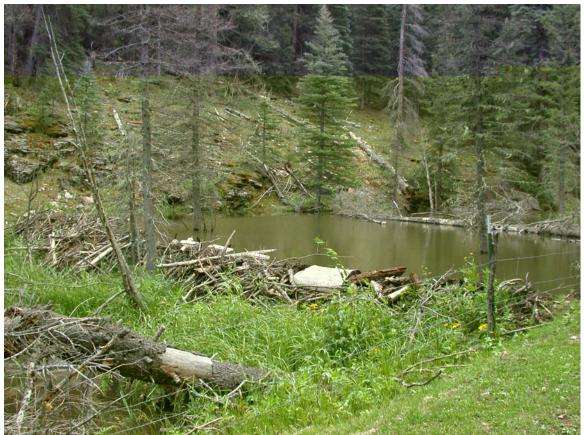
There is a natural barrier near the mouth of Rito Resumidero. Surveys need to be conducted above this to determine species presence below and within the wilderness. A complex of beaver dams exist around the FS Road 93 crossing (see Photo 61).

Photo 61. An active beaver complex is located above and below FS Road 93 and is protected by fencing (17 July 2002).

Rio Puerco de Chama, above FS road 93, is characterized as a low gradient stream with a series of beaver dams for approximately the first 1000 feet. The beaver dams and associated wetlands are protected by a fence enclosure (see Photo 61). Two adult beavers were observed in the ponds in the evening.
