Cedar Creek Fire - Central Washington Fire Recovery 2021

## Cedar Creek Burned Area Summary 2500-8 Burned Area Report

Cedar Creek and Cub Creek 2 Fires Okanogan County, Washington

WASHINGTON GEOLOGICAL SURVEY WALERT Report September 8, 2021

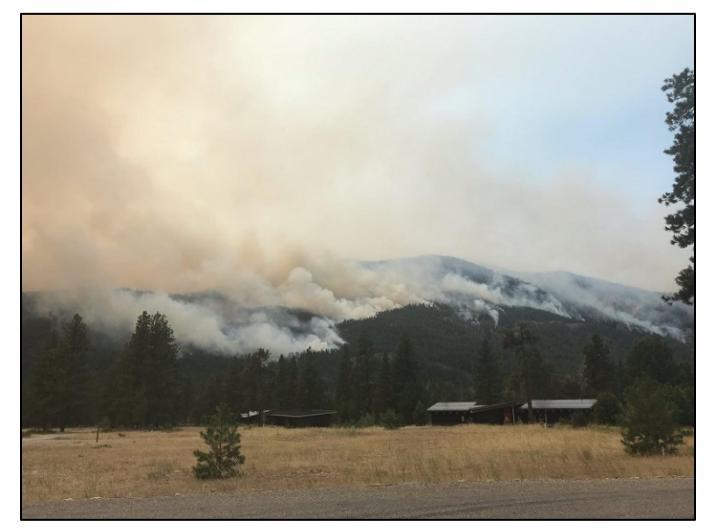
Figure 1 Cedar Creek Fire activity from Goat Creek Road.

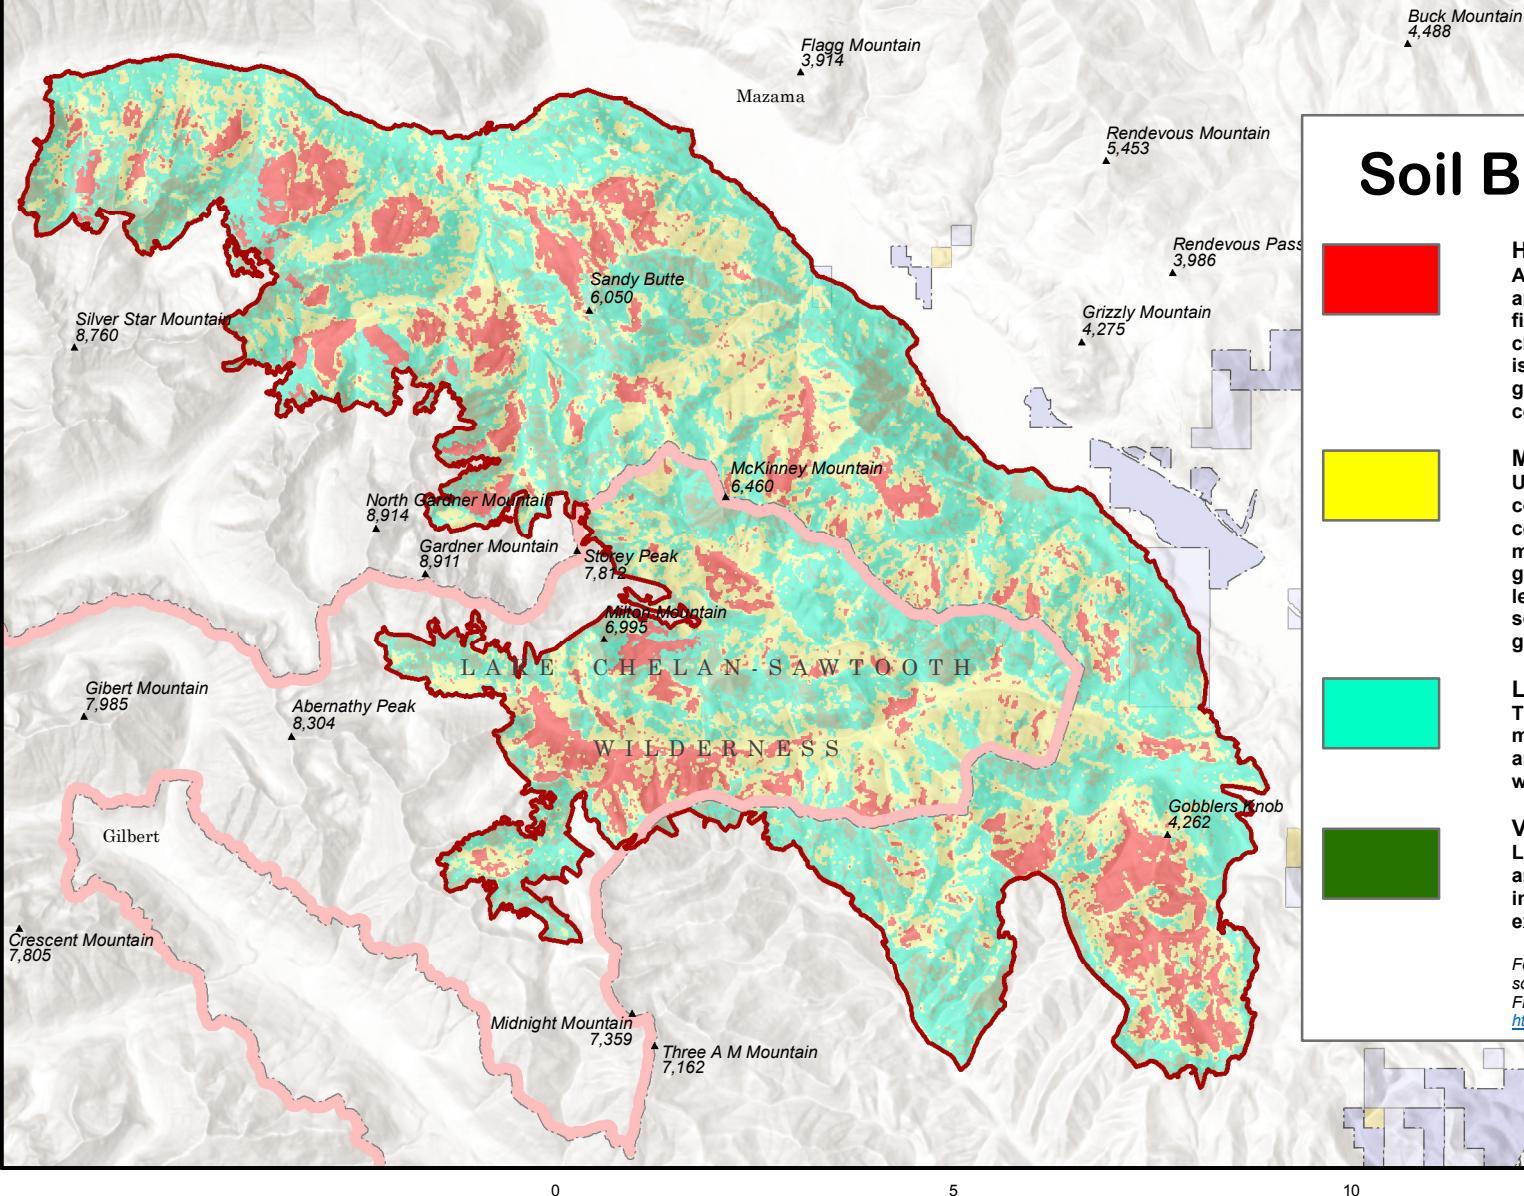
## Soil Burn Severity Map - Cedar Creek Fire

An estimated 48% of the burned area within the Cedar Creek Fire exhibit high or moderate soil burn severity and may have developed water repellent soils as a result (see map on page 7). Like the Cub Creek 2 Fire, vegetation mortality in the moderate and high soil burn severity areas ranged from 80 - 100%.

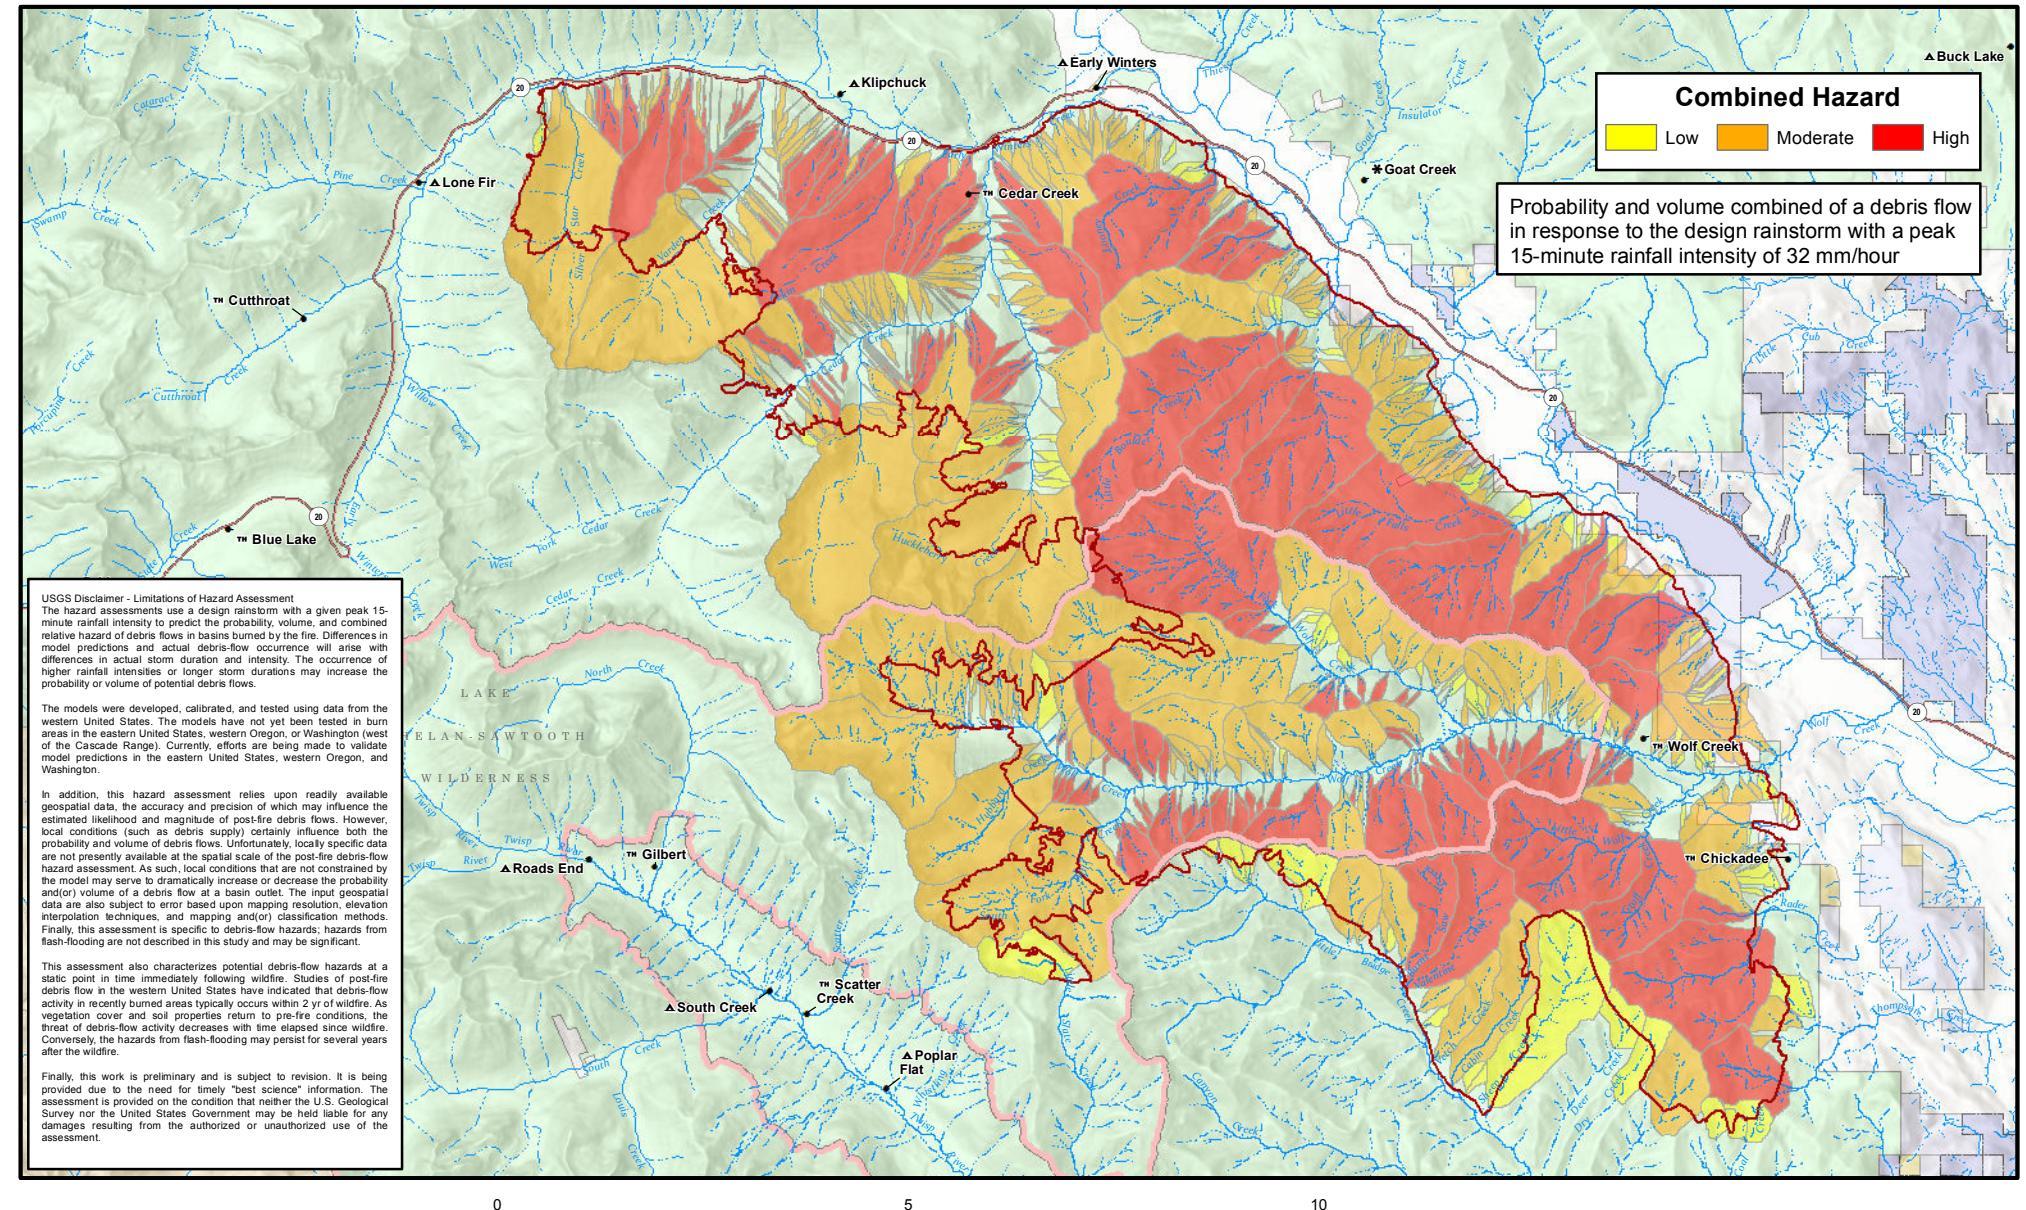
## USGS Debris Flow Combined Hazard - 15 minute Intensity of 32 mm/h - Cedar Creek Fire

The probability of debris flows is even higher in the Cedar Creek burned area in response to a 15minute intensity of 40 mm/h (about 0.4 inches in 15 minutes), a rain event with roughly a 10-year recurrence interval.

Most of these watersheds are roughly estimated to produce more than 1,000 m<sup>3</sup> of debris, resulting in a high debris flow hazard.
