EVALUATION OF MIKE HORSE DAM

January 2005

Stephen Romero, P.E.
Regional Geotechnical and Dams Safety Engineer
U.S. Forest Service

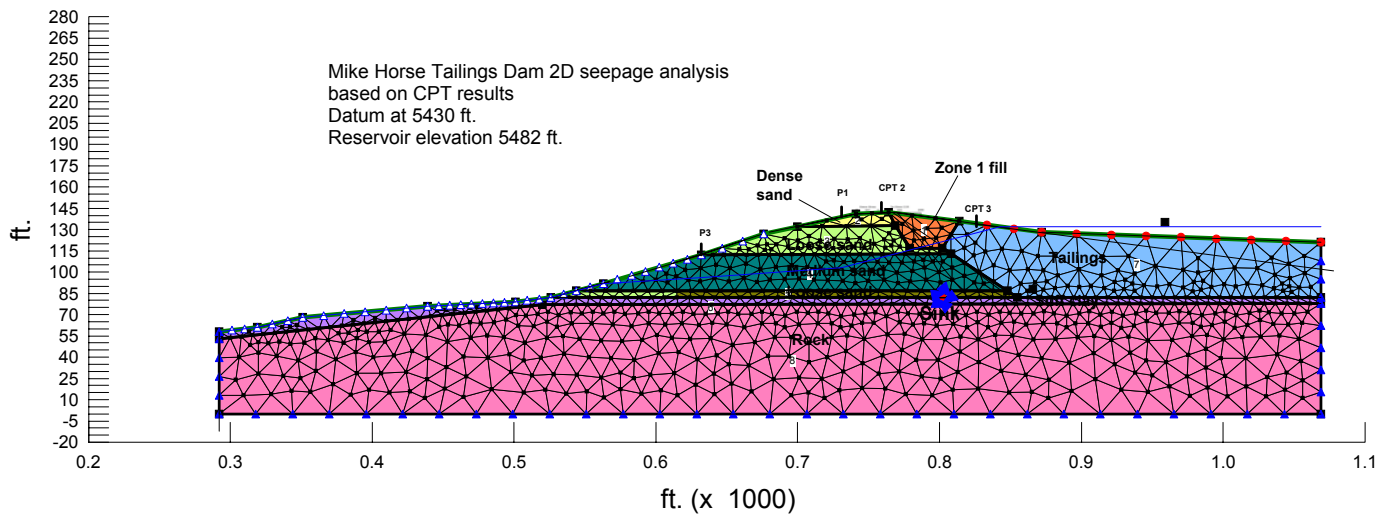
The soil profile developed in SEEP/W for the two dimensional seepage analysis is displayed in Figures 13 and 14.

Figure 13: Representation of finite element seepage model derived from CPT data perpendicular to dam crest.
