7700—Transportation Systems
2500—Watershed and Air Management
September 1998
9877 1806—SDTDC

Response of Road- Stream Crossings to Large Flood Events in Washington, Oregon, and Northern California

September 1998

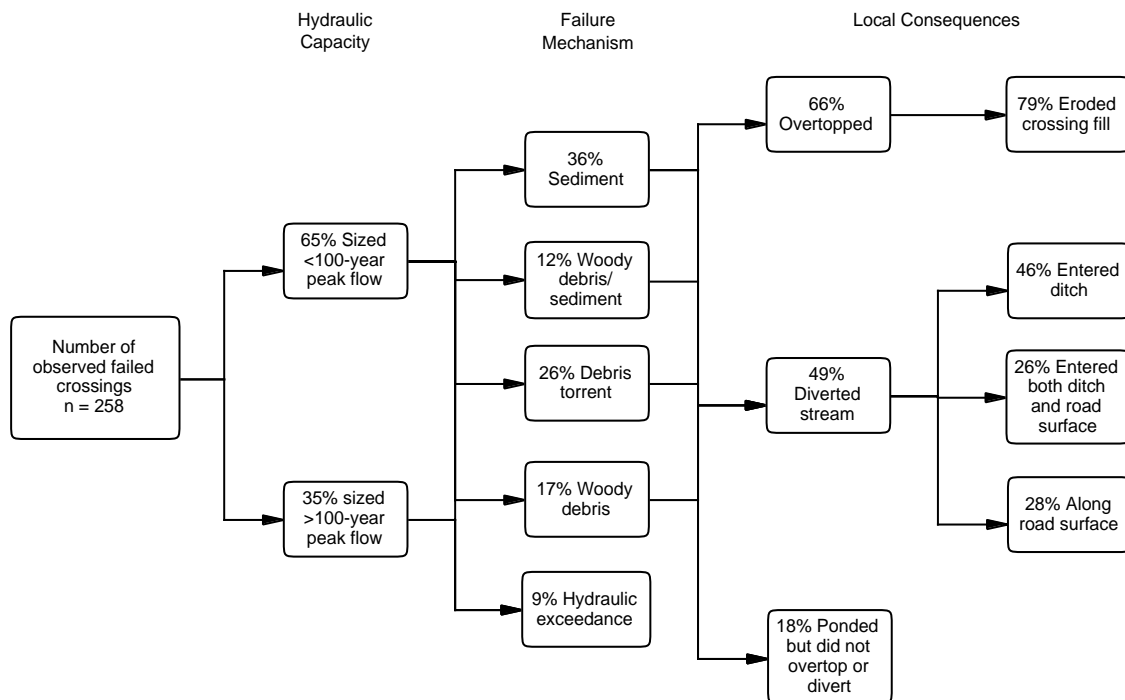
Figure 6 shows the results, sorted by hydraulic capacity, failure mechanism, and local consequences.

Figure 6—Results sorted by hydraulic capacity, failure mechanism, and local consequences

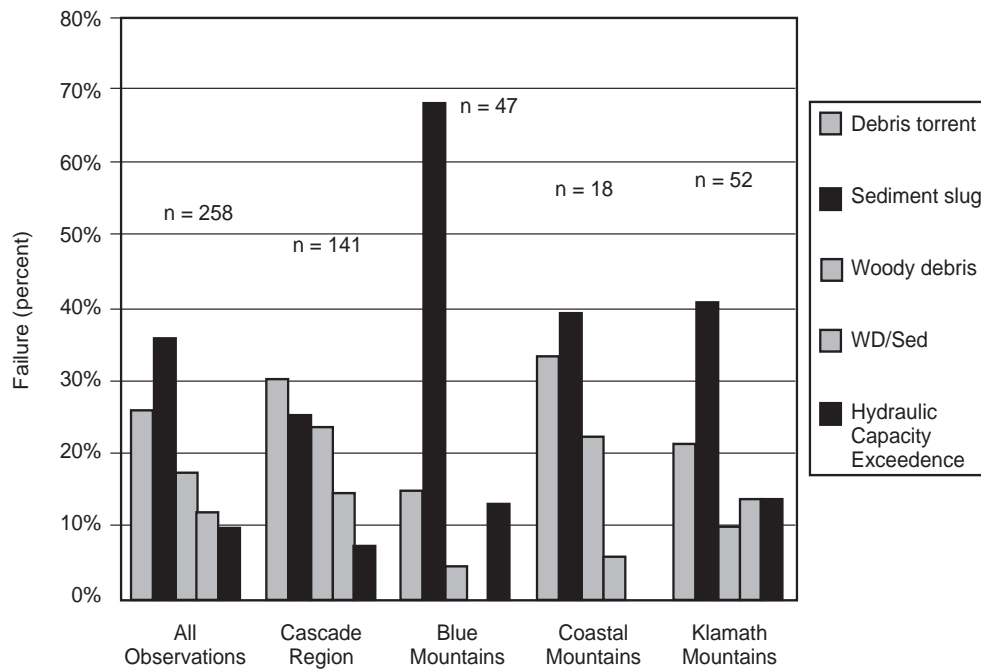
The leading mechanisms of failure observed in the Cascade Region were debris torrents (30 percent), followed by sediment slugs (25 percent), and woody debris (23 percent) (see Figure 3). Crossing failures were most commonly found in mid-slope road sections. These areas have high road-stream crossing densities and are characterized by steep, unstable slopes susceptible to mass wasting. Sediment slugs were the principal mechanism for failure in the Blue Mountains (68 percent), Coast Range (39 percent), and the Klamath Mountains (40 percent). For the Blue Mountains, the preponderance of sediment-slug failures can be attributed to fractured basalts found in the area, which tend to slump from steep roadside cutslopes and hillslopes, rapidly filling inlet basins and overwhelming the capacity of the culvert to pass sediment. Figure 7 shows the distribution of the failure mechanisms.

Figure 7—Distribution of failure mechanisms for physiographic regions in Oregon and Washington and the Klamath Mountains in California.

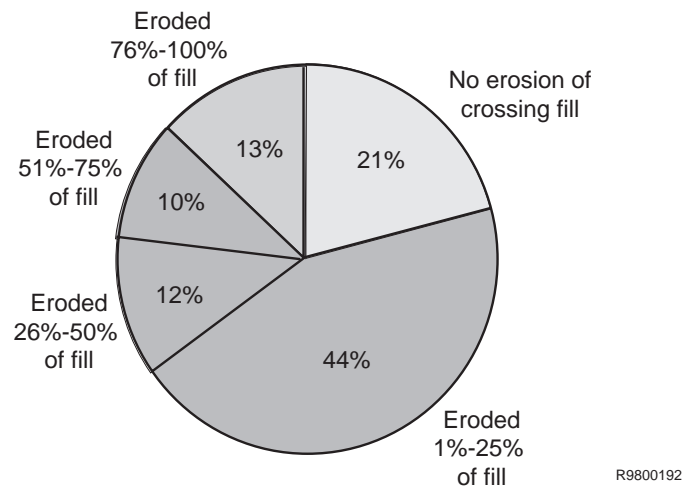
Road-stream crossing fill eroded, either progressively or catastrophically, at 79 percent of the sites where streamflow overtopped the road (n = 171) (Figure 8). Progressive erosion often led to head-cutting of the downstream fill slope, while catastrophic erosion, analogous to a “dambreak” flood, resulted in loss of a large proportion of the fill. At several sites, rapid stream aggradation associated with sediment slugs filled the inlet basin, depositing material on the road surface and resulting in net deposition and little or no fill erosion. Material was deposited onto the road surface, the crossing fill, or both at 15 percent of the sites (n = 92) commonly associated with sediment slug and debris-torrent failures.

Figure 8—Proportion of road-stream crossing fill eroded where streamflow overtopped the road (n=171).

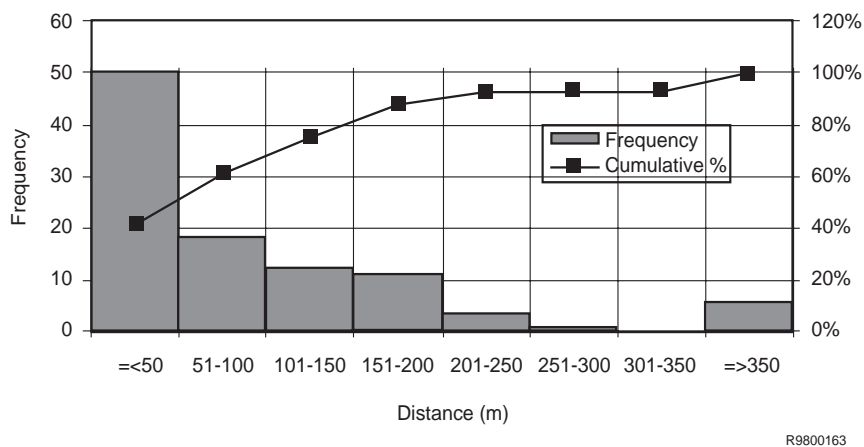
Figure 9—Observed diversion distances at failed stream crossings (n=104).

stream crossings. Diverted streamflow was routed along the inboard ditch, road surface, or often both. Diversion out of the ditch and onto the road surface was often the result of runoff forced out of the inboard ditch, through ditch deposition, failed cross-drains, sharp bends on steep roads, cutslope failure into the ditch, road outsloping, and exceedence of the ditch's hydraulic capacity. Fifty-three percent of diverted streamflows entered adjacent cross-drains or road-stream crossings; the remaining 47 percent either flowed across the road and onto the hillslope or infiltrated the road fill (n = 103). Figure 9 shows the distribution of observed diversion distances.

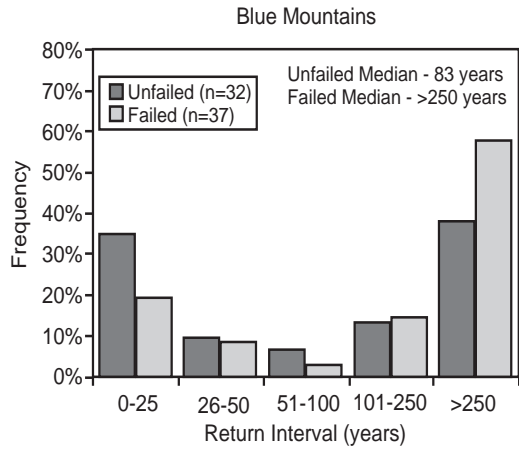
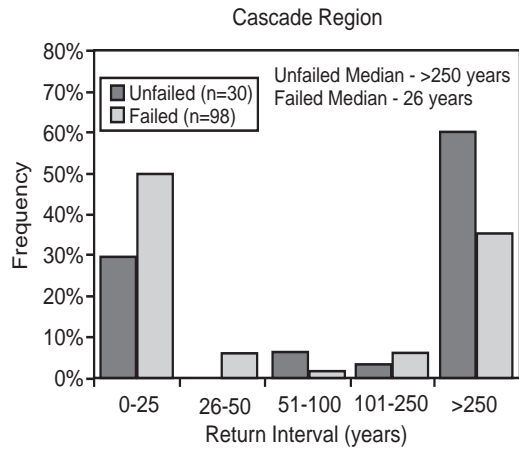
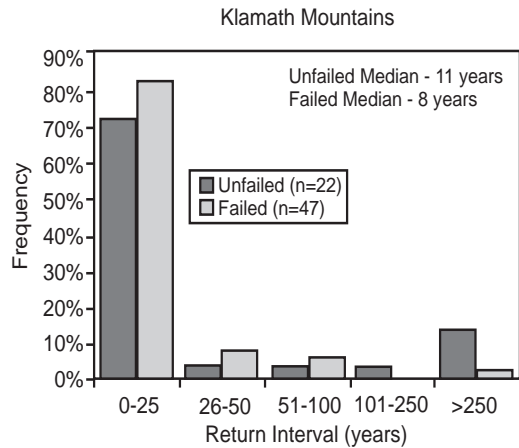
Similar to the observations of Piehl et al. (1988), we found that T_d was distributed bimodally for both failed and unfailed culverts (see Figure 10). The median of T_d in the Cascade Region was greater than 250 years for unfailed crossings but only 26 years for failed crossings. Failures caused by debris torrents were suspected of being unrelated to culvert size. If we neglect debris-torrent failures, the median T_d for failed crossings is only 18 years. The relative frequency distribution in Figure 10 suggests that culverts in the Cascades sized for less than the 25-year peak flow have a higher probability of failure than those sized for greater than the 250-year peak flow. Stream crossings in the Blue Mountains exhibited the opposite trend, with the median of T_d for unfailed crossings less than that of failed crossings. The hydraulic assessment template was not useful as a screening tool in the Klamath National Forest study area because a majority of the sites, both failed and unfailed, had T_d values less than the 25-year peak flow. The survey size in the Coast Range was insufficient for the analysis of the T_d distribution.

Figure 10—The relative frequency of the probability of exceeding culvert hydraulic capacity, expressed as peak flow recurrence interval, T_d , for failed and unfailed stream crossings in the Blue Mountains, Cascade Region, and Klamath Mountains. Within the Cascade Region, failed culverts were more frequently sized for less than the 25-year peak flow (at $HW/D = 1$), while the majority of unfailed culverts were sized for greater than the 250-year peak flow (at $HW/D = 1$). The opposite relationship was found for the Blue Mountains.
