Corrosion of Air Tankers by Fire Retardants

By James B. Davis and Clinton B. Phillips

A Report for

California Air Attack Coordinating Committee

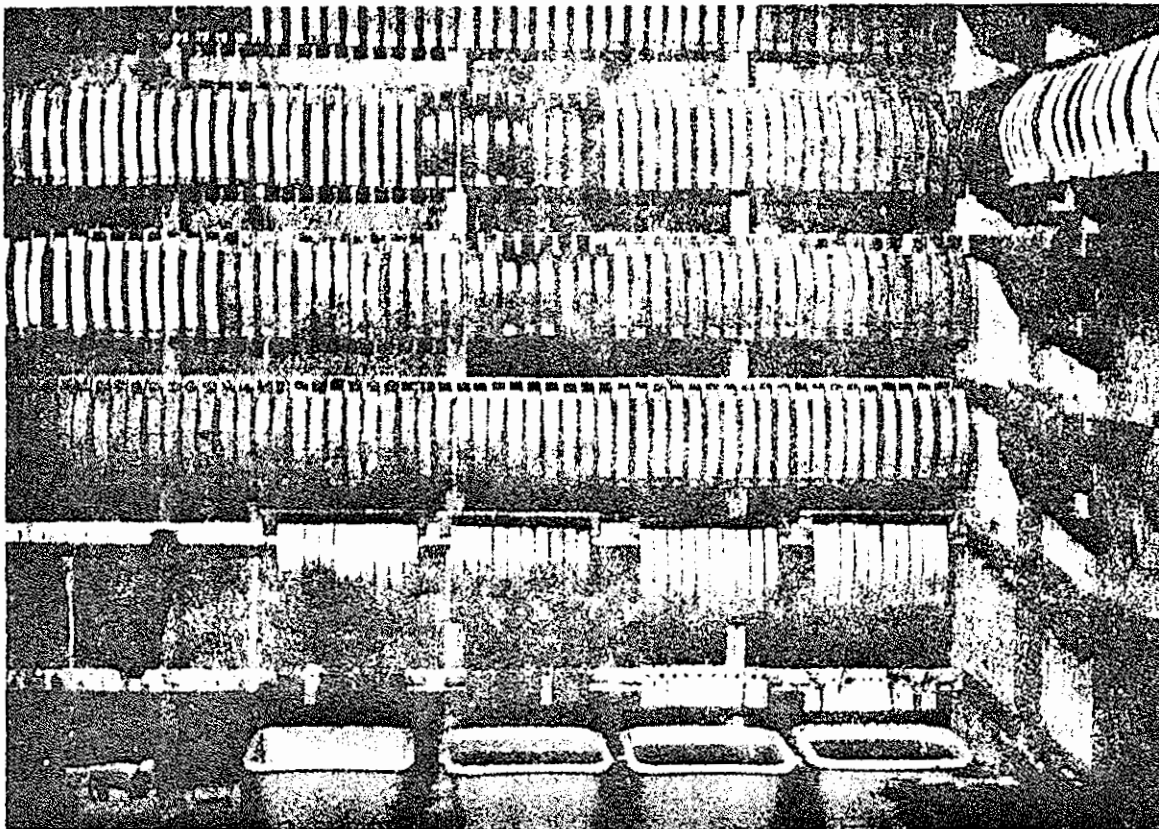
Figure 1.--Tests were conducted by the U.S. Forest Service's Arcadia Equipment Development Center to study weight loss stress and fatigue corrosion. Metal samples were bent to simulate stress corrosion and dipped for various lengths of time into fire retardant solutions. The number of pieces that cracked was recorded.

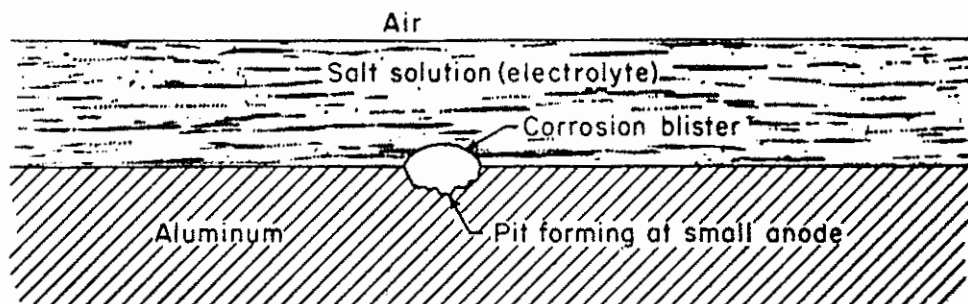
Figure 4.--Pit corrosion forming on aluminum surface.

1. (cont'd) If this form of corrosion is allowed to continue, the surface becomes rough and possibly frosted in appearance.
2. PITTING CORROSION The most common effect of corrosion on aluminum and magnesium alloys. It is first noticeable as a white or gray powdery deposit similar to dust which blotches the surface. When the deposit is cleared away, pits or holes can be seen in the surface (fig. 4, 5).

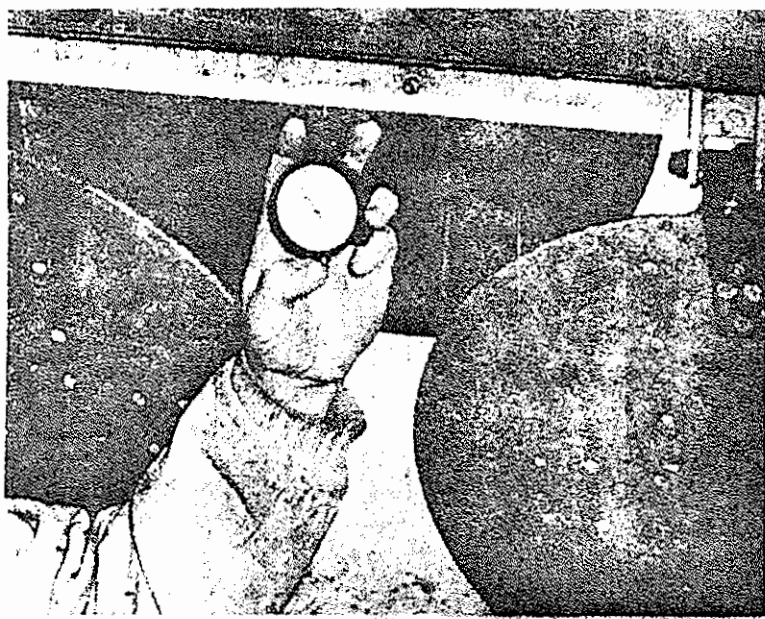
Figure 5.--Depth of corrosion action can be measured with a pit depth gage.

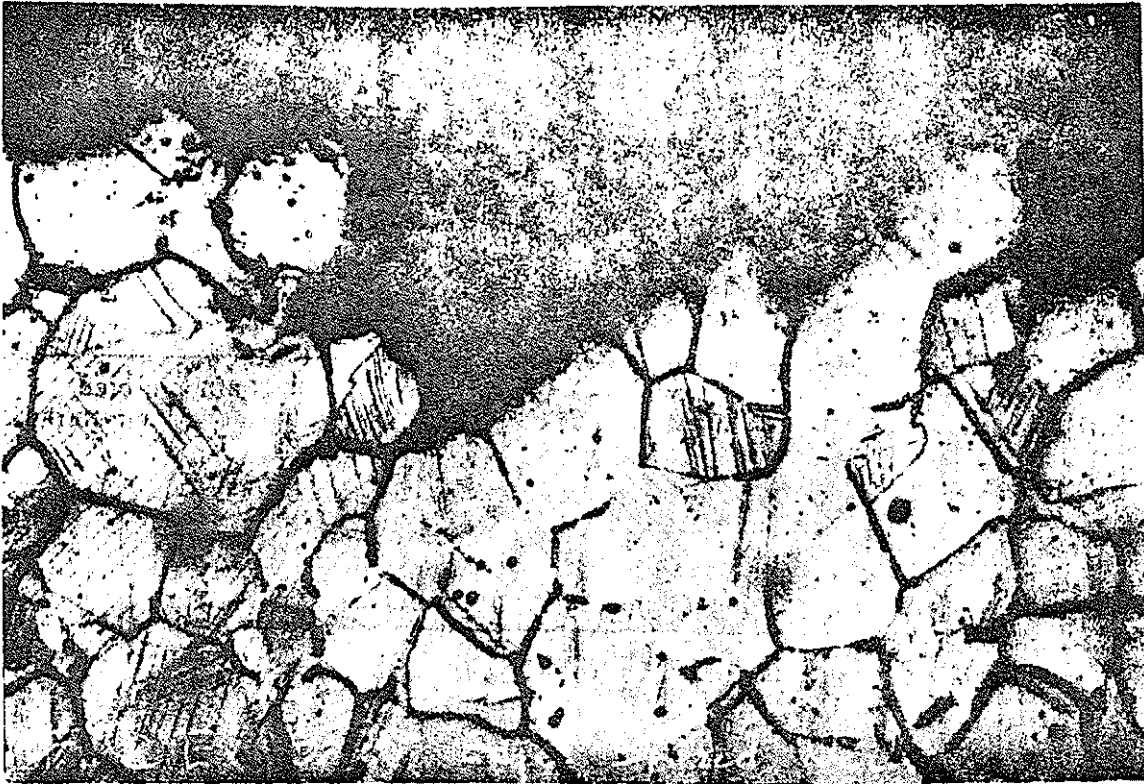
Figure 6.--Grain boundaries in stainless steel along fracture edge adjacent to an overheated silver soldered joint (California State Division of Highways Engineering Report). Magnified 1000 times.

3. INTEGRANULAR CORROSION Results from an attack on the grain boundaries of a material. A highly magnified cross section of a commercial alloy shows the granular structure of the metal (fig. 6). When in contact with specific types of electrolytes, the adjacent grains of the metal and the elements in the grain boundary can act as Anodes and Cathodes.

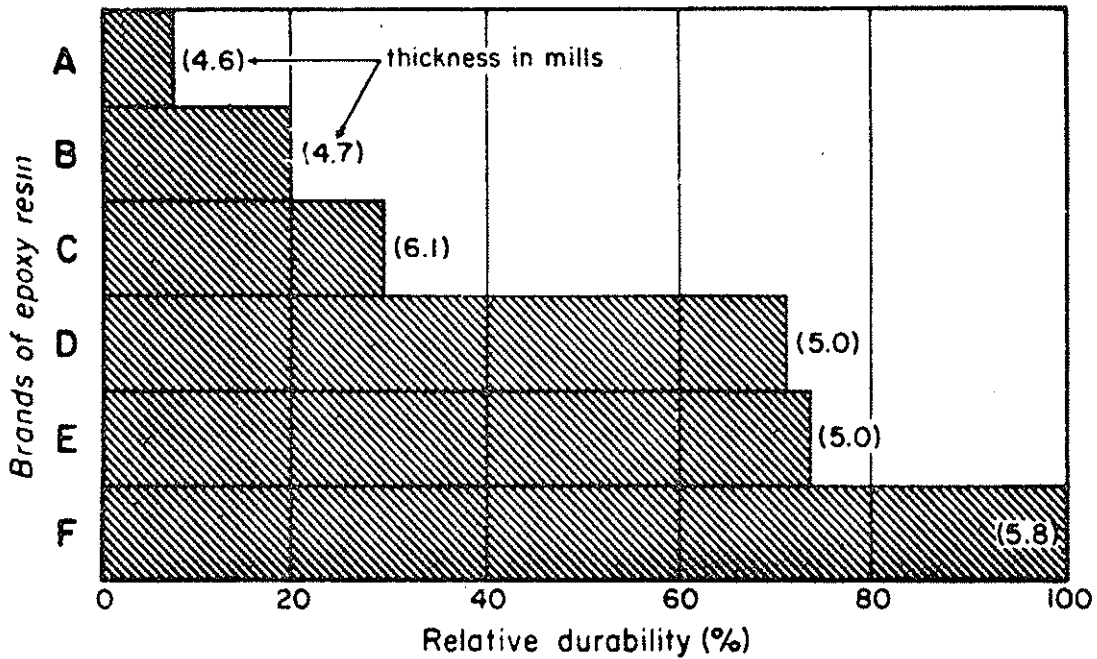
Allgood, et.al., (1964) reported wide variation in the effectiveness of epoxy resin paints exposed to the atmosphere of a manufacturing plant producing phosphate and nitrogen fertilizers. In one test area where 24 tests of catalyzed epoxy paints had been conducted, the variations in durability ranged from 7 to 82 percent (fig. 8). These variations are attributed to differences in the raw materials used and to the methods used in paint manufacture.

Figure 8.--Typical variations in relative durability of epoxy resin coatings that have about the same thickness.
