**SOUTH FORK CLEARWATER RIVER
HABITAT ENHANCEMENT**

ANNUAL REPORT - 1985

**BY
Don Hair, Project Biologist
and
Rick Stowell, Project Coordinator
U.S.D.A. Forest Service
Nezperce National Forest**

**Agreement No. DE-A179-84BP16475
Project No. 84-5**

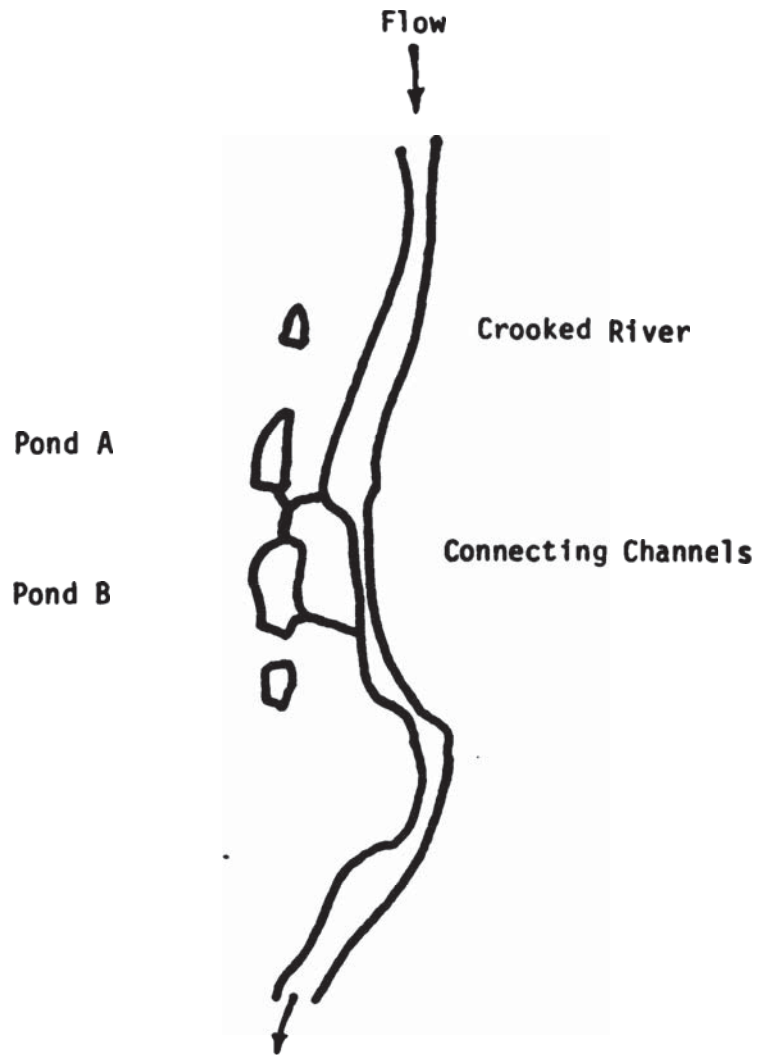
FIGURE 4

Site 1 - Ponds Connected to Crooked River

Pond A = 53' x 18' = 954 ft.²
Pond B = 70' x 26' = 1820 ft.²
Channels = 100' x 3' = 300 ft.²

Ponds and side channels. This type of activity was used in both Crooked River and Red River. In Crooked River, existing ponds at three sites were connected to the stream. At two of the sites, the ponds were connected at both the upstream and downstream ends of the ponds so that a small portion of the stream is flowing through the ponds (See Figures 4 and 5). At the other Crooked River site, one pond that has a considerable amount of intergravel flow was connected only at the lower end (See Figure 6). The objective here was to provide an off channel refuge during spring runoff. All of these connections were made using the hydraulic excavator. Finishing touches to the connecting channels (placing rip rap, planting, installing log drop structures) were completed by hand.

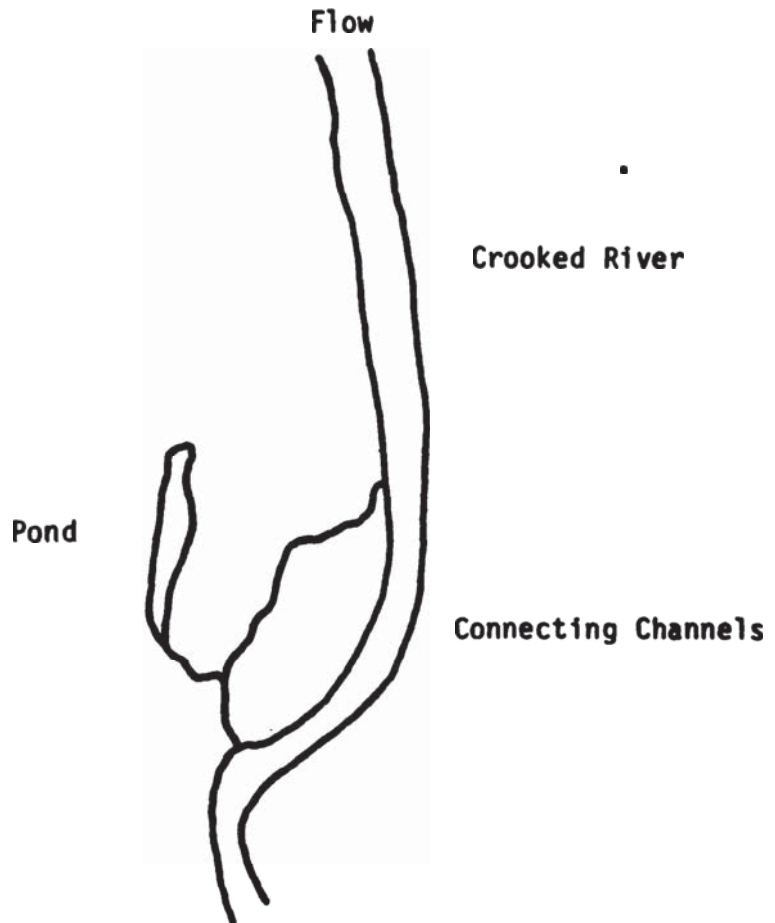
FIGURE 6

SITE 3 - POND CONNECTED AT DOWNSTREAM END ONLY

Pond = 130' x 18' = 2340 ft.²
Channels = 95' x 3' = 285 ft.²

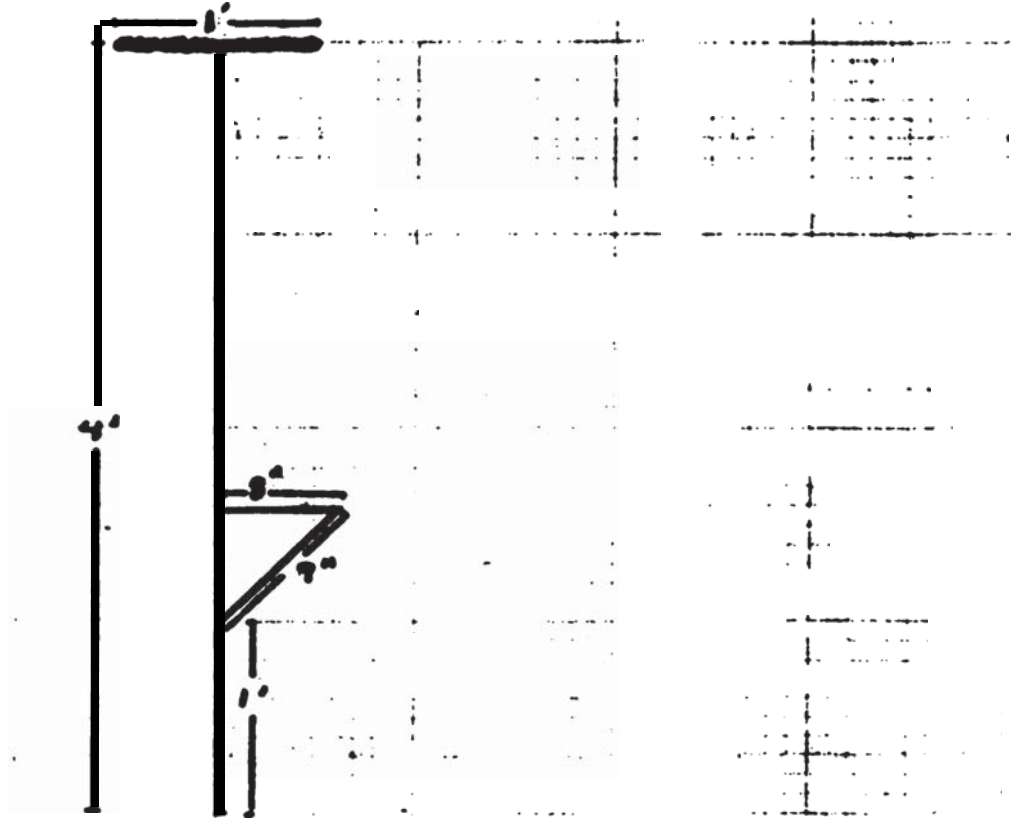
5/8 Diameter RE-BAR PLANTING TOOL
