Anan Wildlife Observatory Replacement

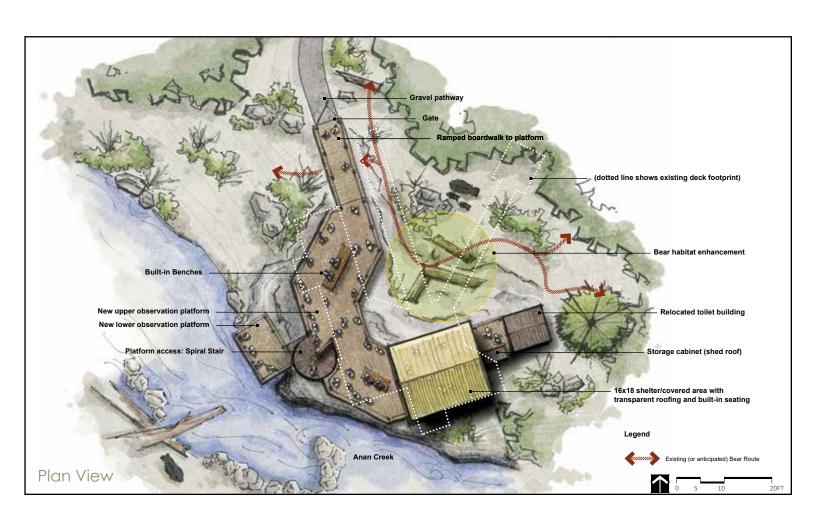
The proposed design is intended to accommodate up to 40 people. The existing toilet building will be relocated, and a new 16'x18' open shelter will be installed with seating and transparent roofing. Access to the lower deck will be via a spiral staircase. The design focuses on optimizing bear viewing, providing for public safety, and minimizing future maintenance.

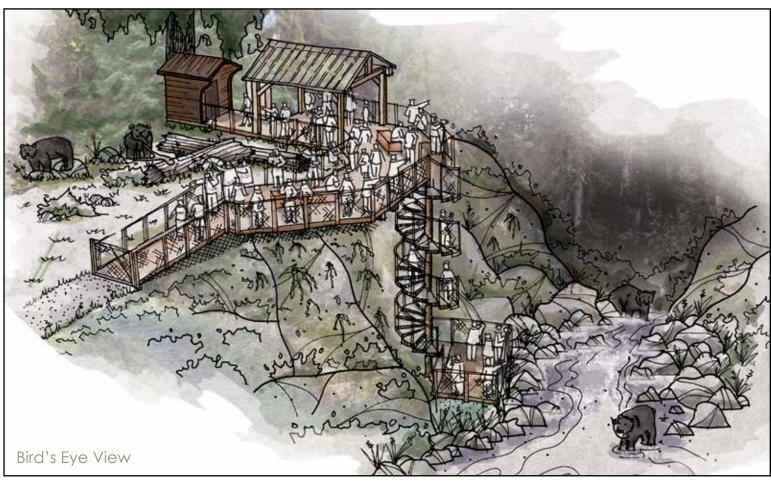
Timber decking

Cable mesh guardrail panels

The new structure will use western red cedar for decking and top rails. The infill within the guardrails will be chosen to minimize visual impact, with a material such as stainless steel mesh being a possible option. Seating will be wide western red cedar benches that will allow for placement of backpacks and camera equipment, in addition to seating. The shelter is placed back from the main view of bears on the creek, but will allow views up the creek. The shelter will have transparent roofing to minimize shady areas.
