Owl Creek Trail Assessment

Assessment Development

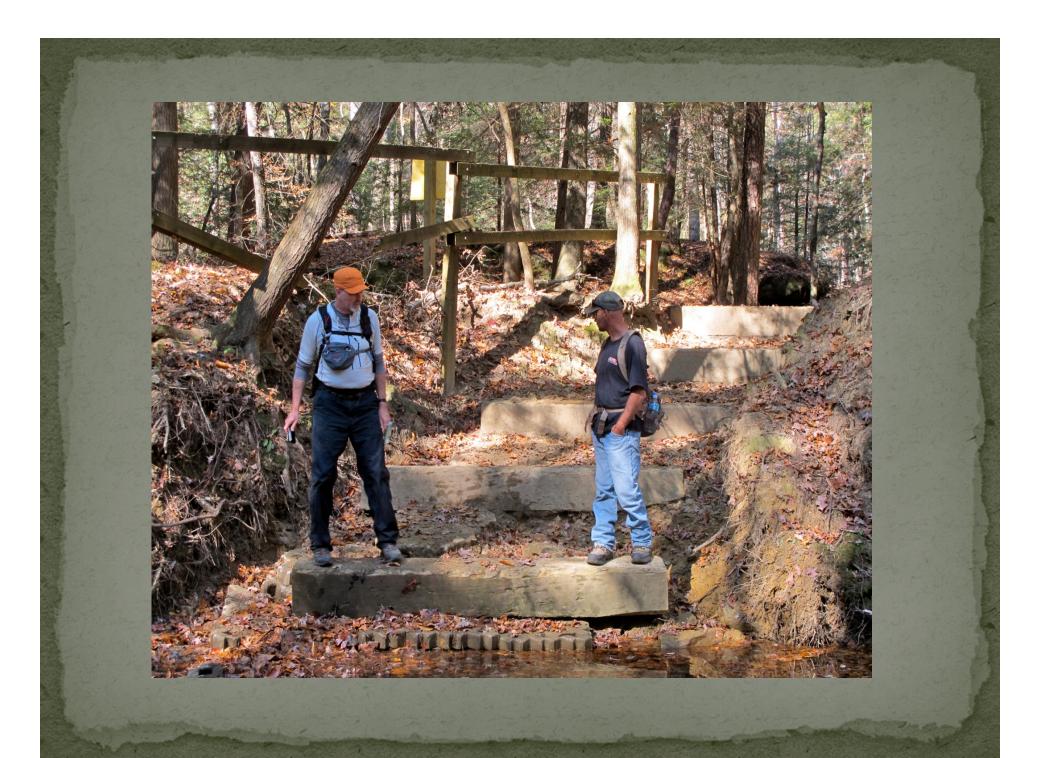
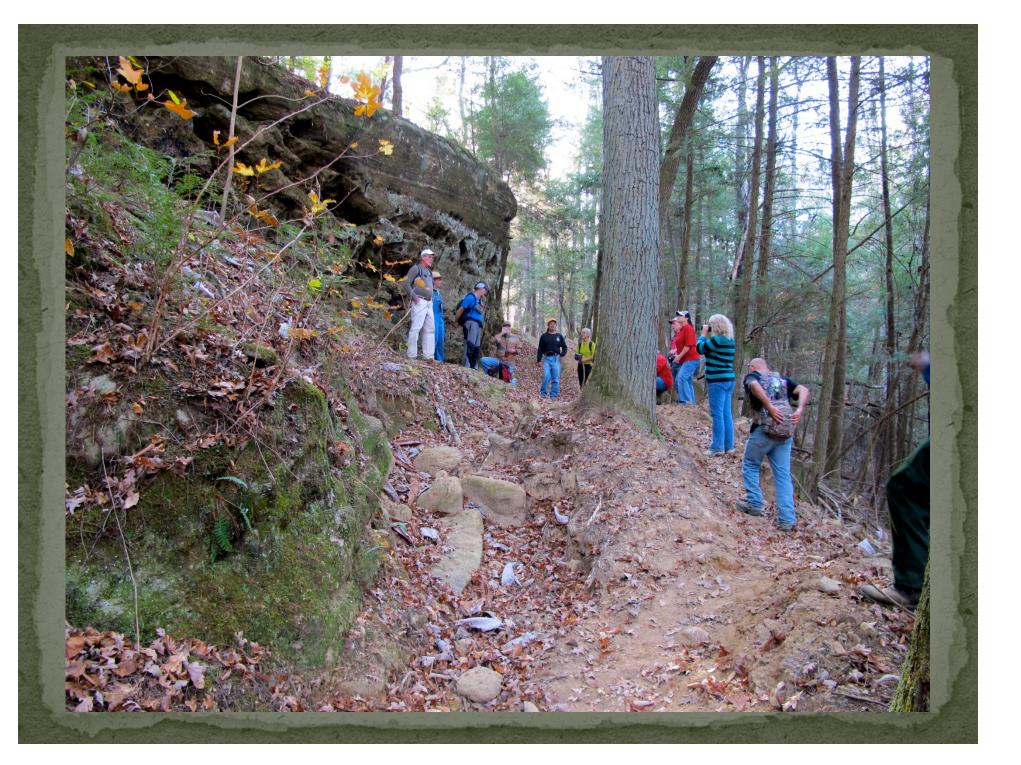
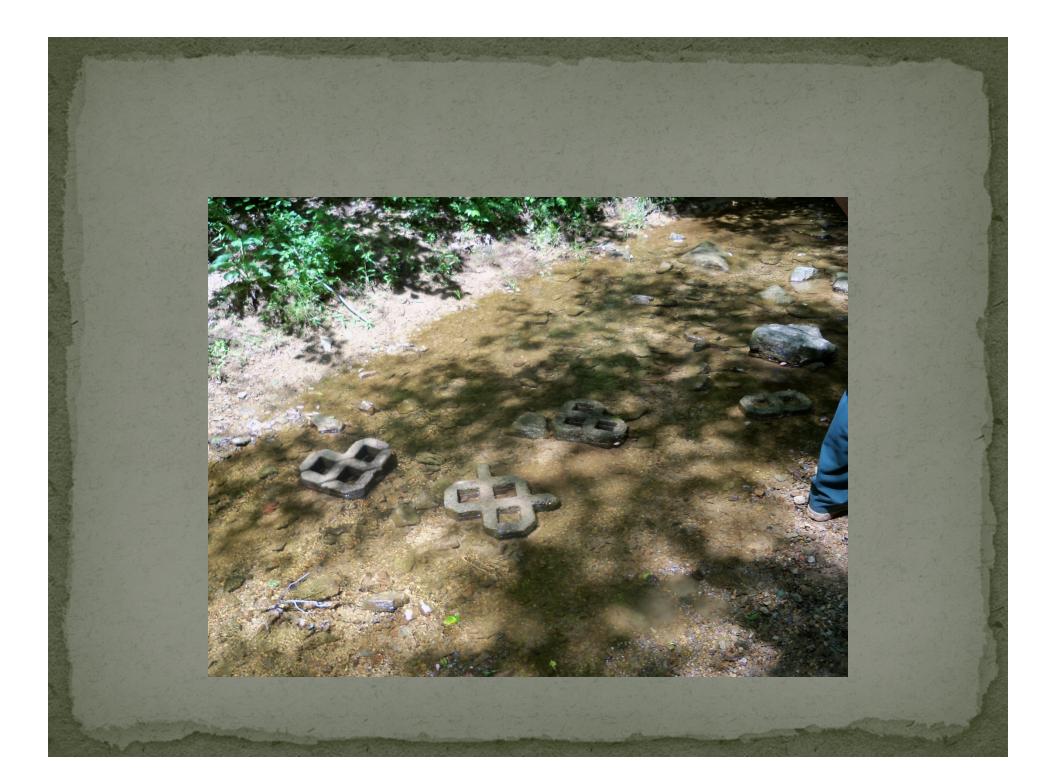
- Majority of the trails have become deeply incised carrying water to the bottom of drainages.
- Major sedimentation and erosion problems have also been identified where drainages are crossed. Mainly designated creek crossing.
- Less than 7% of mitigation by FS and volunteers still work.
- Trails below the outcrop elevation has significant erosion and soil deposition hydrology and friable soils
